Rehabilitation of reinforced concrete slab-column system using CFRP sheets.

**REHABILITATION OF REINFORCED CONCRETE SLAB-COLUMN SYSTEM
USING CFRP SHEETS**

Submitted to the Faculty of Graduate Studies and Research
through Civil Engineering
in Partial Fulfillment of the Requirements for
the Degree of Master of Applied Science at the
University of Windsor

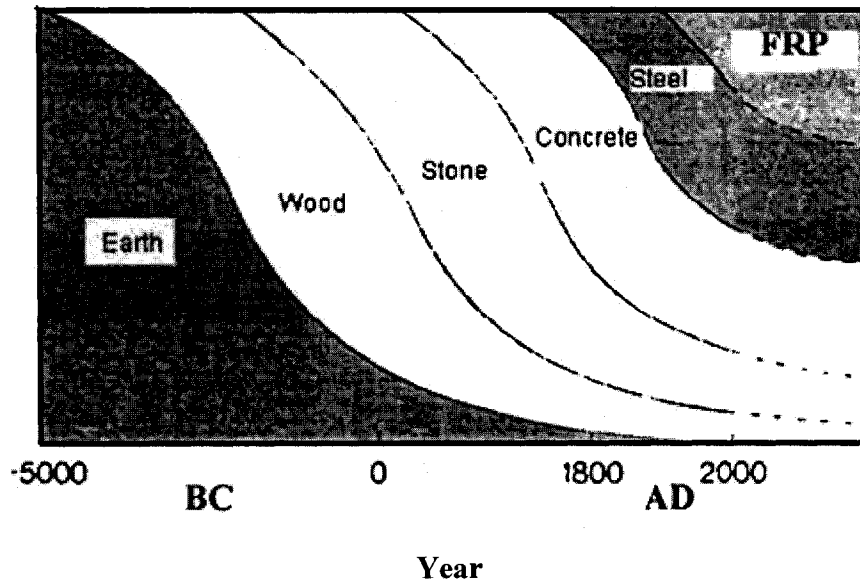
Fig. 2-1: Construction materials in different ages

Buildings and construction are an important symbol of civilization. Different materials have been used throughout the ages. Earth was the first material used for this purpose, the oldest civilization; Sumer, Iraq, (3500BC - 1792BC) had few natural resources, but Sumerians used what they had wisely; they built with earth and water to make bricks of clay. Straw (fiber) was added to clay as reinforcement material to protect clay bricks from cracking. Through the history, the usage of earth became less common as new materials such as wood, stone, concrete, steel and finally Fiber Reinforced Polymers (FRP) were introduced (Figure 2-1).

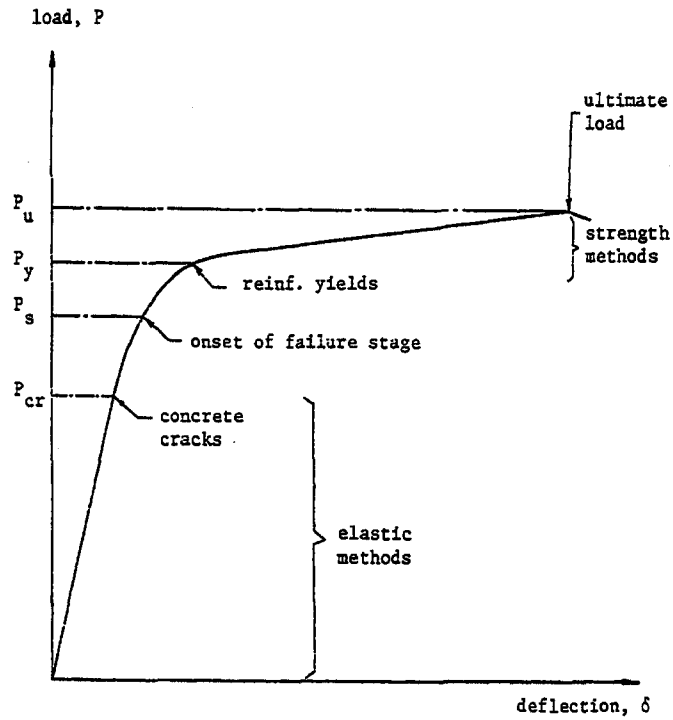
P_{cr} = flexural cracking load

P_s = Shear-cracking load

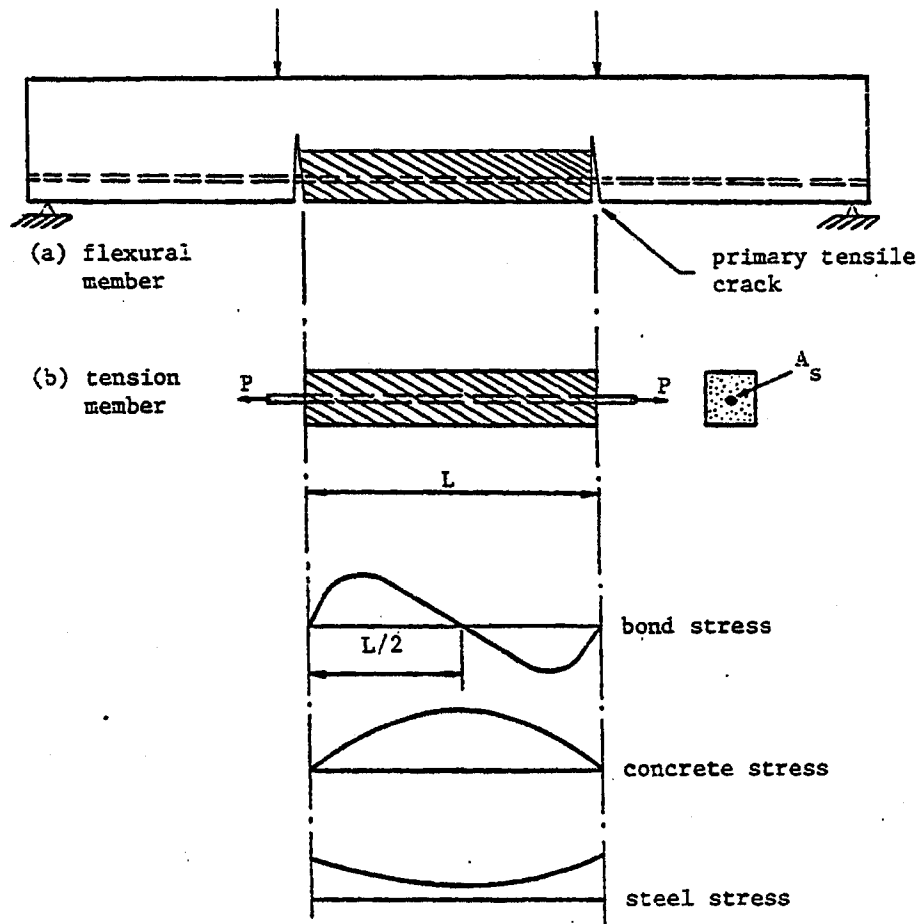
Fig. 2-5: Flexural and tension members after cracking

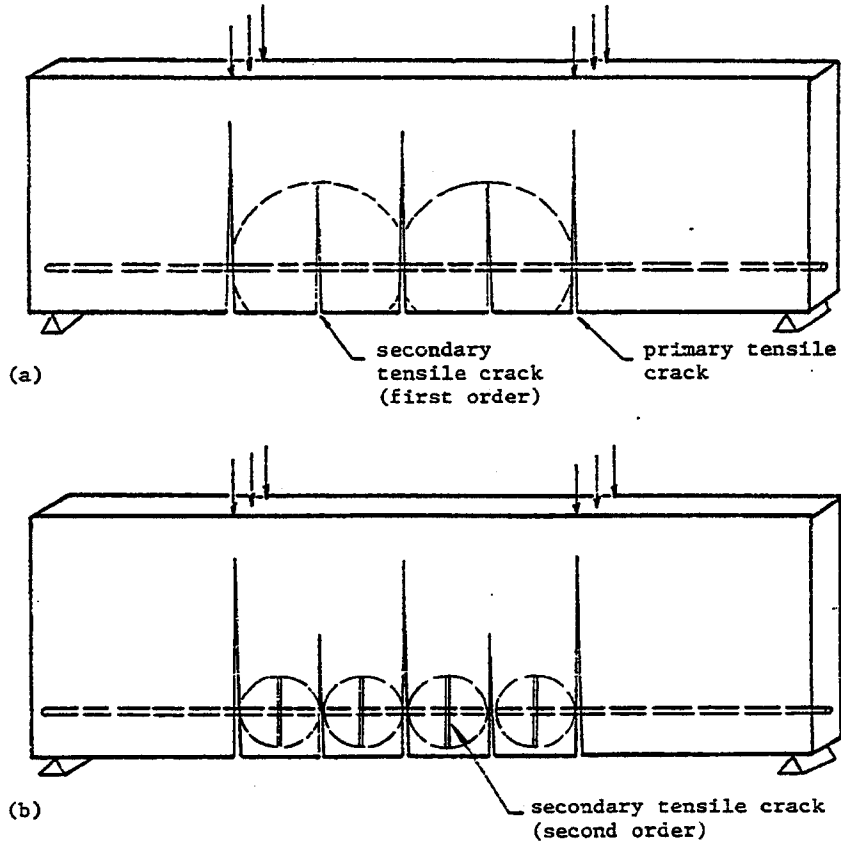
Fig. 2-7: Mechanism of tension cracking in flexural member

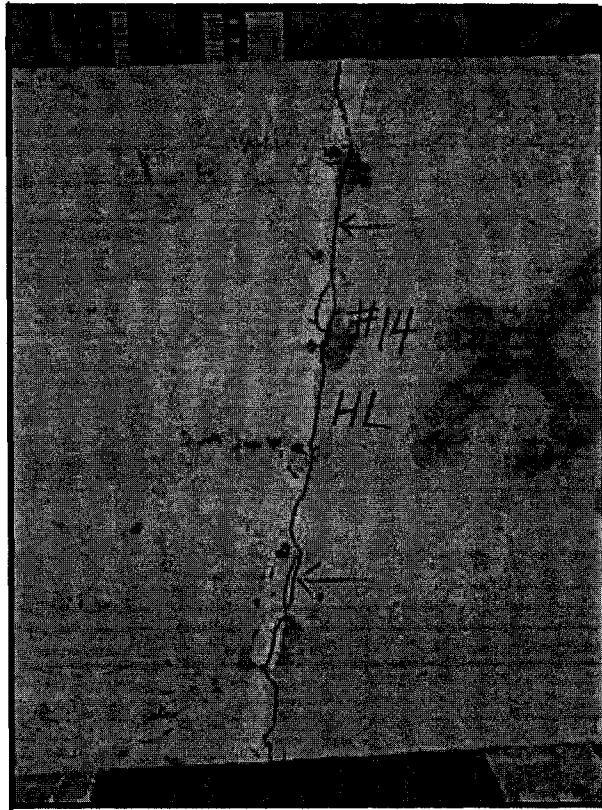
Fig. 2-8: Typical failure of slab specimens after repaired
(New crack adjacent to the original but outside of repaired crack)
(NAHB Research Center, Inc.)

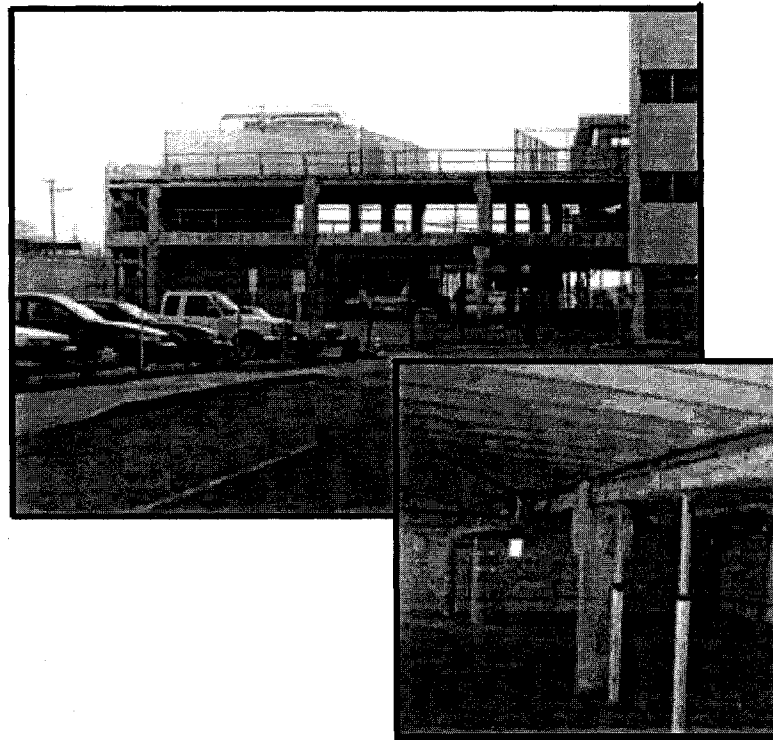
Fig. 2-14: City Court Garage, Arizona
(Repair of corrosion damaged T-beams using GFRP)
QuakeWrap, Inc. (<http://www.quakewrap.com>)

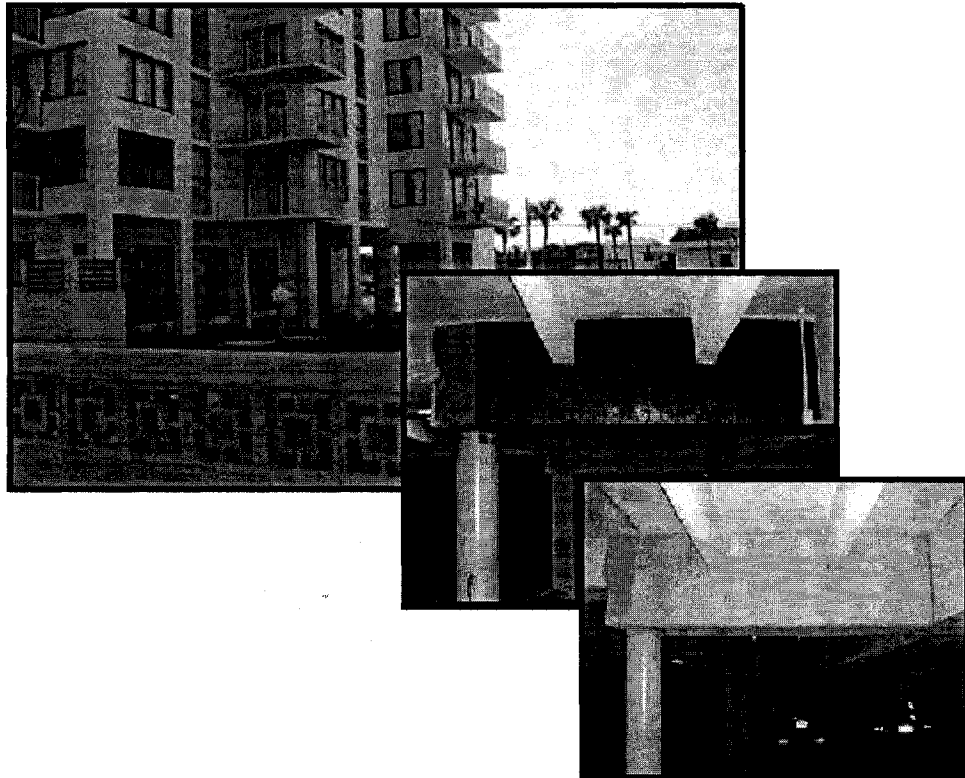
Fig. 2-17: Parking structure of the Oceans One Condominium
(Repair of corrosion damaged and shear cracking beam with CFRP)

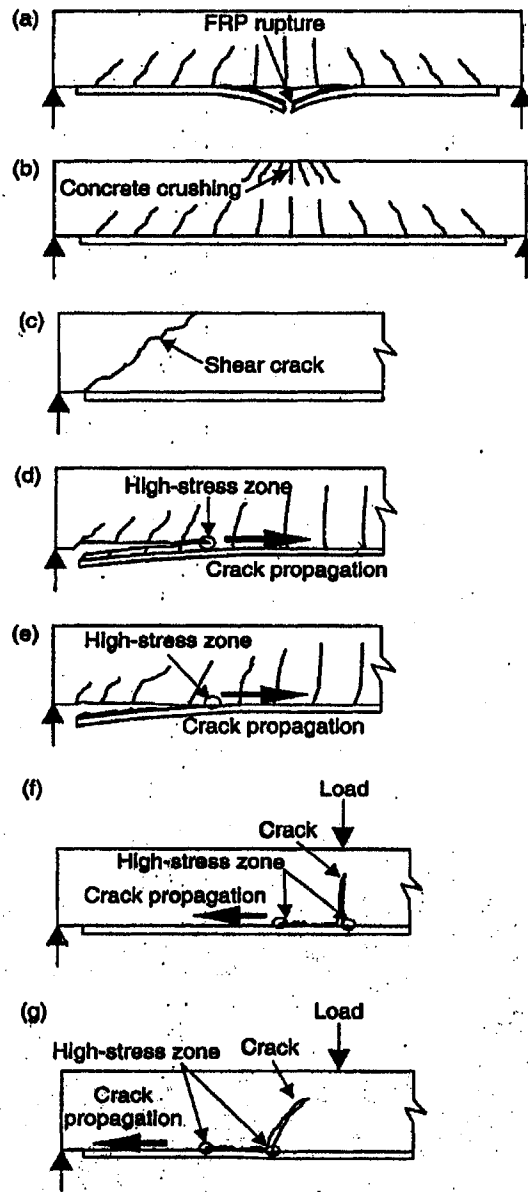
Fig. 2-25: Failure modes of FRP in RC beams

(a) FRP rupture; (b) crushing of compressive concrete; (c) tensile concrete failure; (d) concrete cover separation; (e) plate end interfacial debonding; (f) intermediate flexural crack-induced interfacial debonding; (g) intermediate flexural shear crack-induced interfacial debonding.

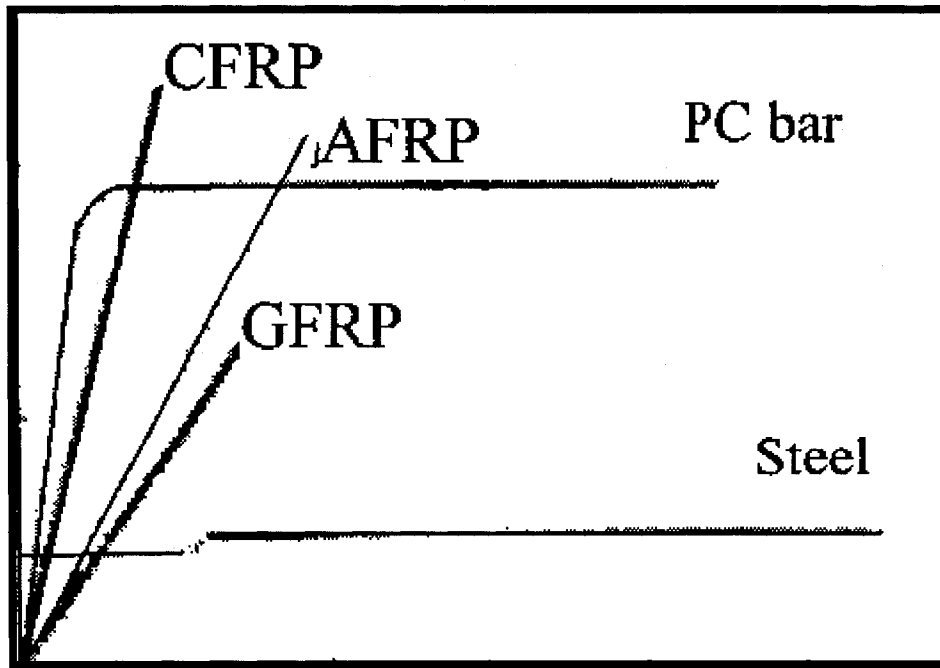
Fig. 2-26: Typical stress-strain curves for some fiber reinforced polymer composite

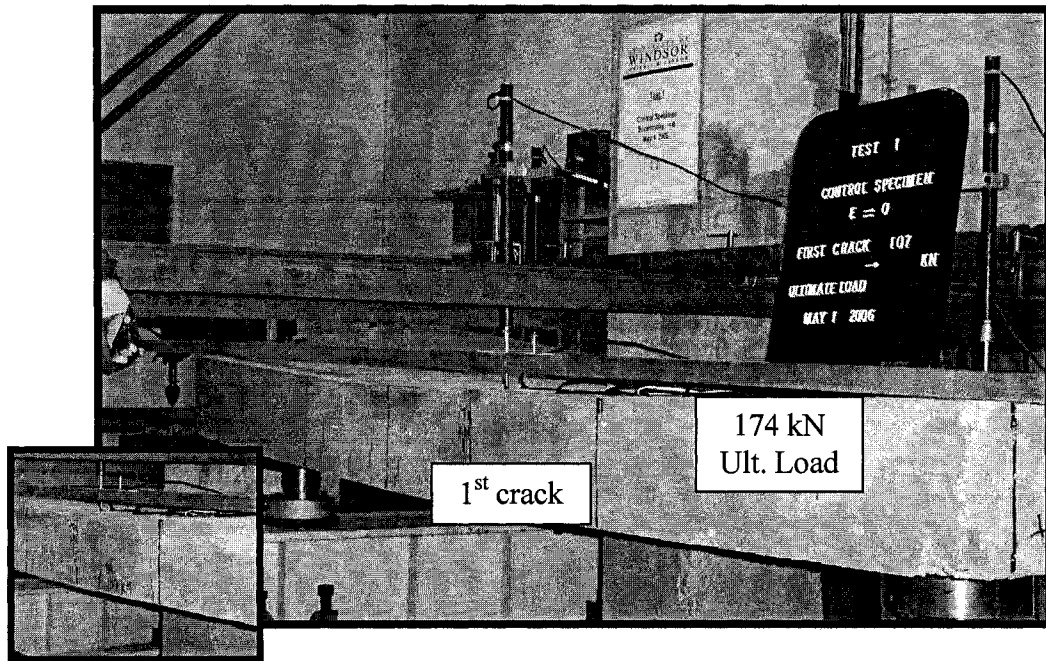
Fig. 3-47: The control specimen (CTRL0) after failure

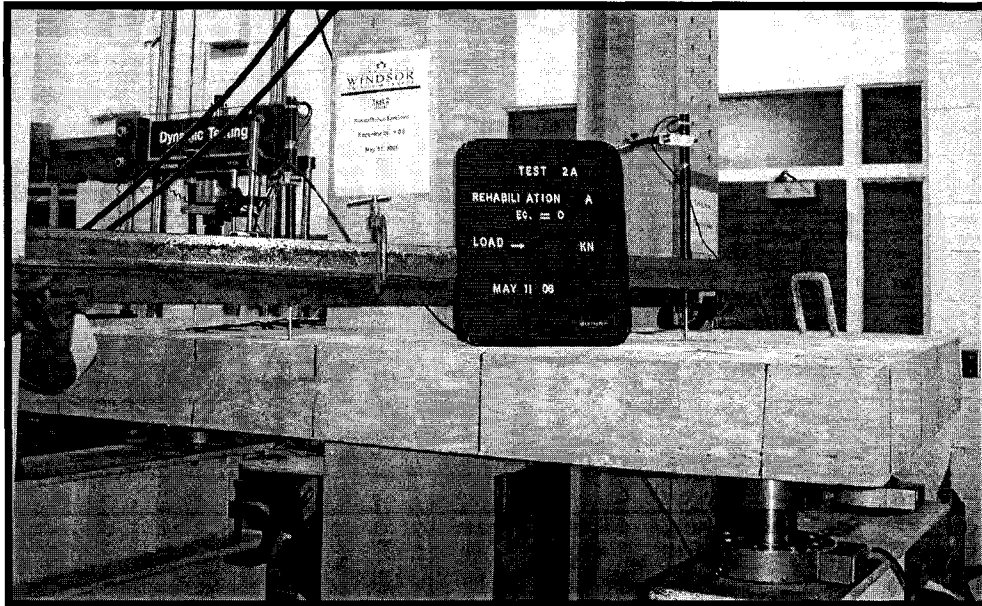
Fig. 3-48: The cracked specimen (CRAK0) before test

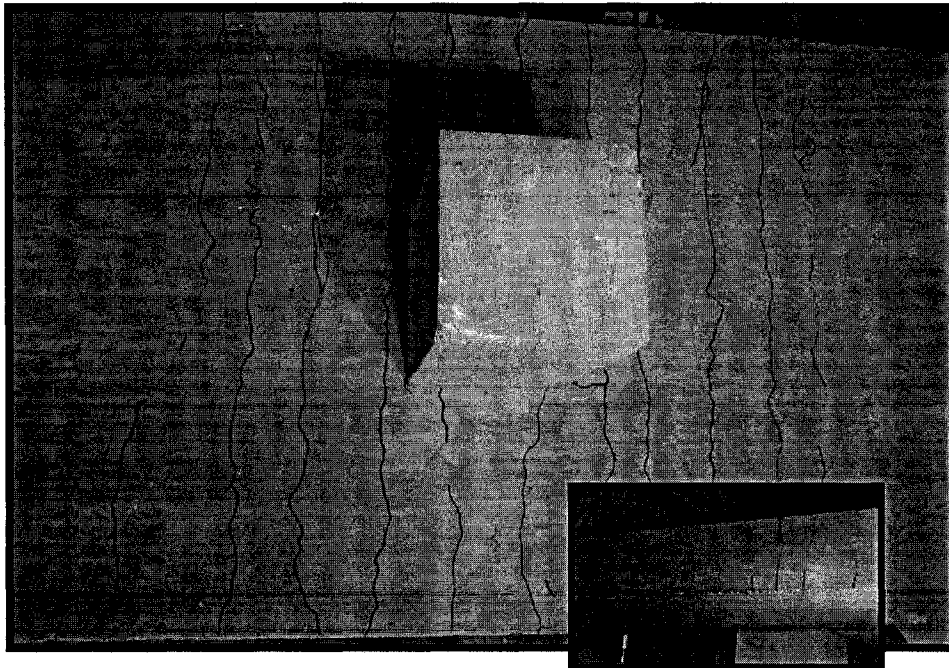
Fig. 3-49: The cracked specimen (CRAK0) after failure

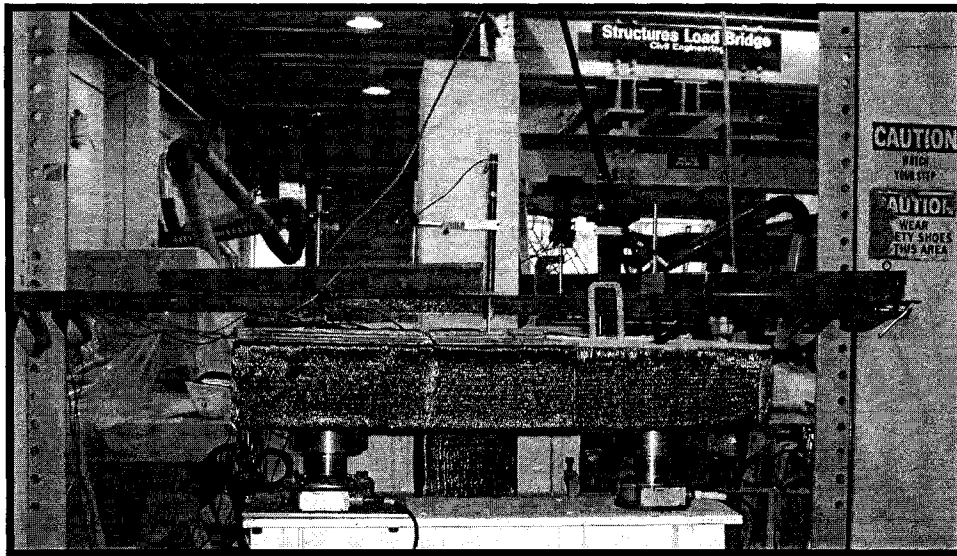
Fig. 3-50: The rehabilitated specimen (REHB0) before testing

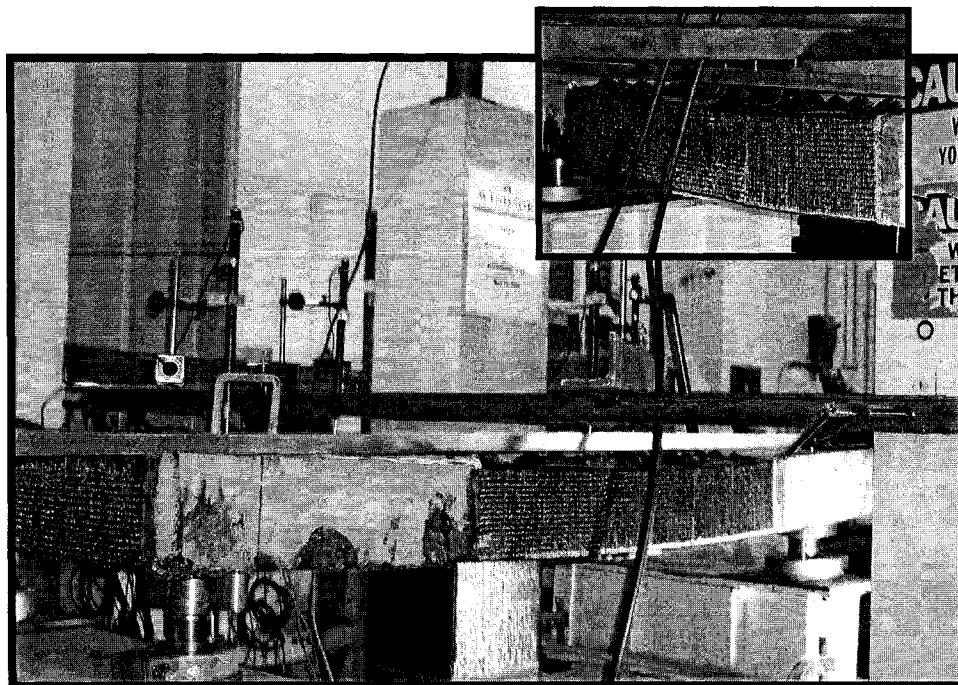
Fig. 3-51: The rehabilitated specimen (REHB0) after failure

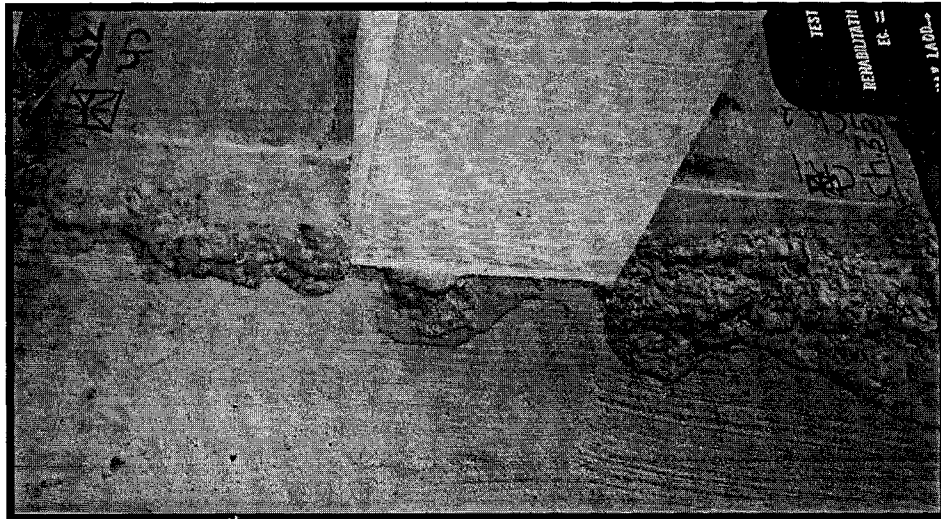
Fig. 3-52: The rehabilitated specimen (REHB0) after failure

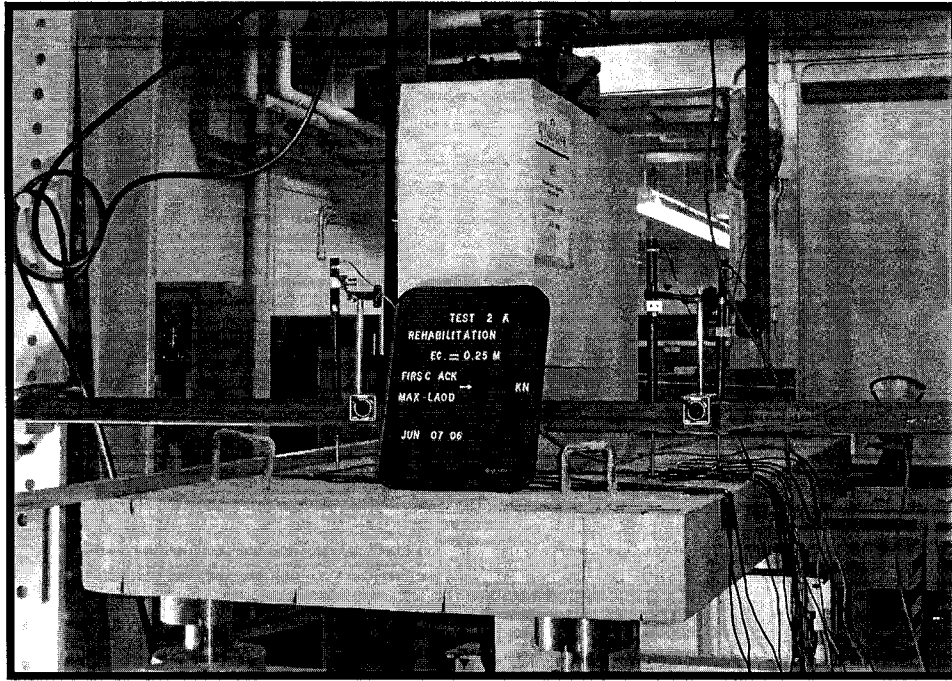
Fig. 3-56: The cracked specimen (CRAK25) before testing

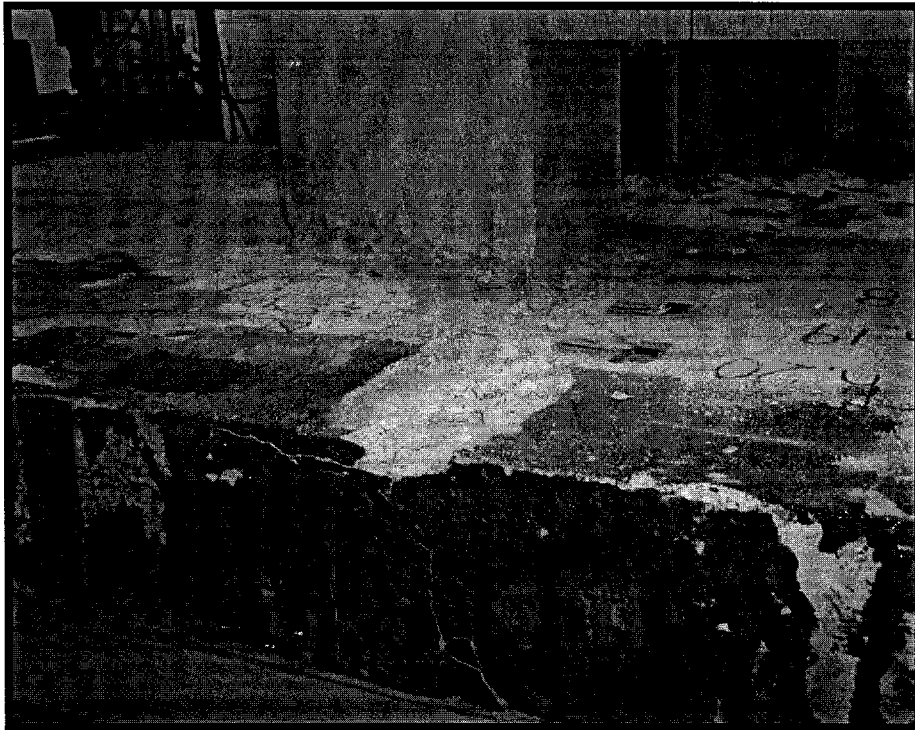
Fig. 3-59: The rehabilitated specimen (REHAB25) after failure
(after removing CFRP from the side)

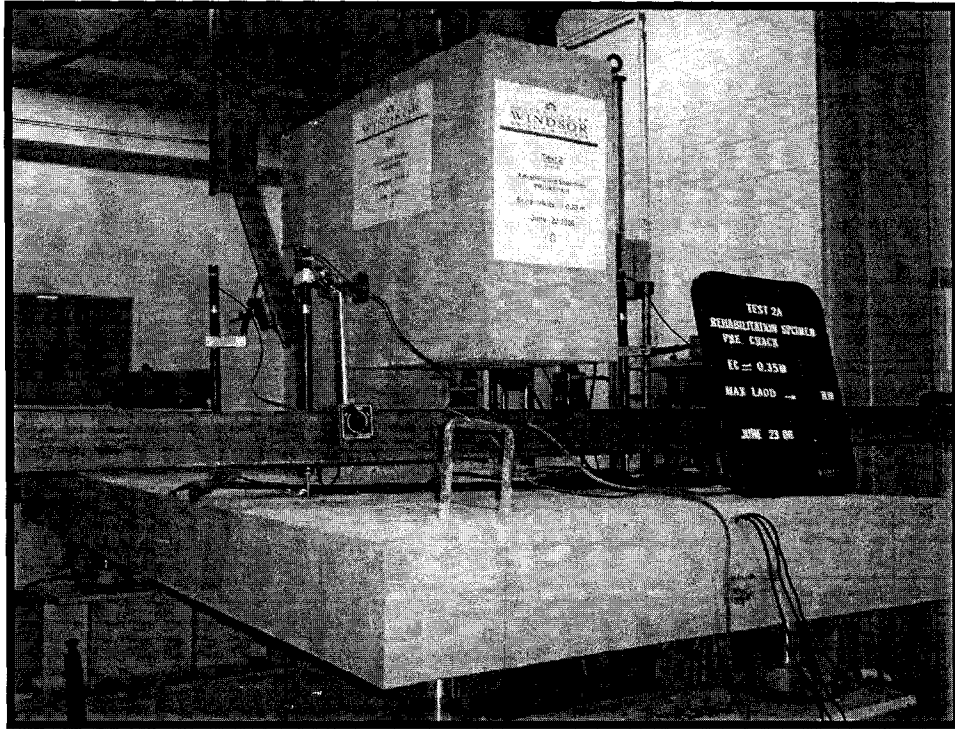
Fig. 3-62: The cracked specimen (CRAK35) before test

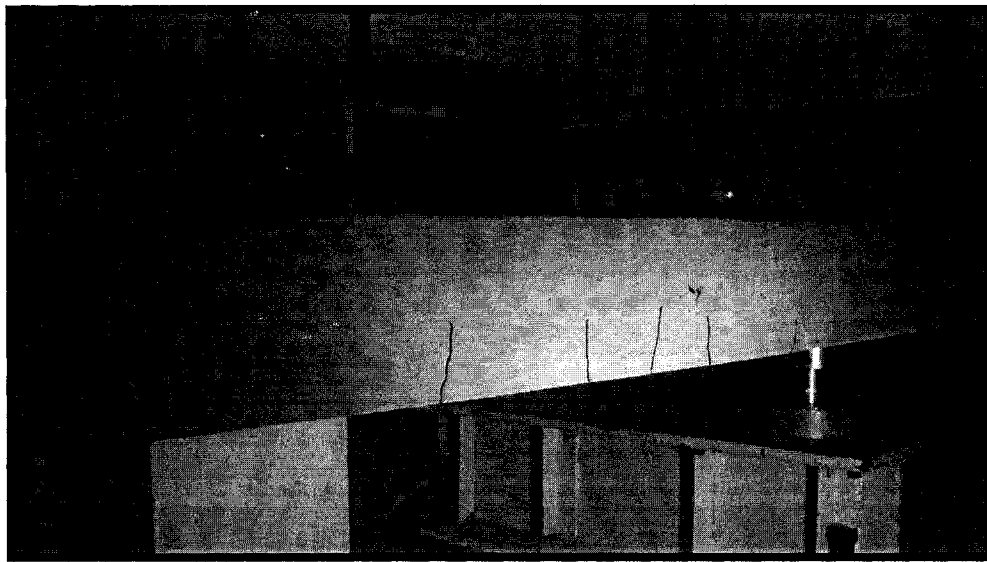
Fig. 3-63: The cracked specimen (CRAK35) after failure

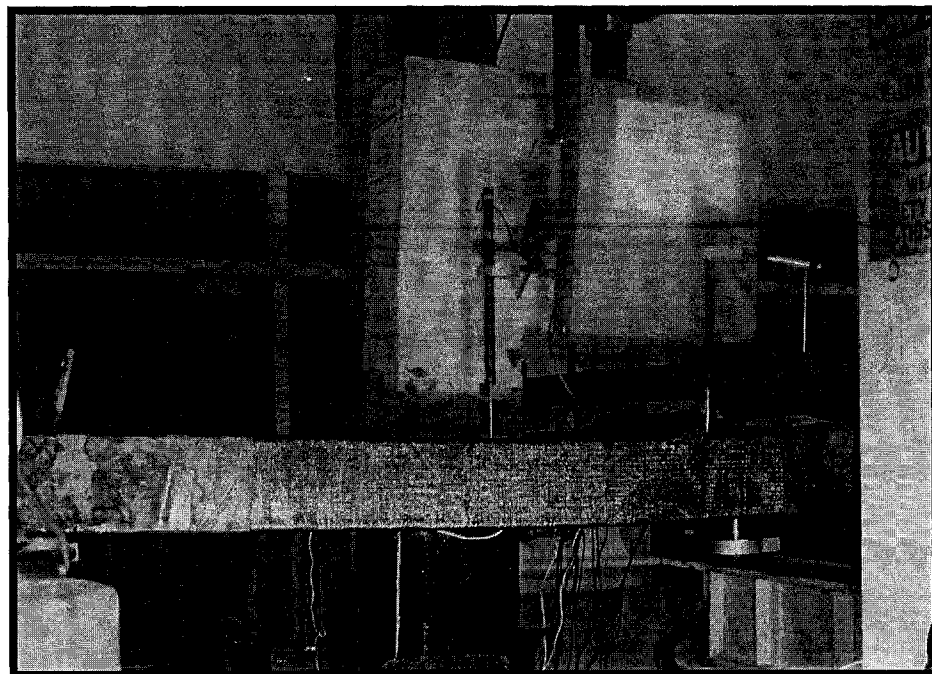
Fig. 3-67: The rehabilitated specimen (REHAB35) after failure

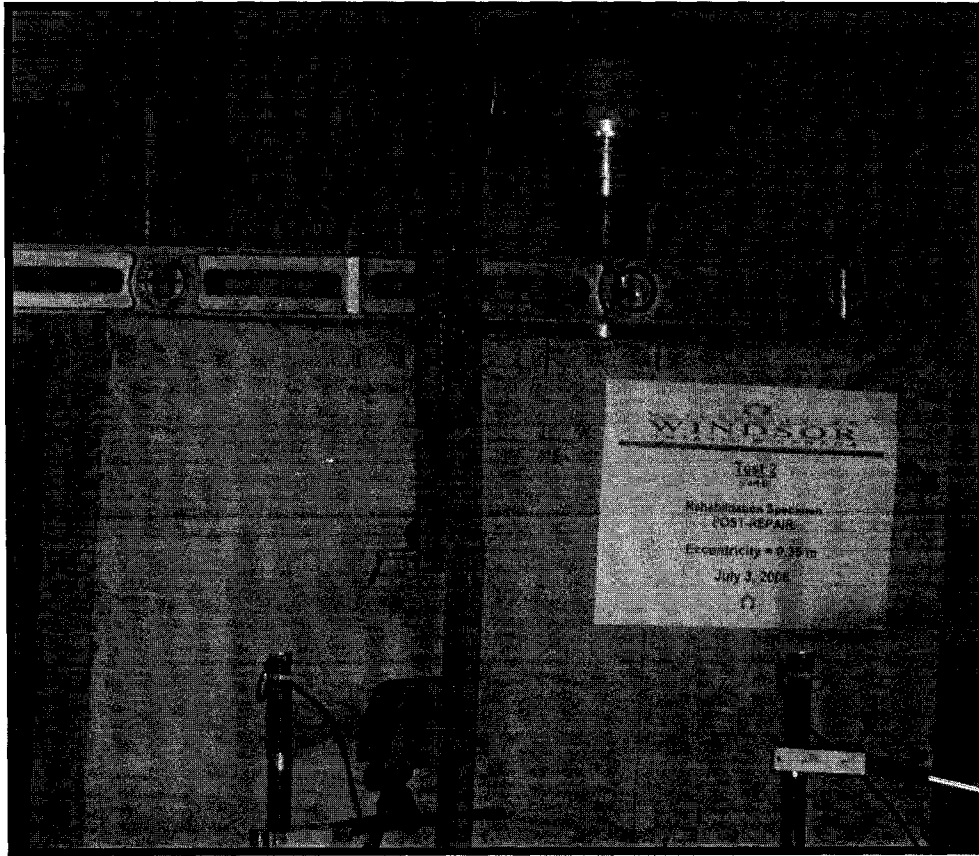
Fig. 3-68: The rehabilitated specimen (REHAB35) after failure

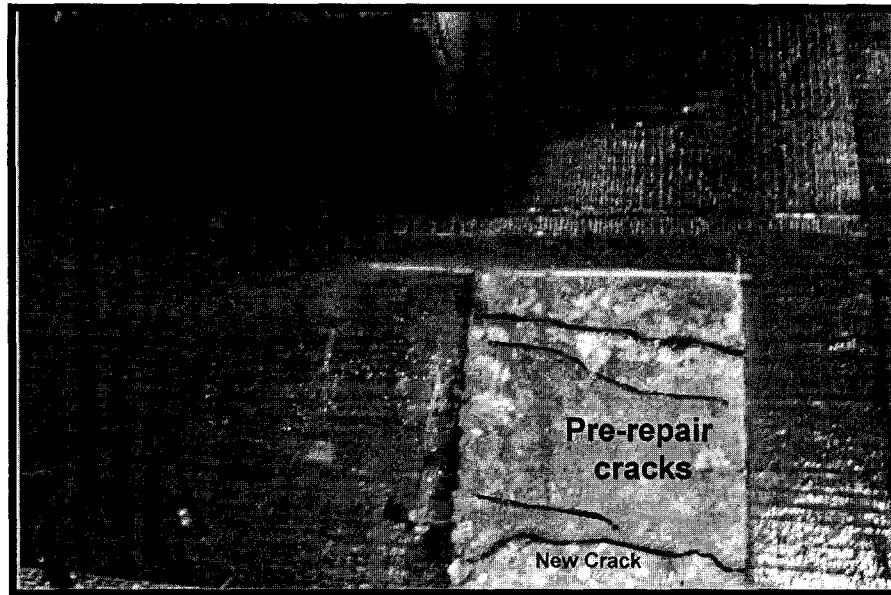
Fig. 3-69: The rehabilitated specimen (REHAB35) after failure (after removing CFRP from the bottom side, tension zone, of the slab)

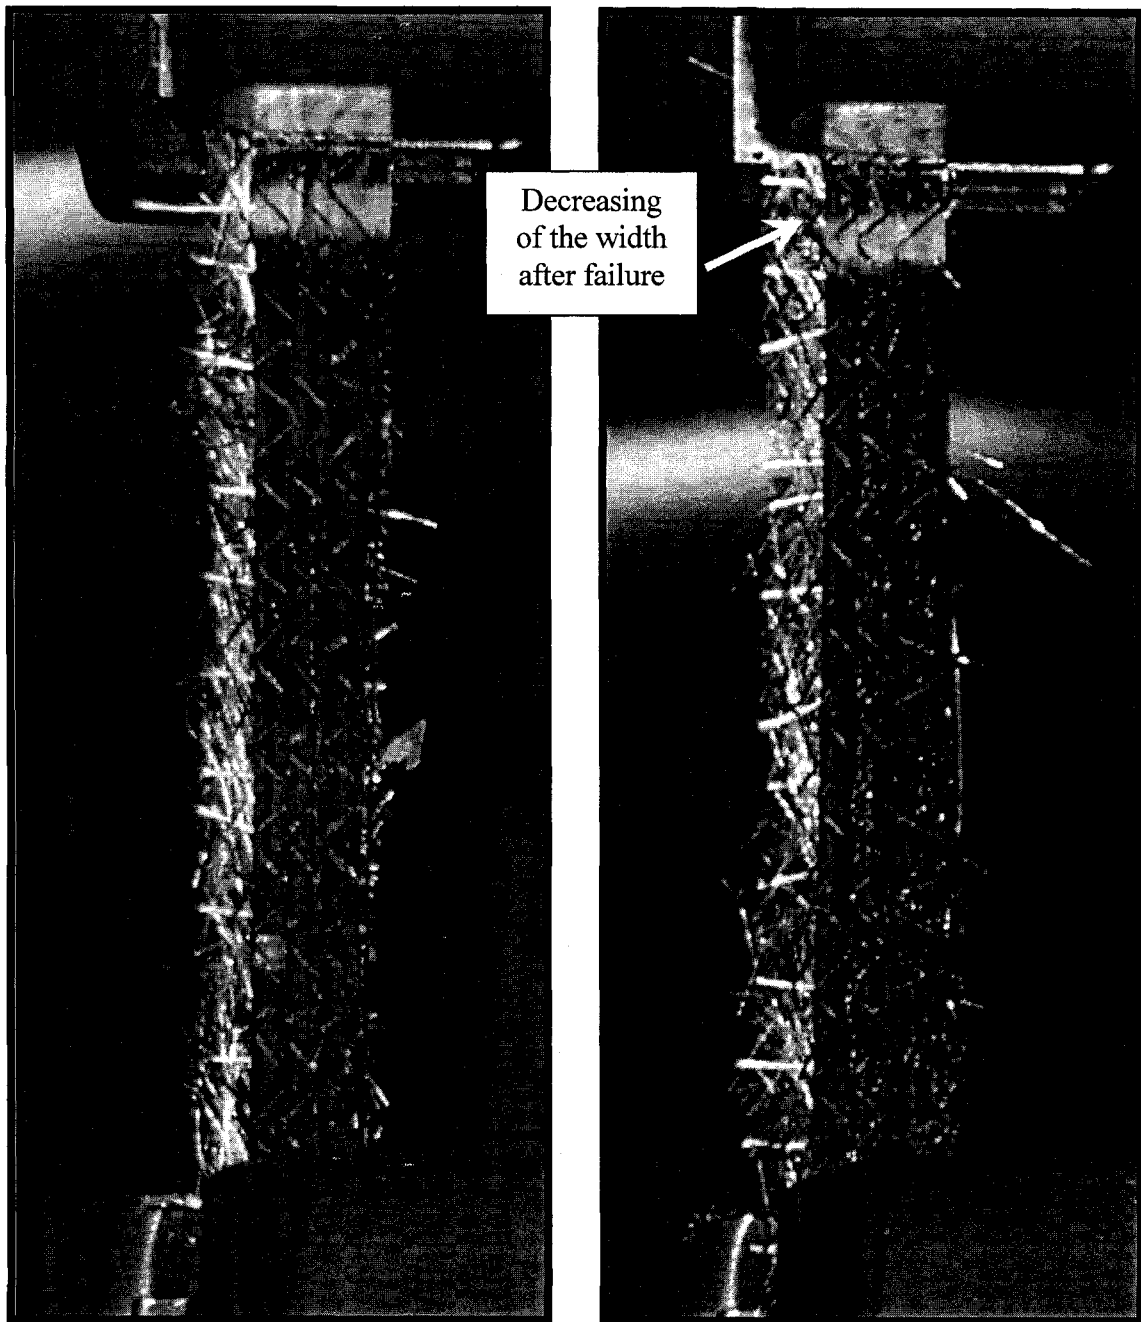
During the test

After failure

Fig. 3-78: Tensile test of CFRP sheets

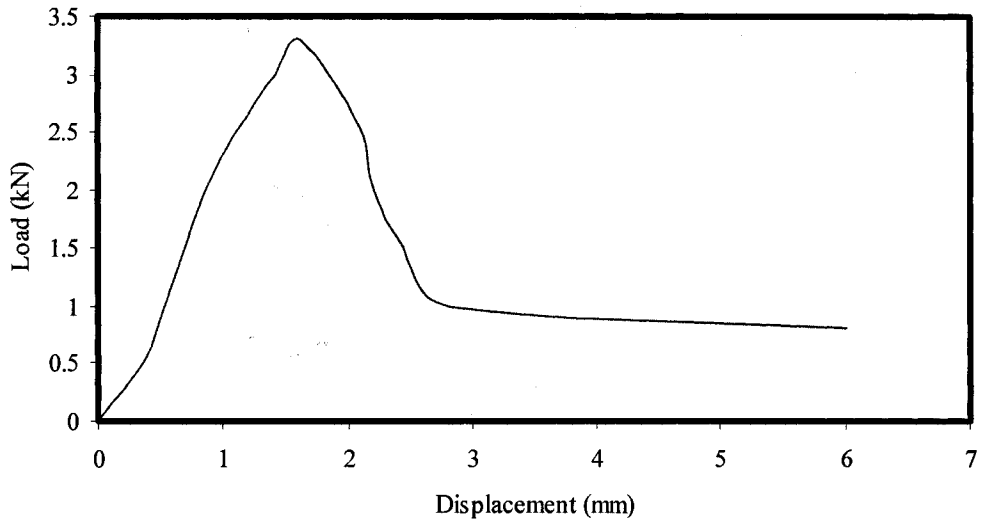
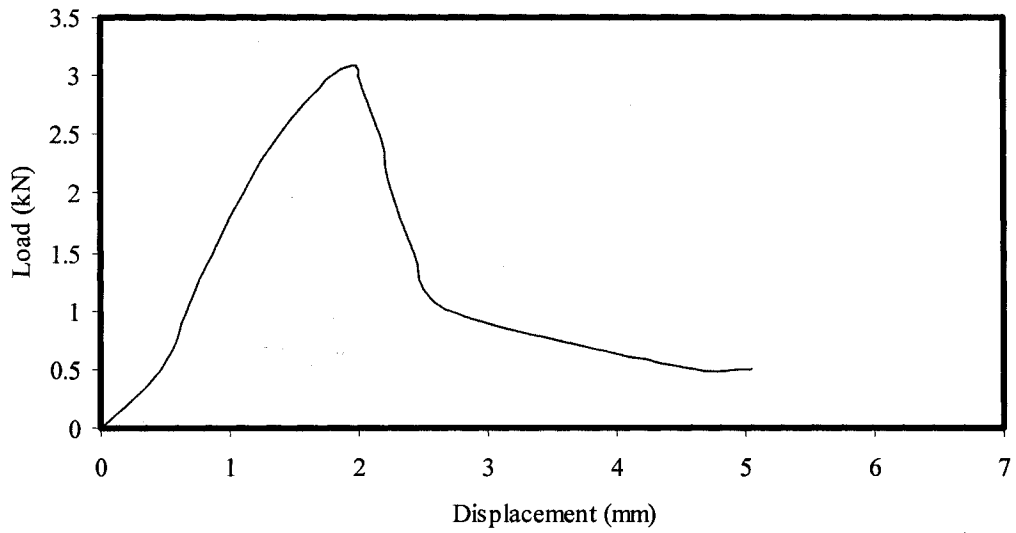
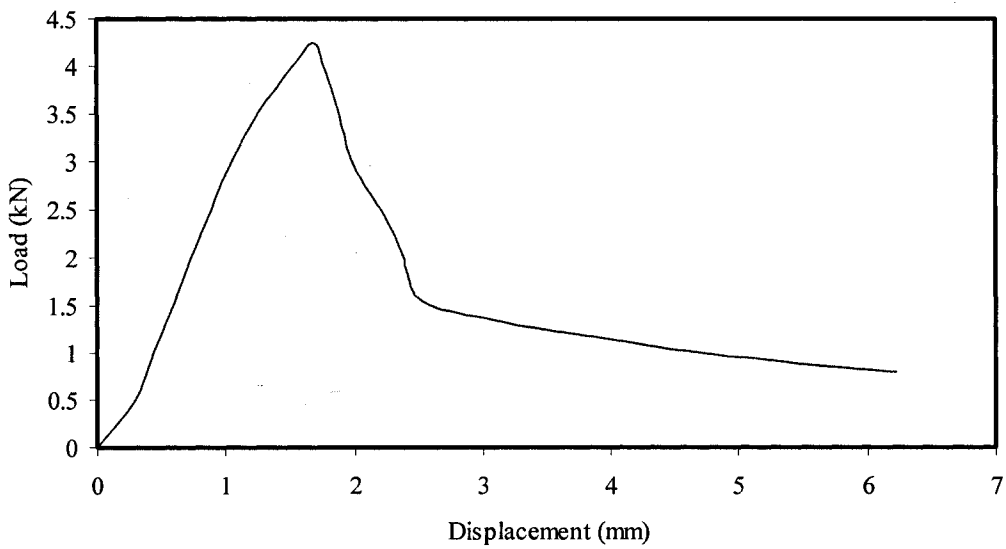
Fig. 3-79: CFRP sheets tensile strength test (Load-Displacement relationship)

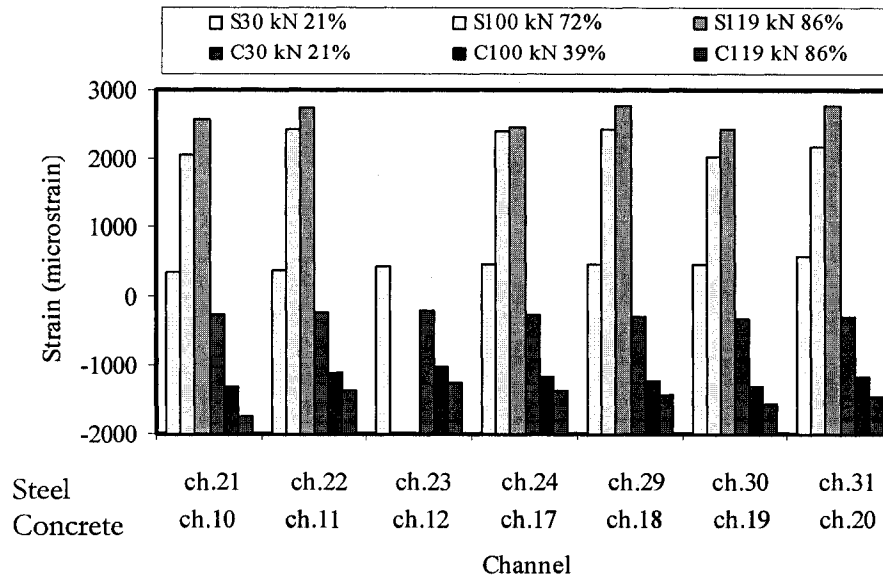
Fig. 4-94: Concrete and Steel strain response on the long direction control specimen (CTRL25) (Flexural failure)

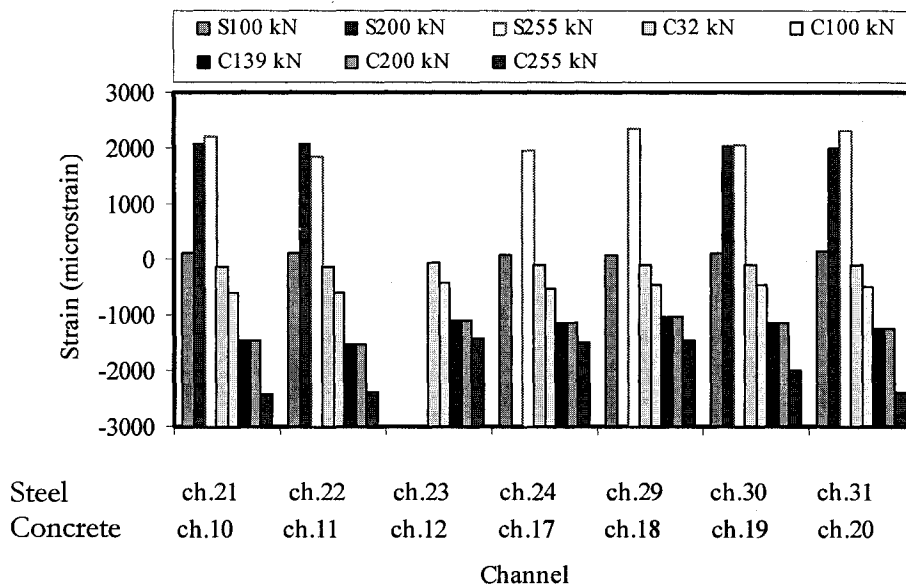
Fig. 4-95: Concrete and Steel strain response on the long direction Rehabilitated specimen (REHB25)

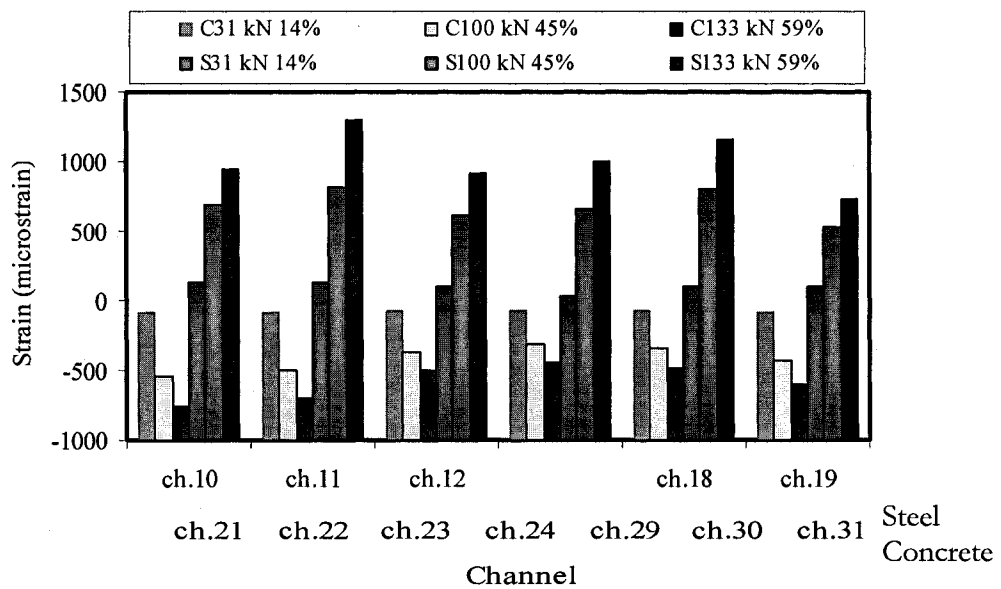
Fig. 4-140: Concrete and Steel strain response on the long direction
Rehabilitated specimen (REHB35)
(Flexural failure)

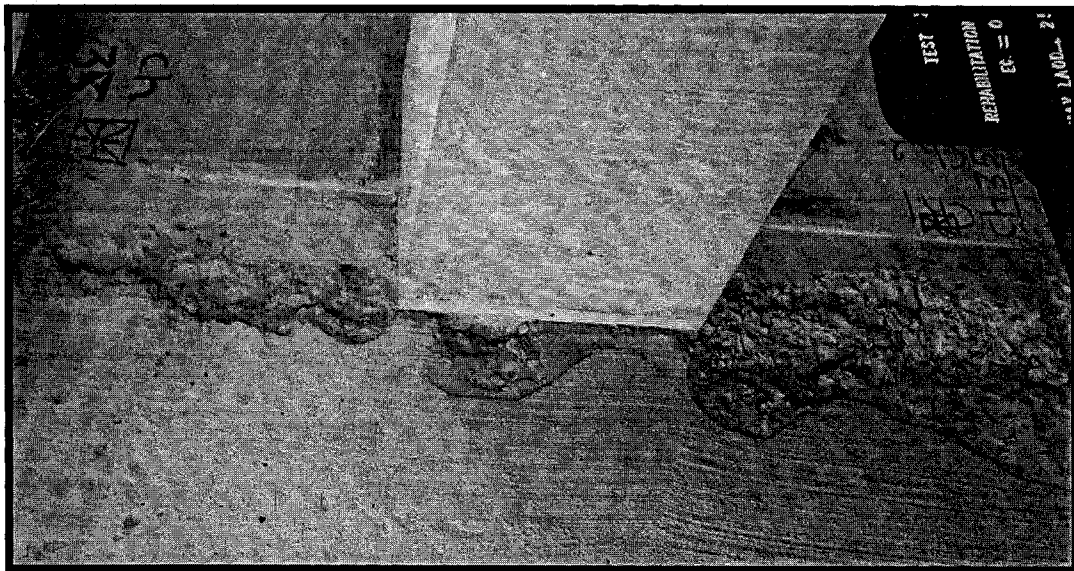
Fig. 4-164: The rehabilitated specimen (REHB0) after failure and moving

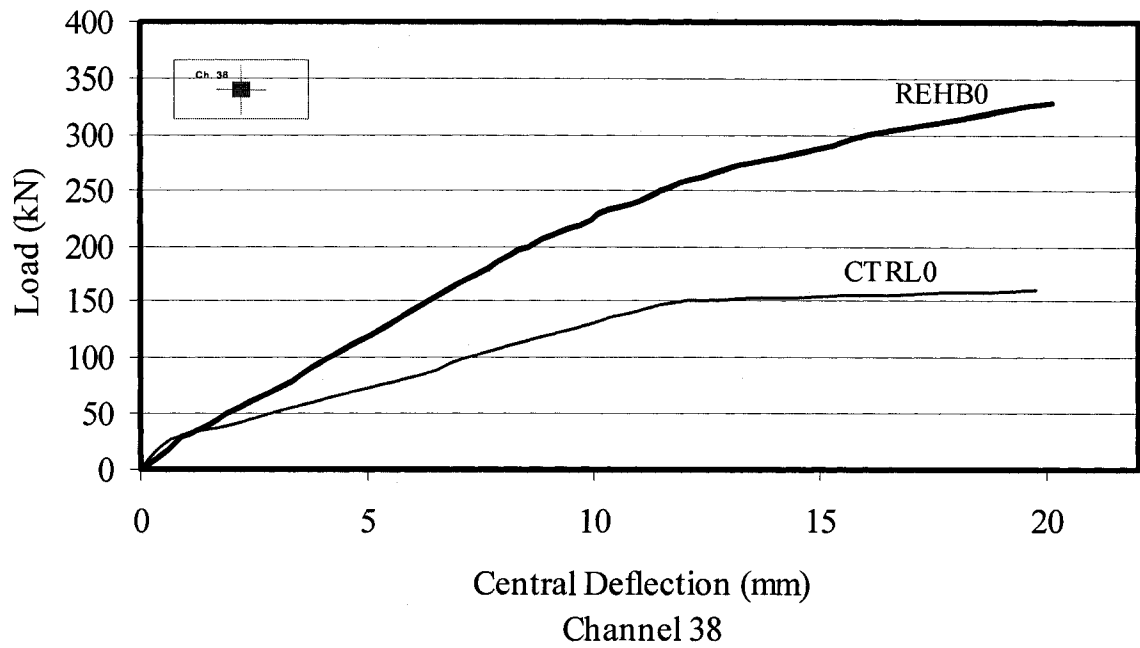
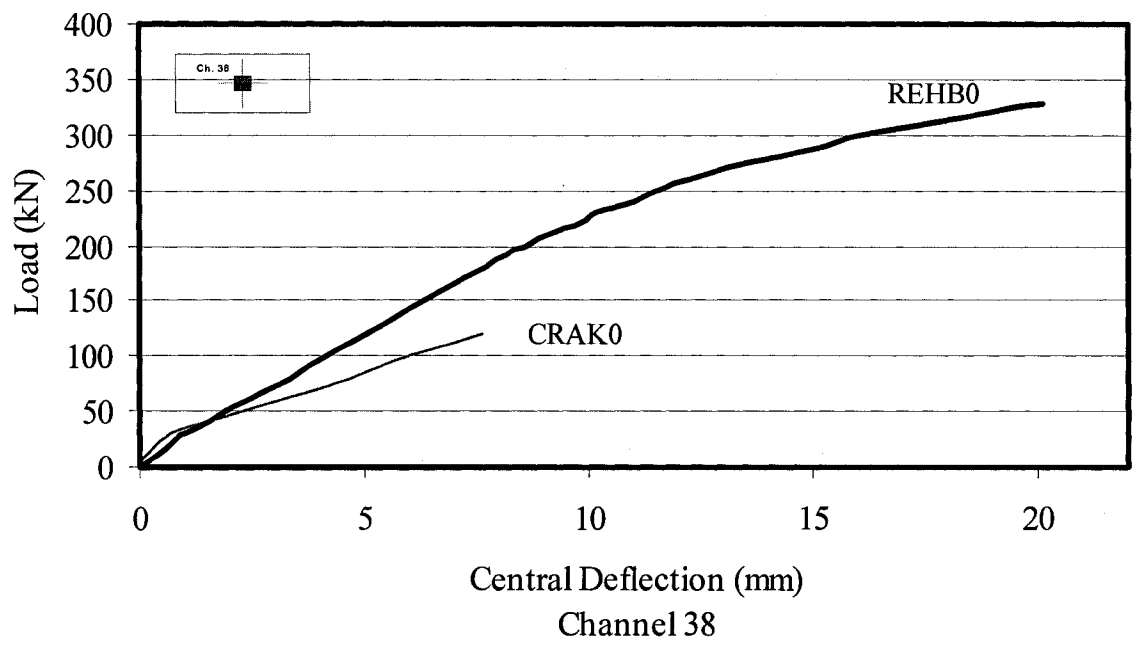
Fig. 4-165: Load versus central deflection for group I specimens (Ch. 38)

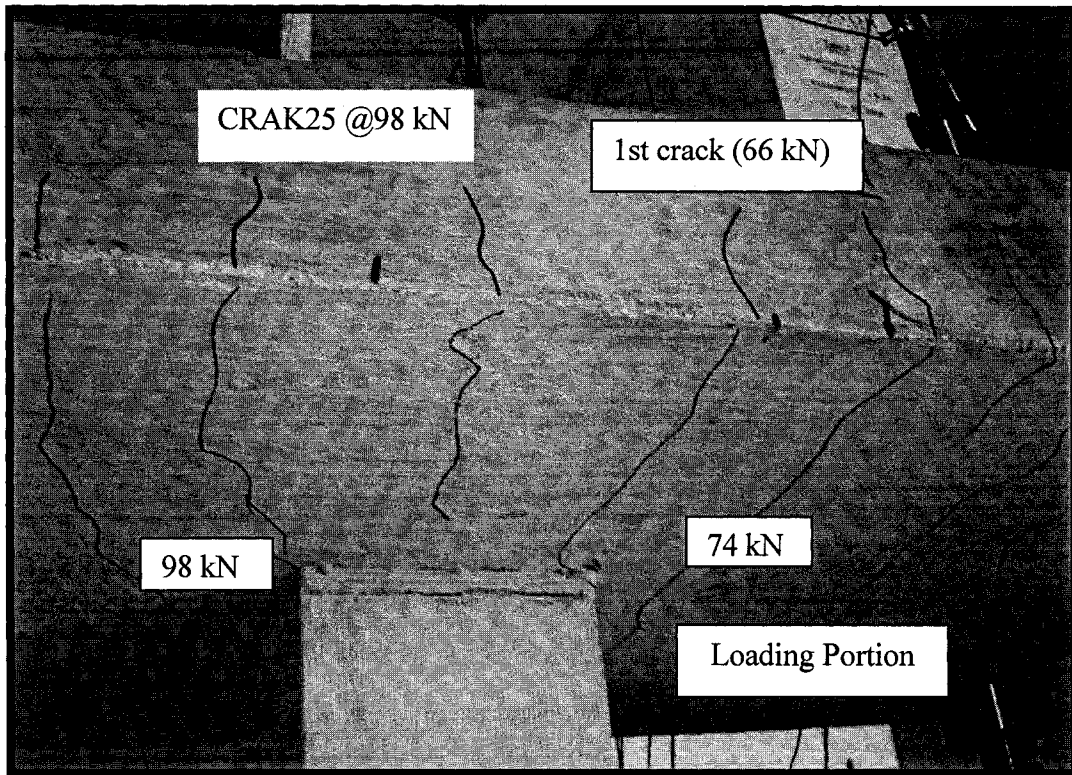
Fig. 4-169: The cracked specimen (CRAK25) at 99 kN applied jacking load
