Rehabilitation of reinforced concrete slab-column system using CFRP sheets.

**REHABILITATION OF REINFORCED CONCRETE SLAB-COLUMN SYSTEM
USING CFRP SHEETS**

Submitted to the Faculty of Graduate Studies and Research
through Civil Engineering
in Partial Fulfillment of the Requirements for
the Degree of Master of Applied Science at the
University of Windsor

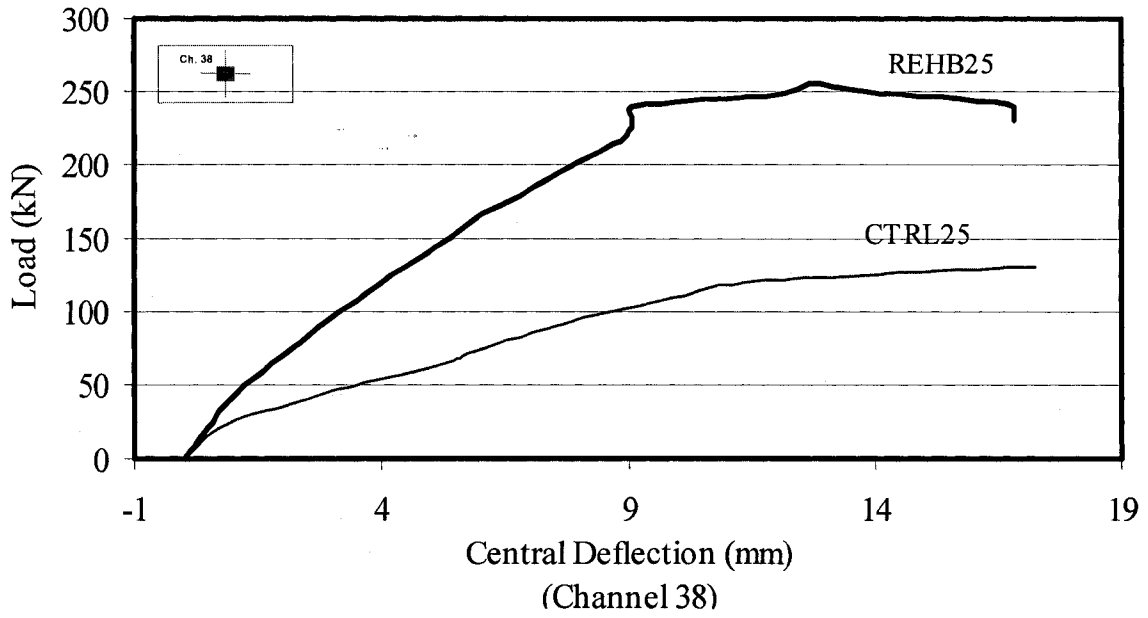
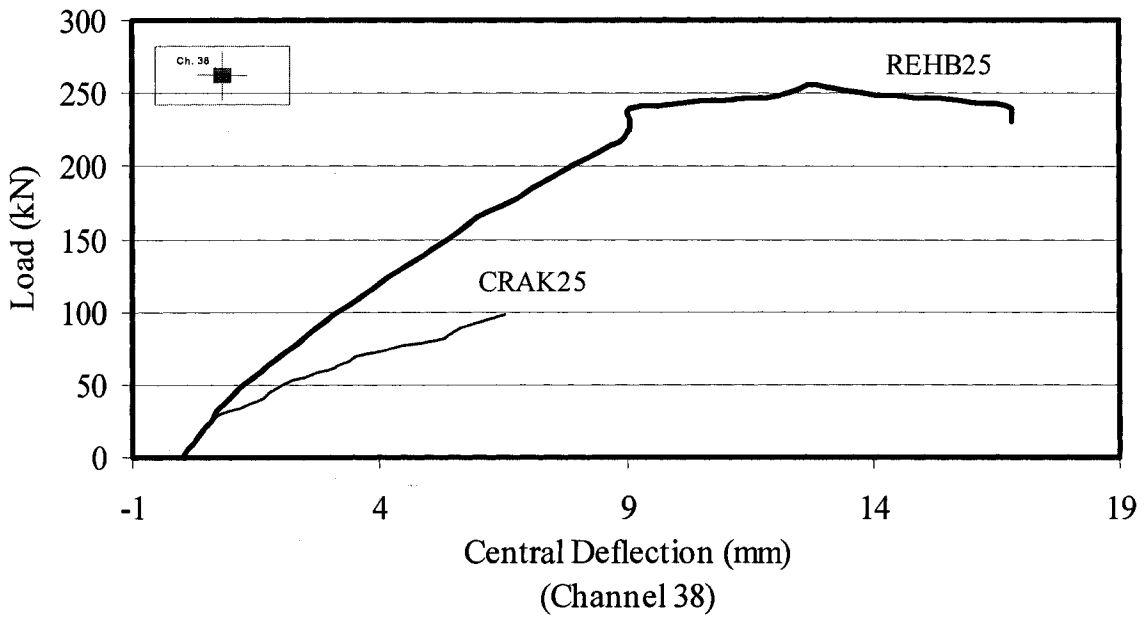
Fig. 4-174: Load versus central deflection for group II specimens (Ch. 38)

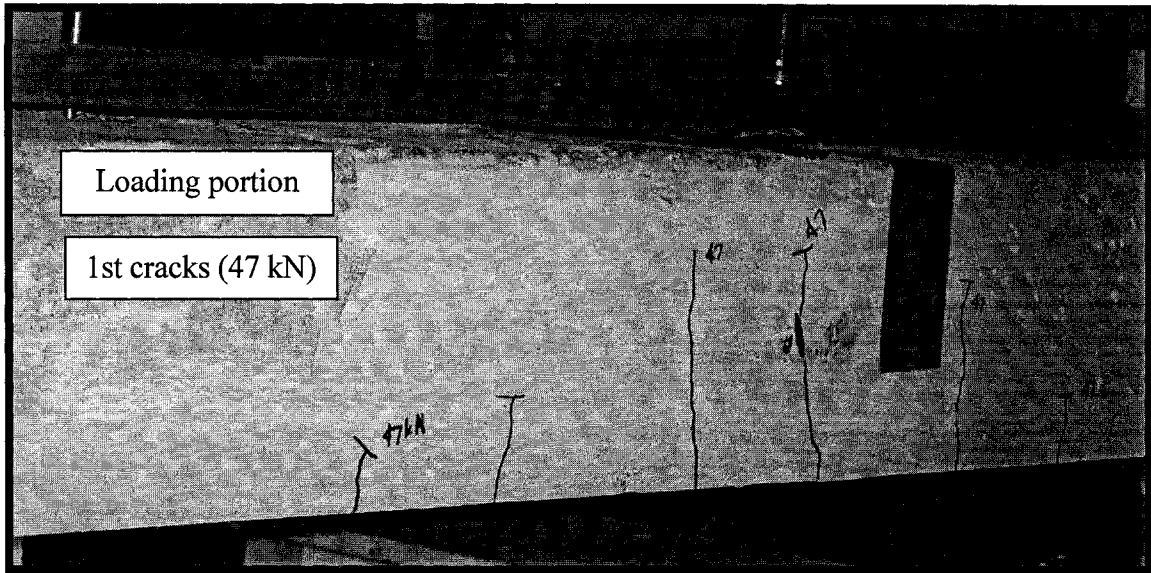
Figure 4-175: The control specimen CTRL35 at first visible cracks (47 kN)

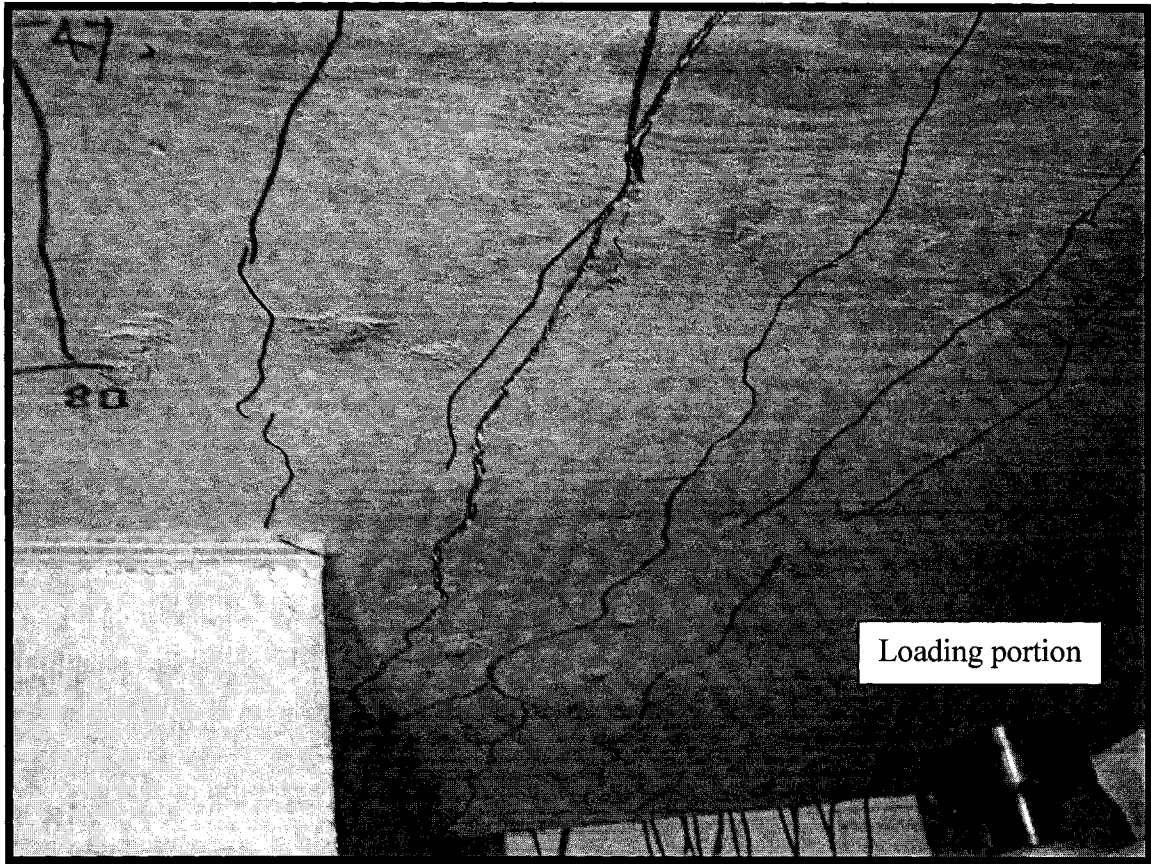
Fig. 4-179: The control specimen CTRL35 after failure

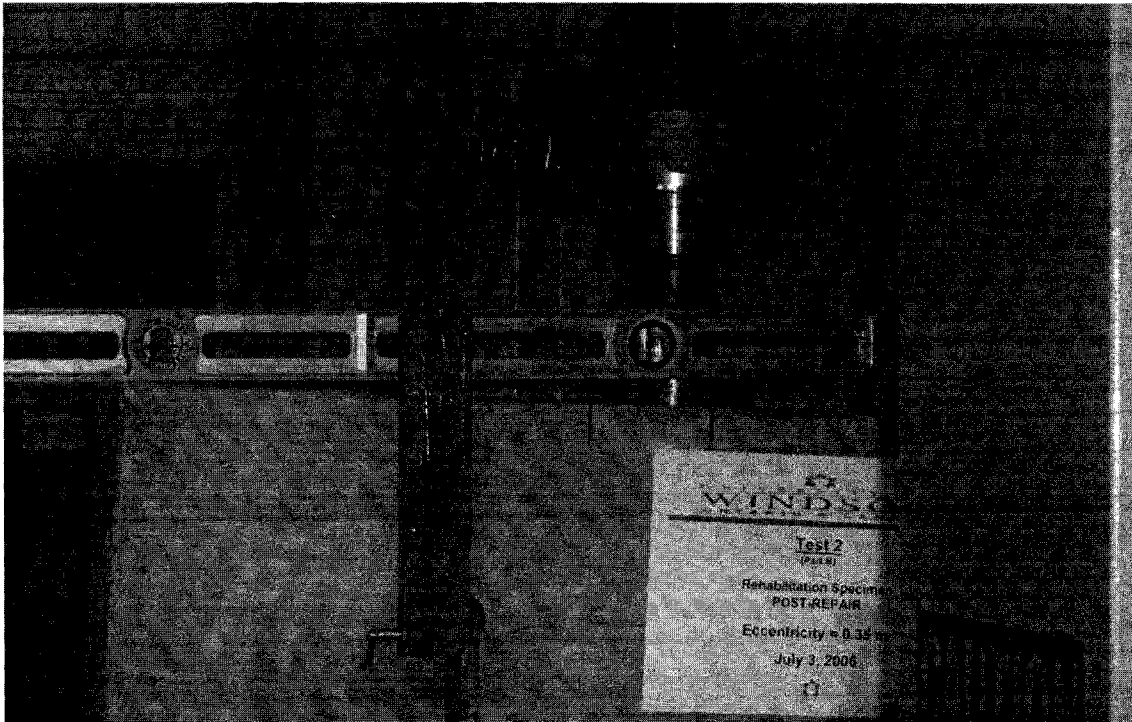
Fig. 4-182: The inclination of the upper part of Rehabilitated specimen REHB35 before failure

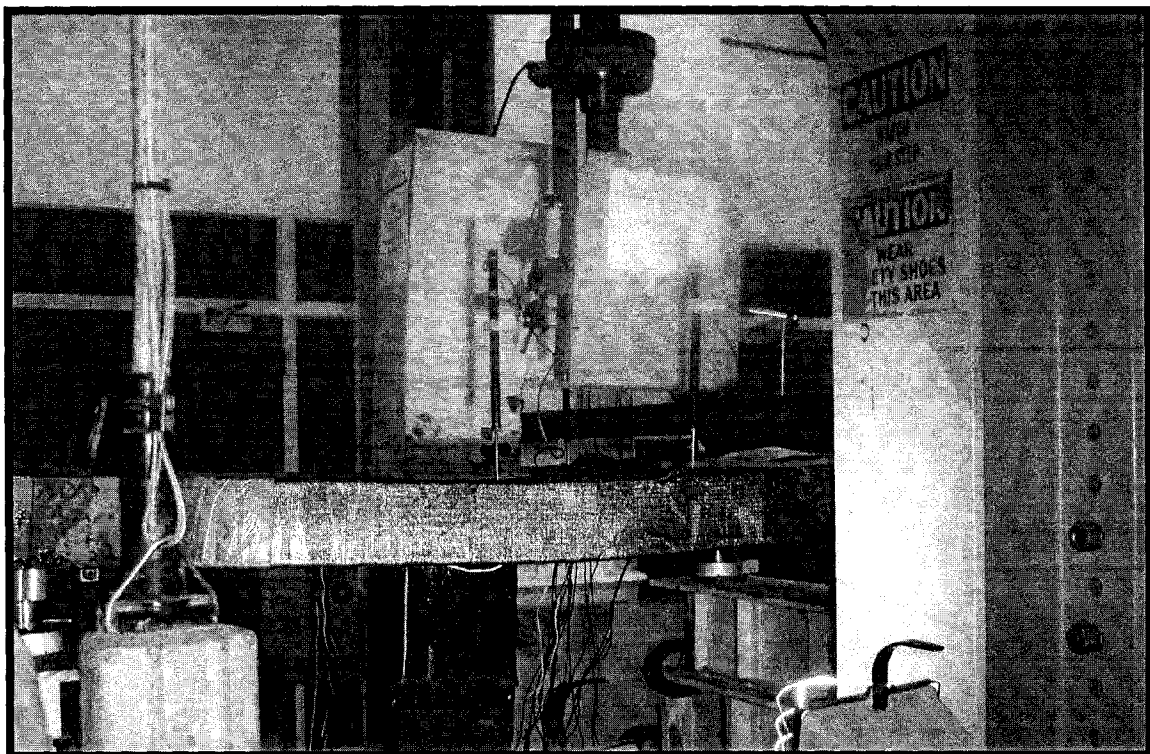
Fig. 4-183: Deflection of the rehabilitated specimen REHB35 before failure

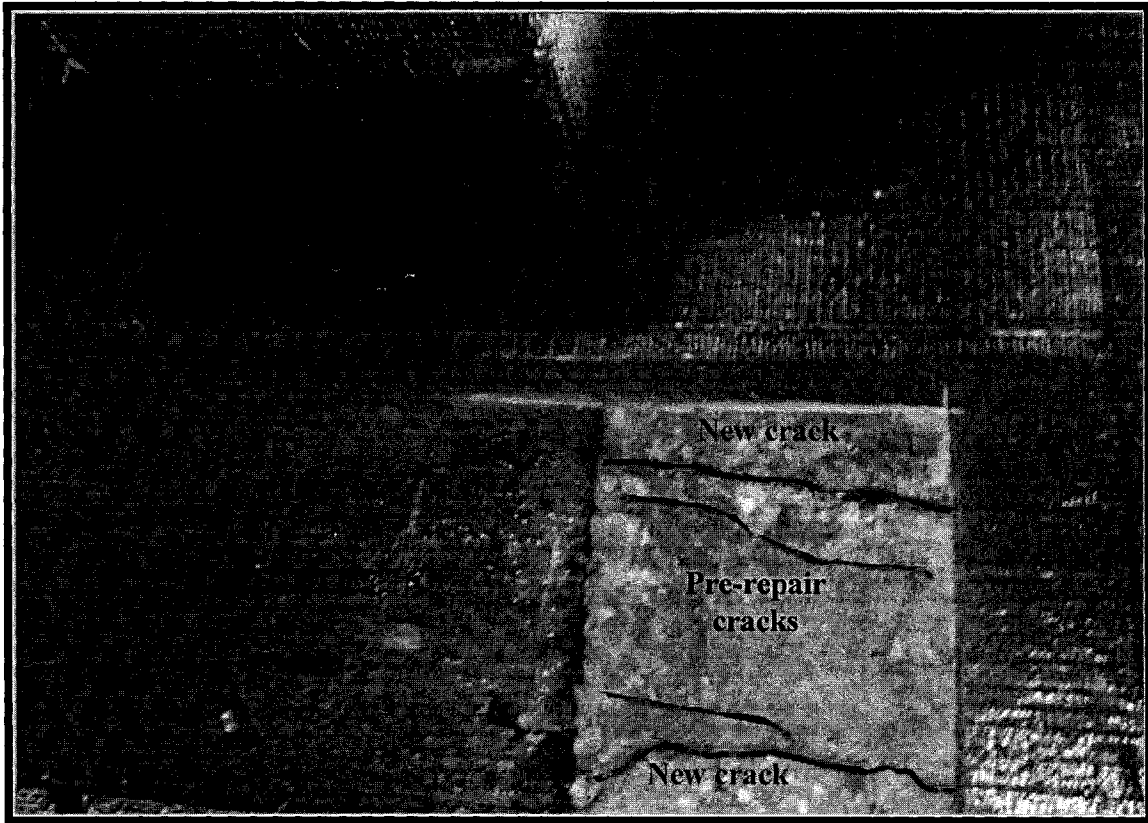
Fig. 4-188: Pre-rehabilitation and post-rehabilitation cracks after releasing the load and partial removing CFRP sheet from the tension zone (bottom surface) of the rehabilitated specimen REHB 35

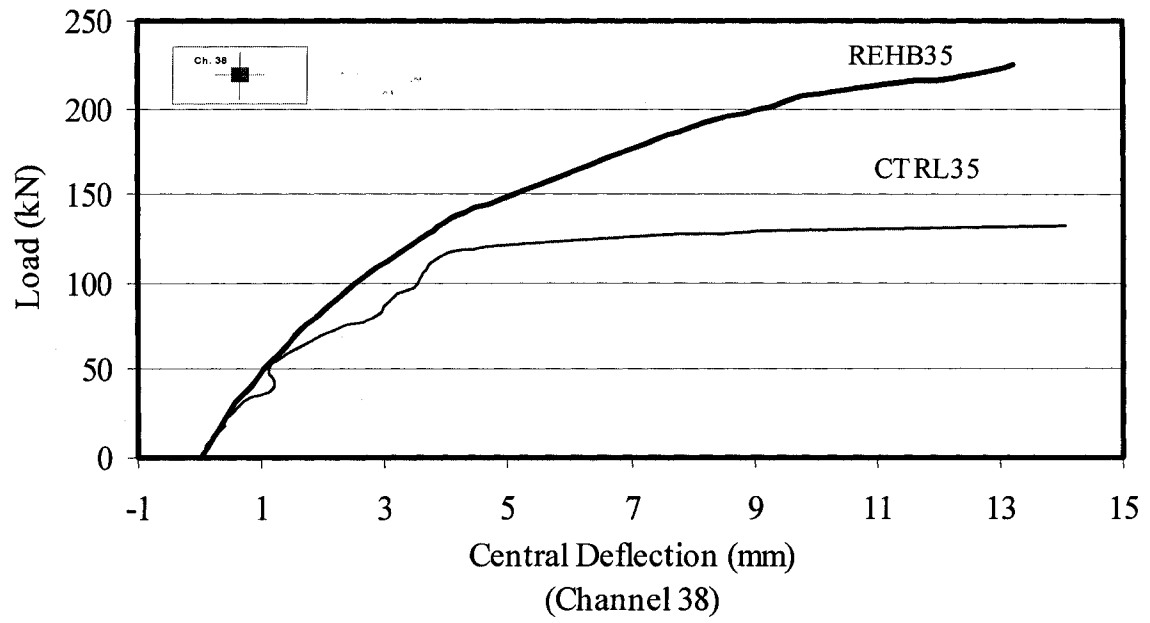
Fig. 4-190: Load versus central deflection for group III specimens (Ch. 38)
