Comprehensive Approach to Characterizing Tool Steel Damage Mechanisms

A Thesis
Submitted to the Faculty of Graduate Studies
through the Department of Mechanical, Automotive & Materials Engineering
in Partial Fulfillment of the Requirements for
the Degree of Master of Applied Science at the
University of Windsor

2020

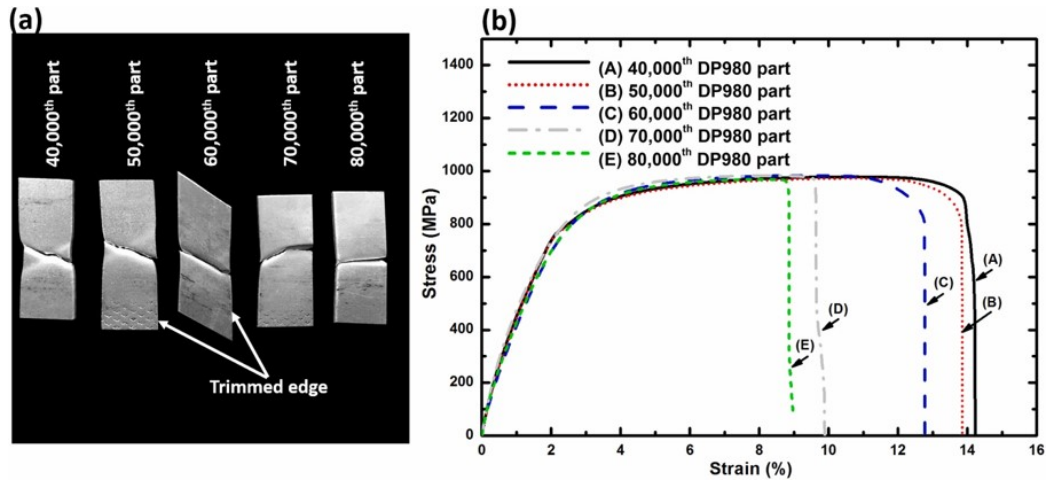
Figure 1.1: (a) Failure modes and (b) tensile stress-strain curves of trimmed DP980 sheets [4].

Figure 1.1a shows that edge stretchability decreases due to the change in failure mode from ductile necking to more brittle fracture with an increasing number of trimming cycles [4]. This phenomenon leads to more splits and tears in the subsequent forming processes.

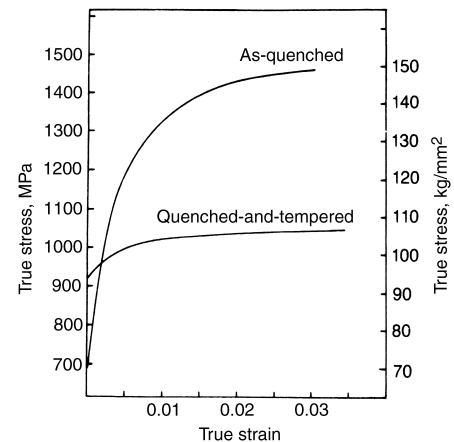
Figure 2.2: Difference in mechanical behaviour of Fe-0.2C as-quenched and tempered lath martensite [10].

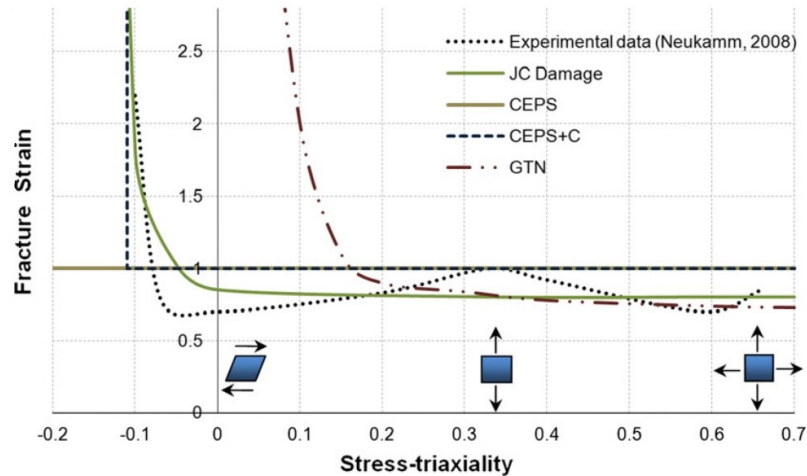
Figure 2.14: Schematic of the fracture strain with respect to the stress triaxiality for different damage criteria [39].

Fig 2.14 shows the comparison of several damage models to experimental data for a DP590 steel. As shown, the material exhibits a variation of fracture strain with stress triaxiality. This can be explained by the different stress states exhibited at key stress triaxialities. To the left, in the negative stress triaxiality region, the sample undergoes compression and exhibits a very high fracture strain, due to the suppression of cracks and voids which would typically lead to failure in a positive stress triaxiality region, where it would undergo tensile stresses. To this effect, it is important to include these results in the characterization of tool steels as they undergo a complex array of stress triaxialities in the course of trimming.

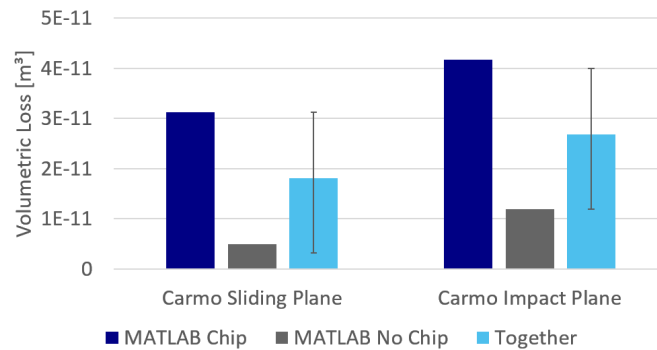
Figure 3.6: Bar chart showing magnitude of effect of chips on wear loss calculation and resultant error bar.

Chipping is also taken into consideration. In areas where chipping can be seen as typical wear behaviour across multiple sections, there was no change to the analysis. In Carmo, where large chipped areas could be seen, but it did not appear to be the typical wear behaviour, the chipping was treated as a deviation factor. The volumetric wear loss was calculated with and without the large chips, and then an average was taken, with the averages of the wear loss with and without chipping used to define the error bar. A more in depth look into the result of this analysis can be seen in Fig 3.6.

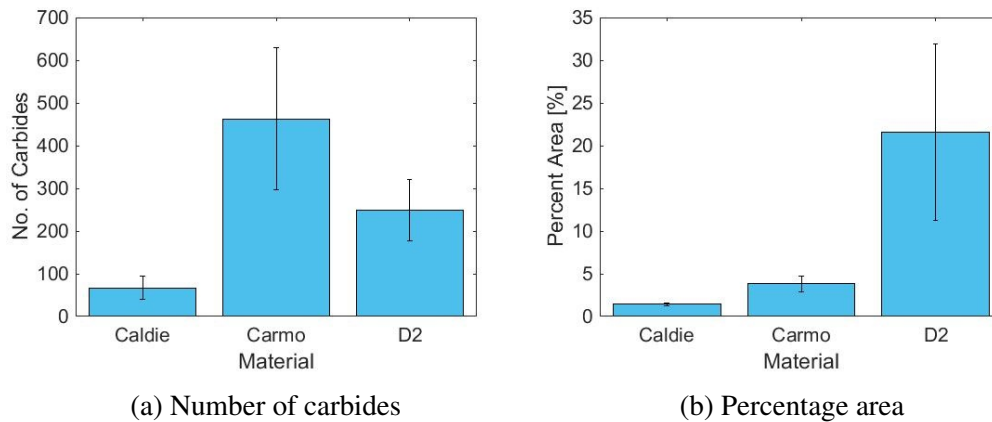
Figure 4.3: Carbide distribution graphs for a $990\mu\text{m}^2$ area

Two very simple metrics for comparing carbide distribution within a matrix are shown in Figure 4.3. Of note is the relatively small % area taken up by carbides when compared to the number of carbides in the same area. This is also reflected in Figures 4.4 and 4.5.

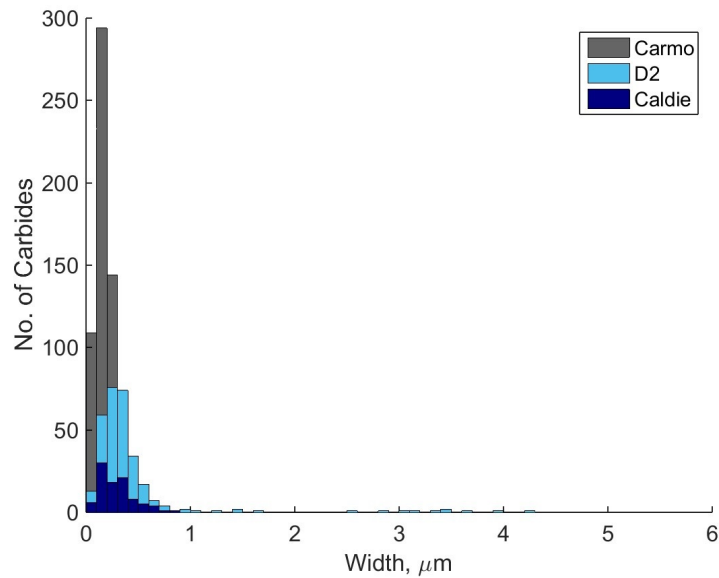
(a) Distribution of carbide lengths

(b) Distribution of carbide widths

Figure 4.4: Carbide distribution graphs for a $990\mu\text{m}^2$ area

homogenous structure in Carmo and Caldie. These figures also show a very high number of equally shaped, micron-sized particles in Carmo, compared to Caldie and D2.

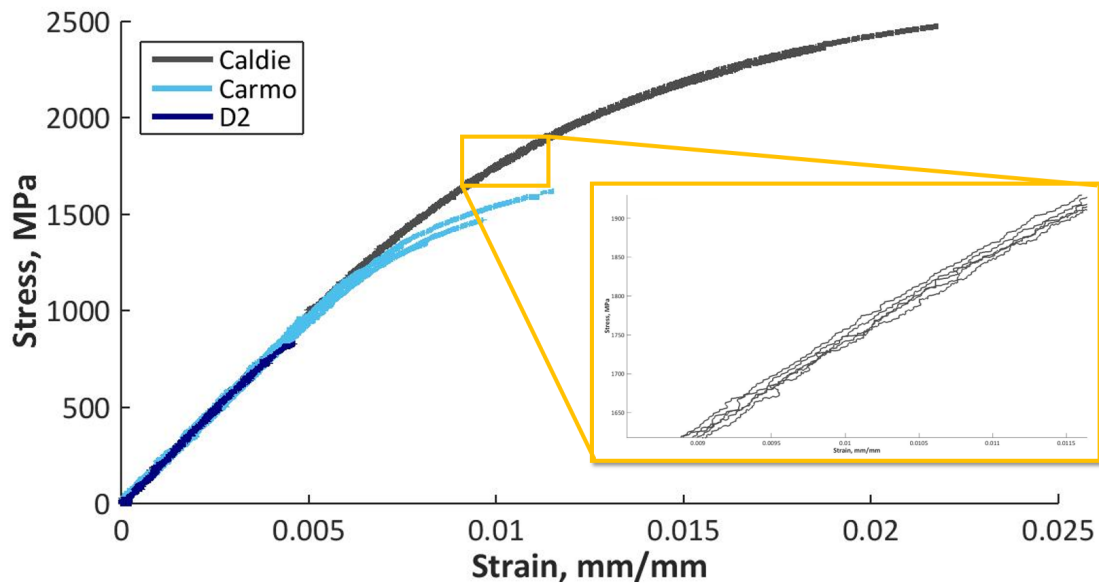
Figure 4.11: Tensile test results

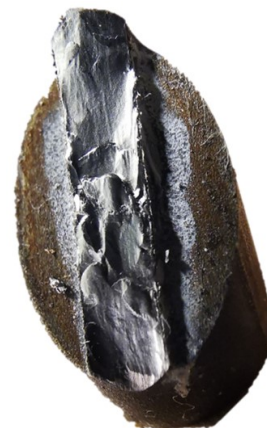
Figure 4.15: Typical Shear Compression Fracture Surface

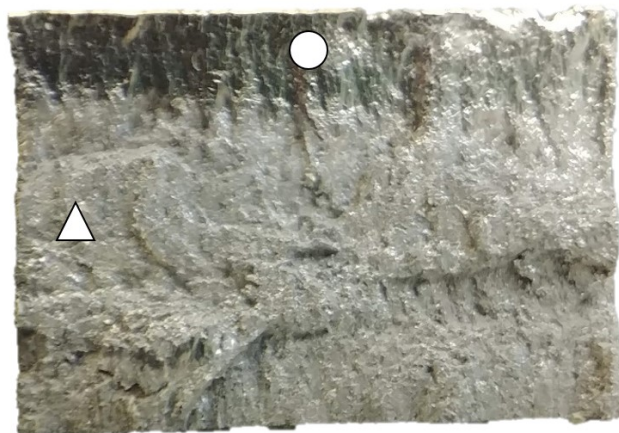
Figure 4.19: Photo of D2 side press fracture surface

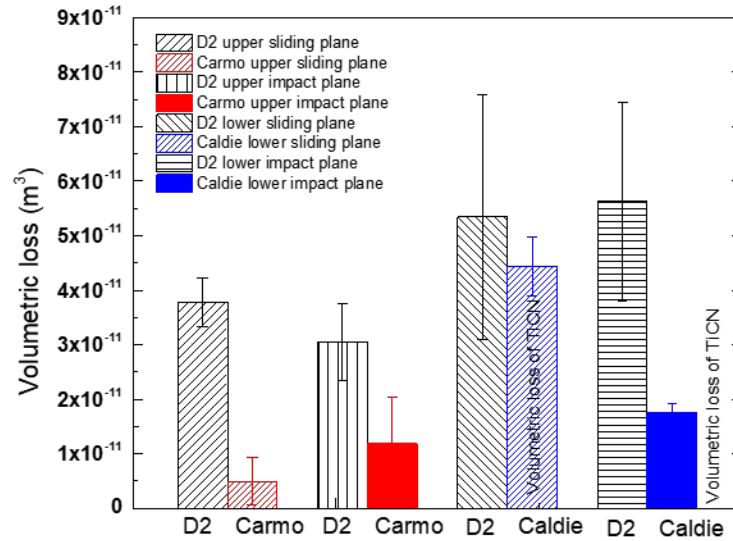
Figure 4.25: Volumetric loss after 40,000 trimming cycles

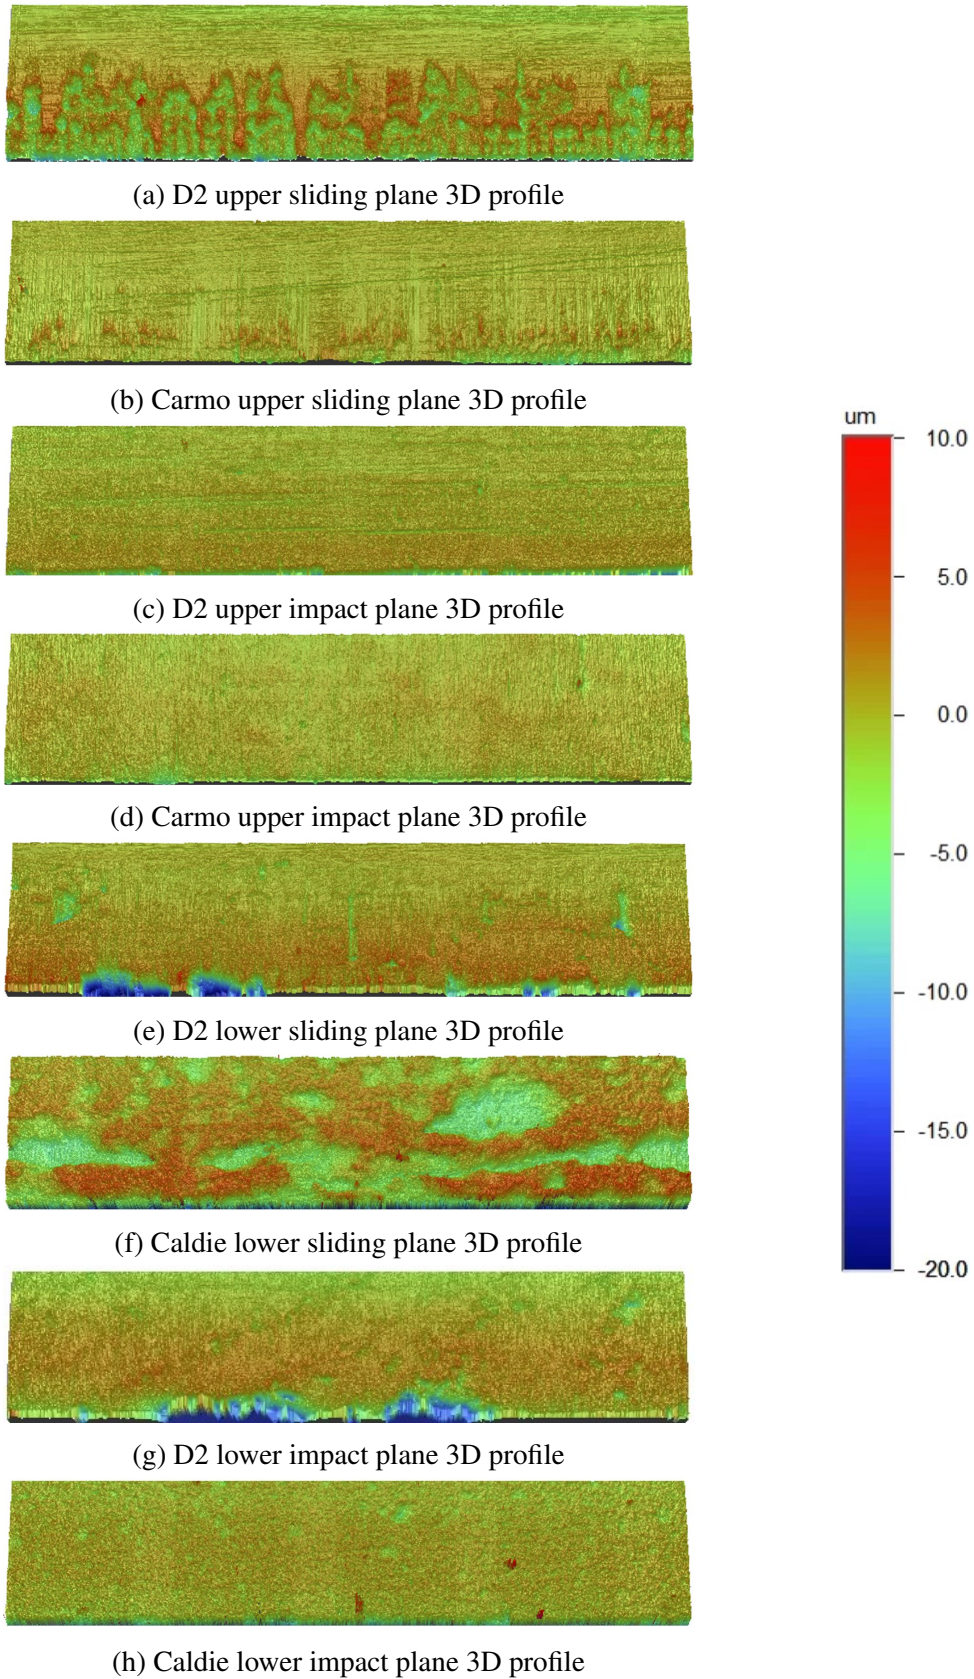
Figure 4.27: 3D Profiles of trim die sliding and impact surfaces

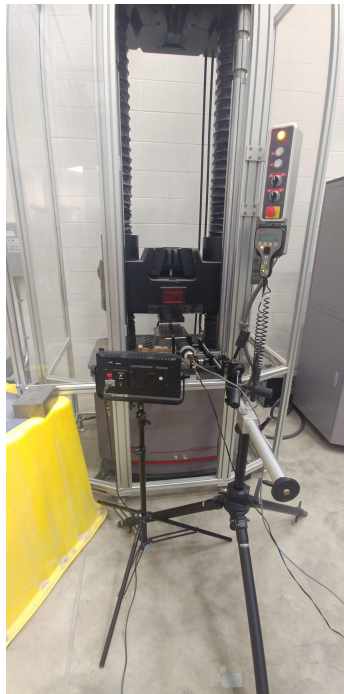
Figure 6.1: MTS Universal Testing Machine with 600kN load cell with camera and light for compression testing

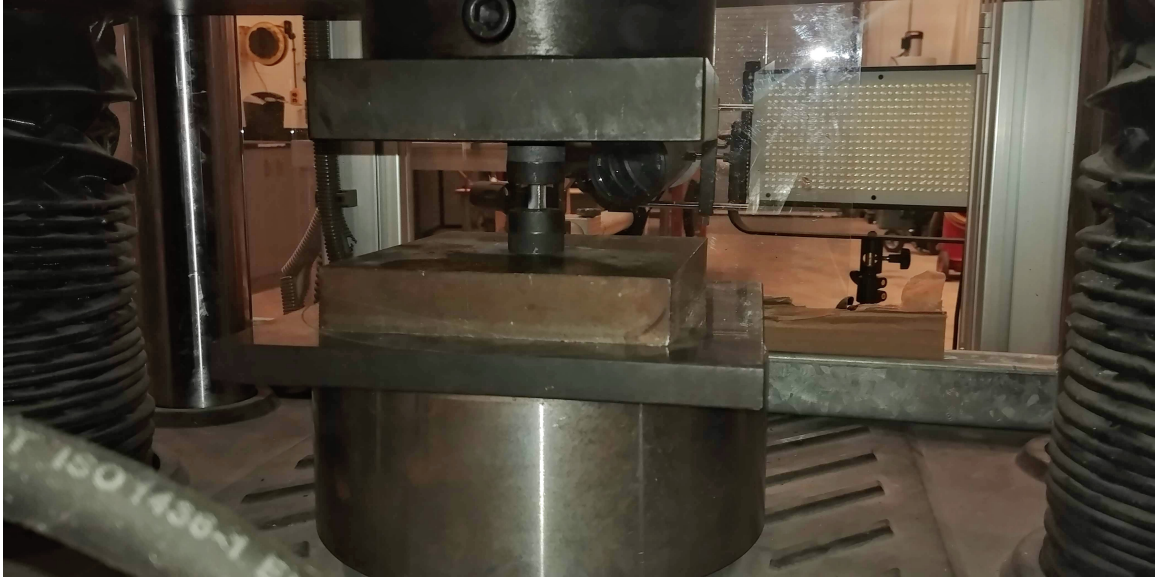
Figure 6.2: MTS Universal Testing Machine with 600kN load cell showing use of platens with compression sample

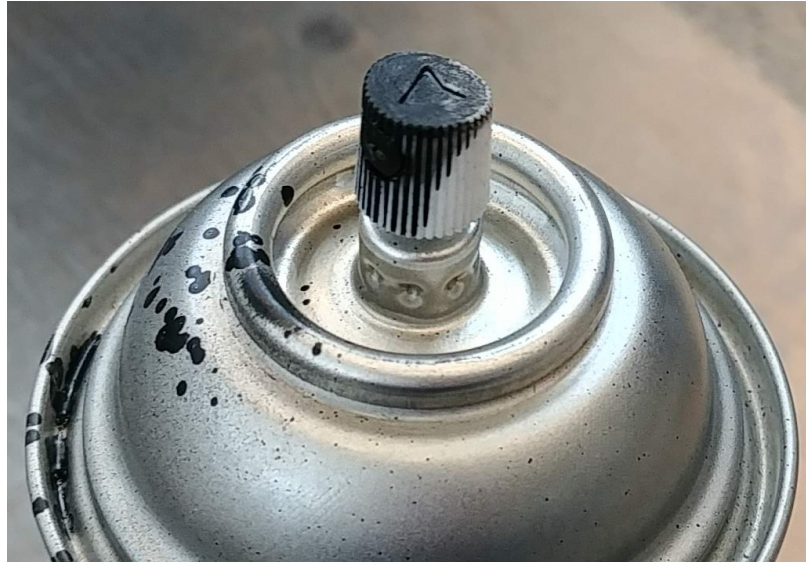
Figure 6.4: Image of spray nozzle used to achieve speckle pattern shown in Figure 6.5

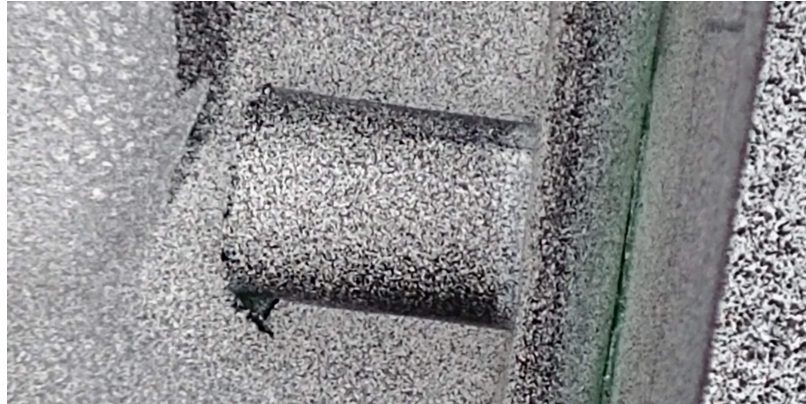
Figure 6.5: Image showing example speckle pattern applied to mechanical test samples
