**Patterns and Behaviours of Barrier Breaching
in Lacustrine Environments: A Case Study
from the Point Pelee Foreland**

A Thesis

Submitted to the Faculty of Graduate Studies
through the School of the Environment
in Partial Fulfillment of the Requirements for
the Degree of Master of Science
at the University of Windsor

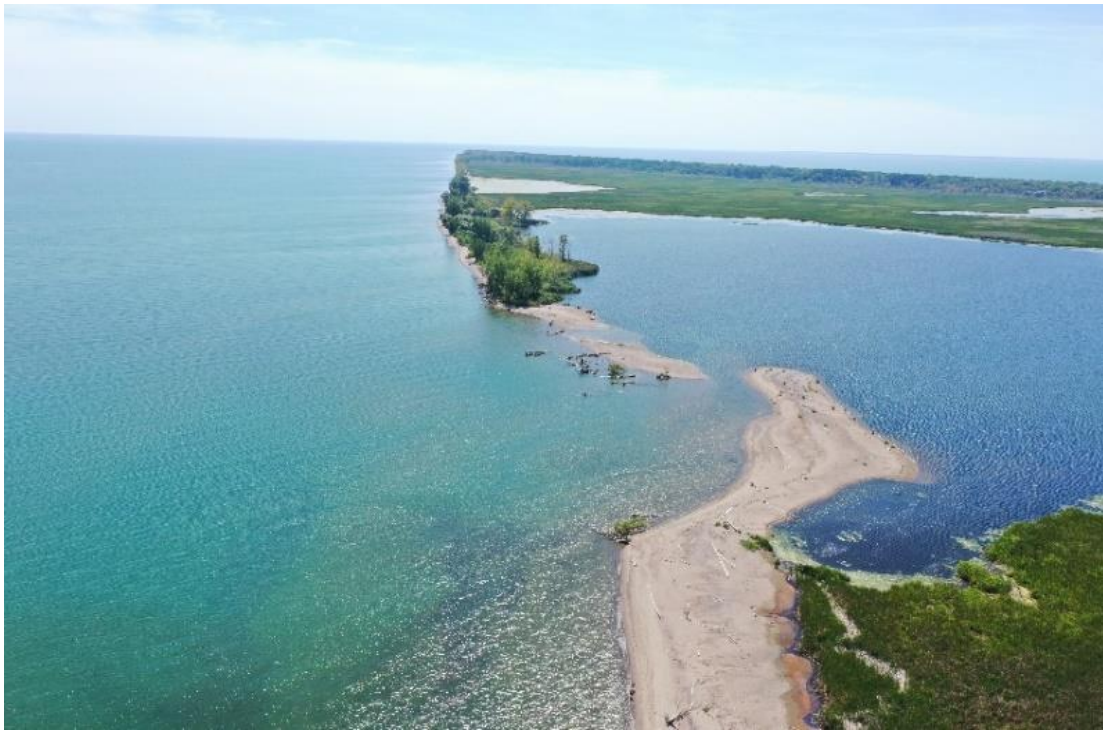
Figure 2: Barrier breaching at East Beach, facing south, located on the eastern shoreline of Point Pelee National Park, in Ontario, Canada.

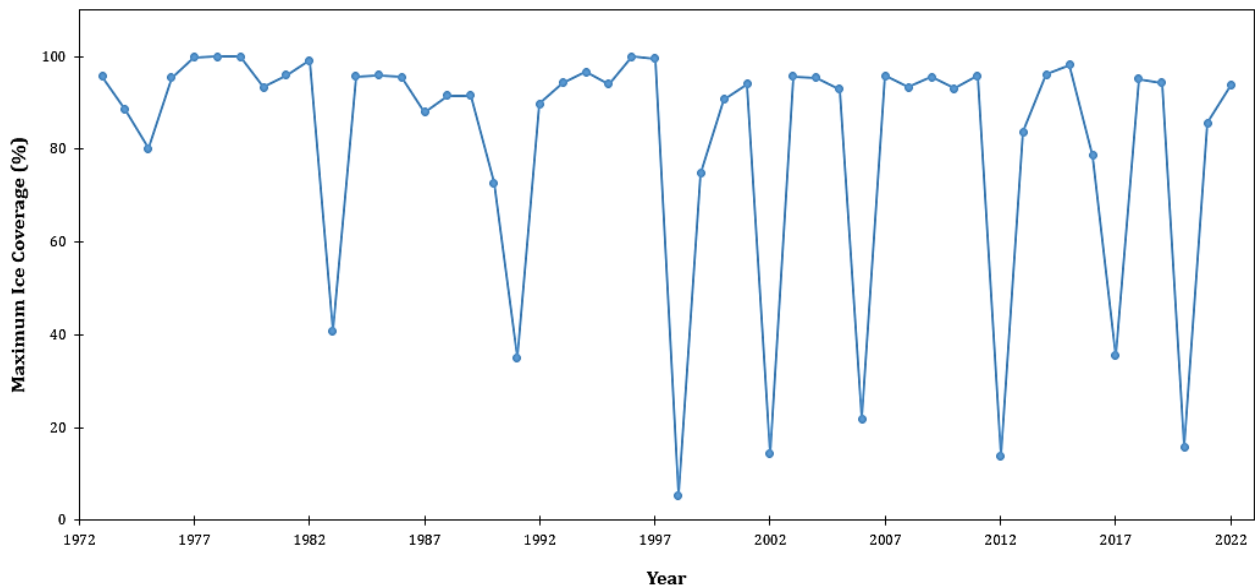
Figure 3: Lake Erie's Historical Annual Maximum Ice Coverage (AMIC) from 1976 to 2020.

2019/2020 had a record low maximum ice cover of 15% (Gharib et al., 2021; Assel et al., 2003) (Figure 3). Between 2013 and 2020, the level of Lake Erie rose by 0.83 m, with water levels reaching the previously recorded average monthly water level high of 175.04 m set in 1986, surpassing it at 175.14 m in 2019, and again at 175.1 m in 2020. During this time, barrier beaches located on the eastern shore of the Point Pelee foreland experienced accelerated rates of erosion, breaching, loss of vegetation, and damage to infrastructure. Barrier breaching exposes the lagoon to harsh waves from the open water, jeopardizing the stability of sensitive ecosystems and habitats, and can raise the water level in the lagoon, subsequently leading to flooding of the mainland. Climate change in the Great Lakes is projected to increase the variability of water level fluctuations, further intensifying these effects.

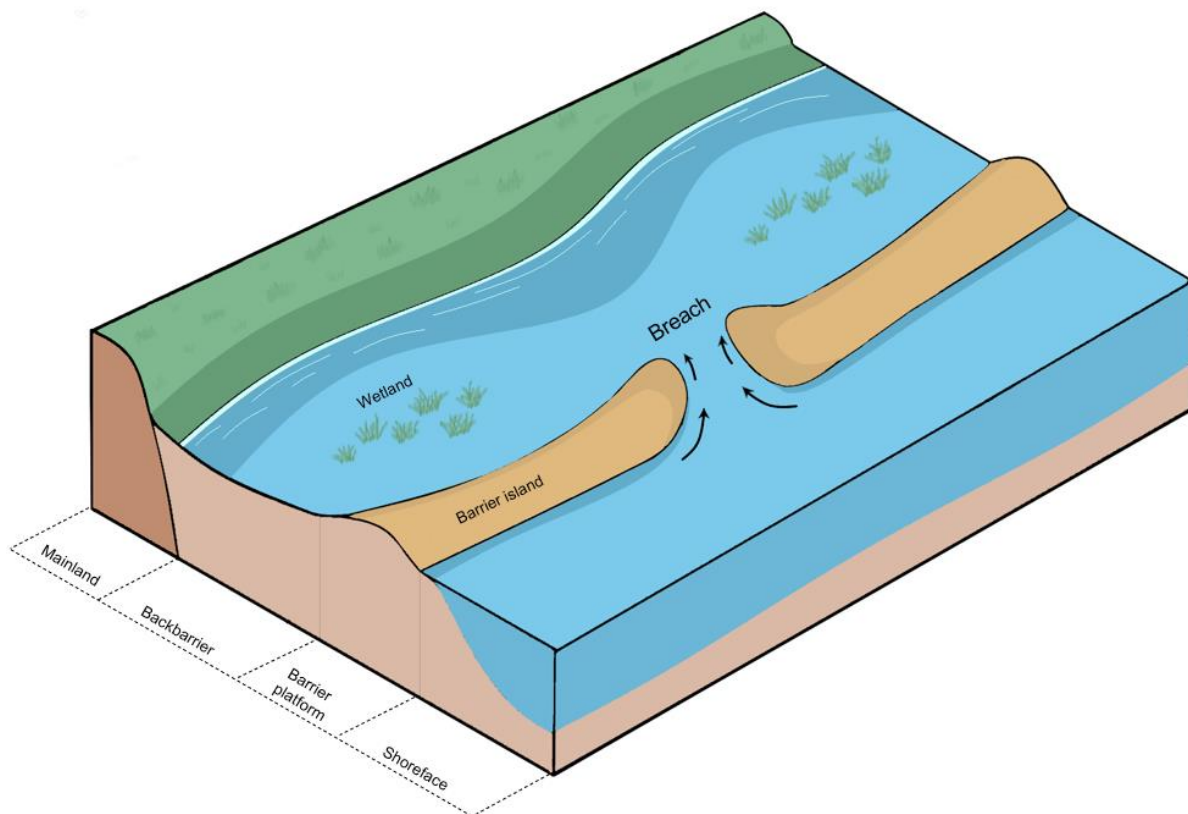
Figure 4: The six main components of a barrier system: the mainland, the backbarrier, the barrier platform, the barrier island, the shoreface, and the inlet.

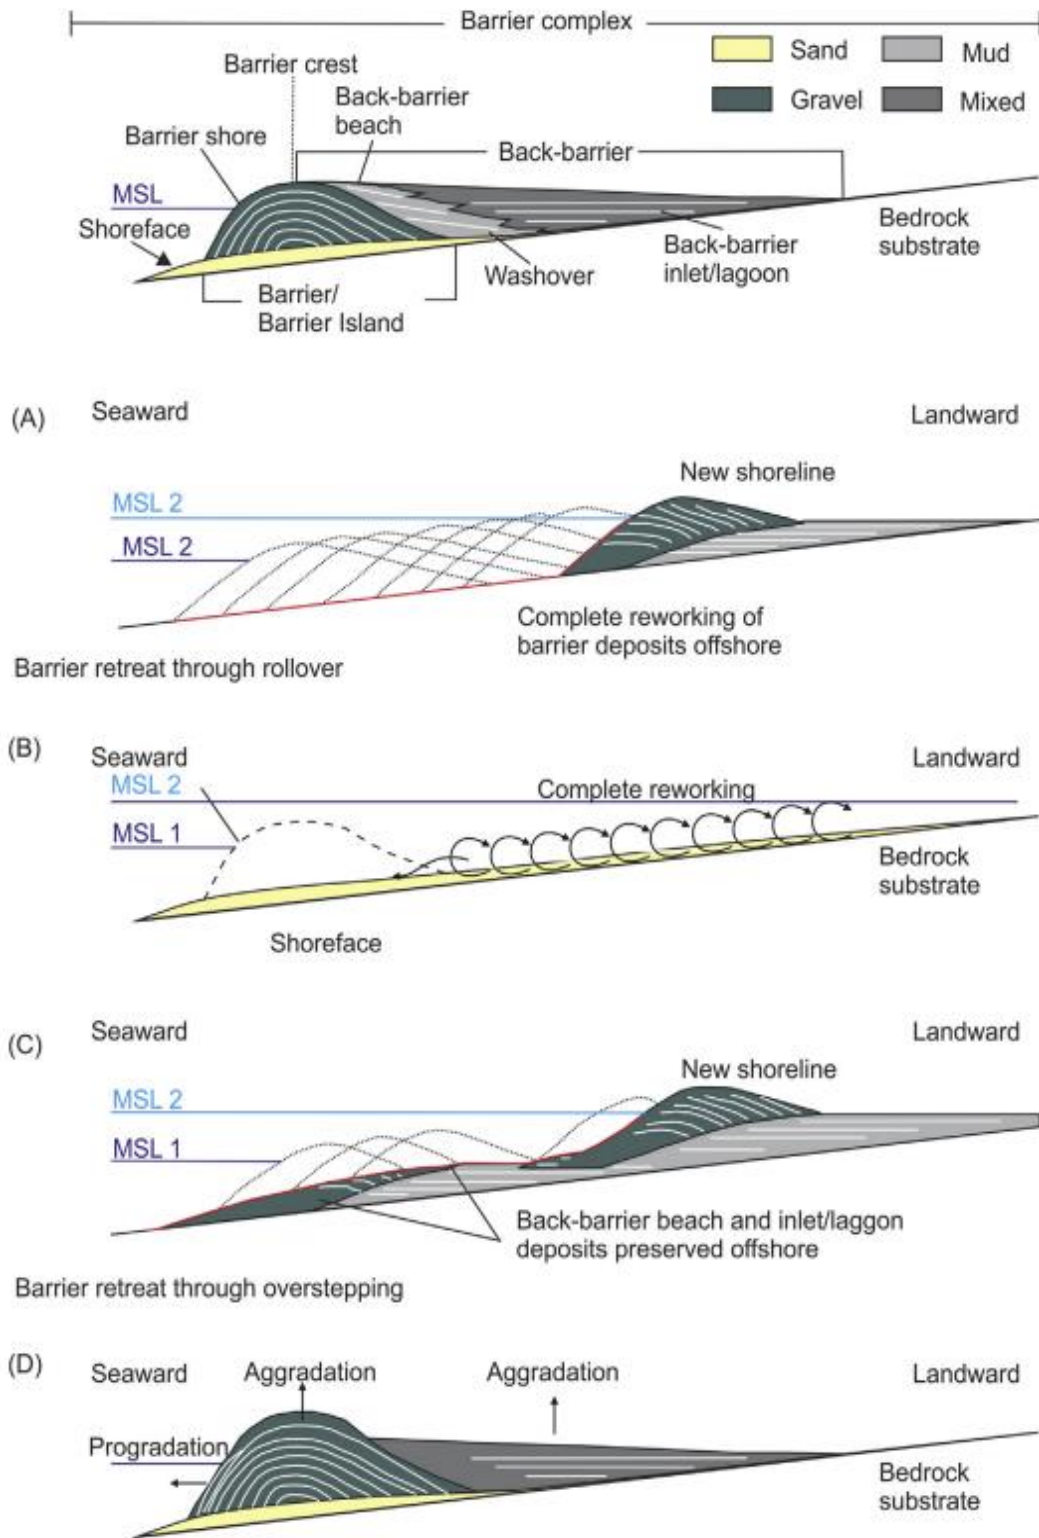
Figure 5: Profile models of barrier response. (A) Rollover; (B) Erosion; (C) Overstepping; (D) Progradation/aggradation (from Cooper et al., 2018).

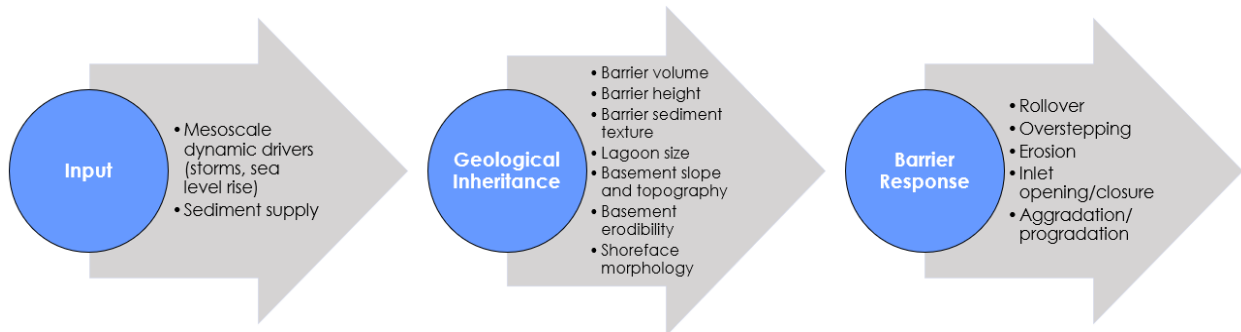
Figure 6: Linkage between energy and sediment output, geological inheritance and constraints, and subsequent barrier response. Adapted from Cooper et al., (2018).

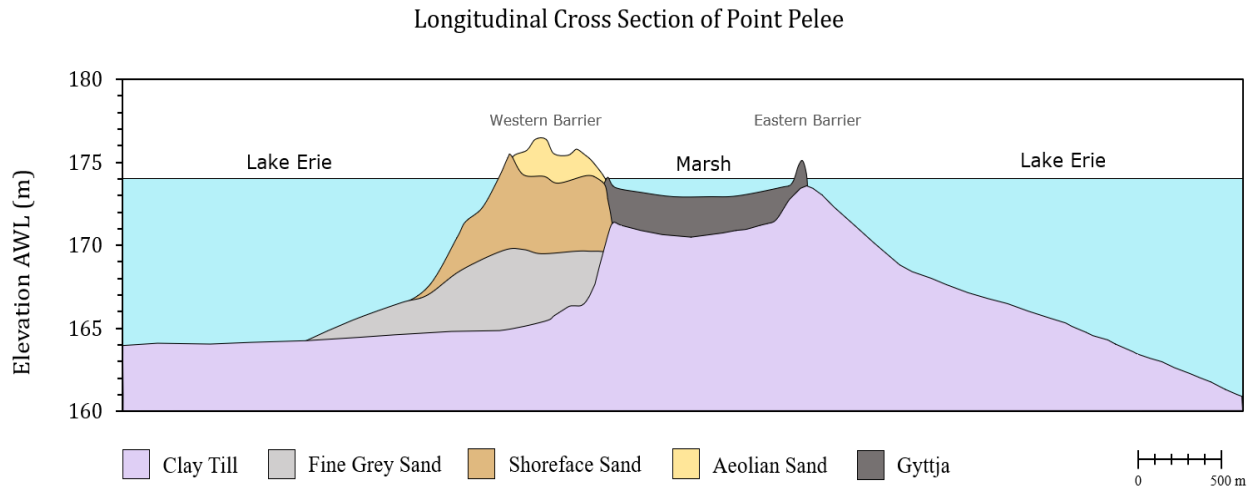
Figure 7: Longitudinal cross section of Point Pelee, adapted from Coakley et al. (1998).

where the basement topography was a gentle slope. This original shape helped influence the foreland as it is today, which consists of a low-lying marsh and barrier spit on the east side, and dune and beach system on the west (Figure 7).

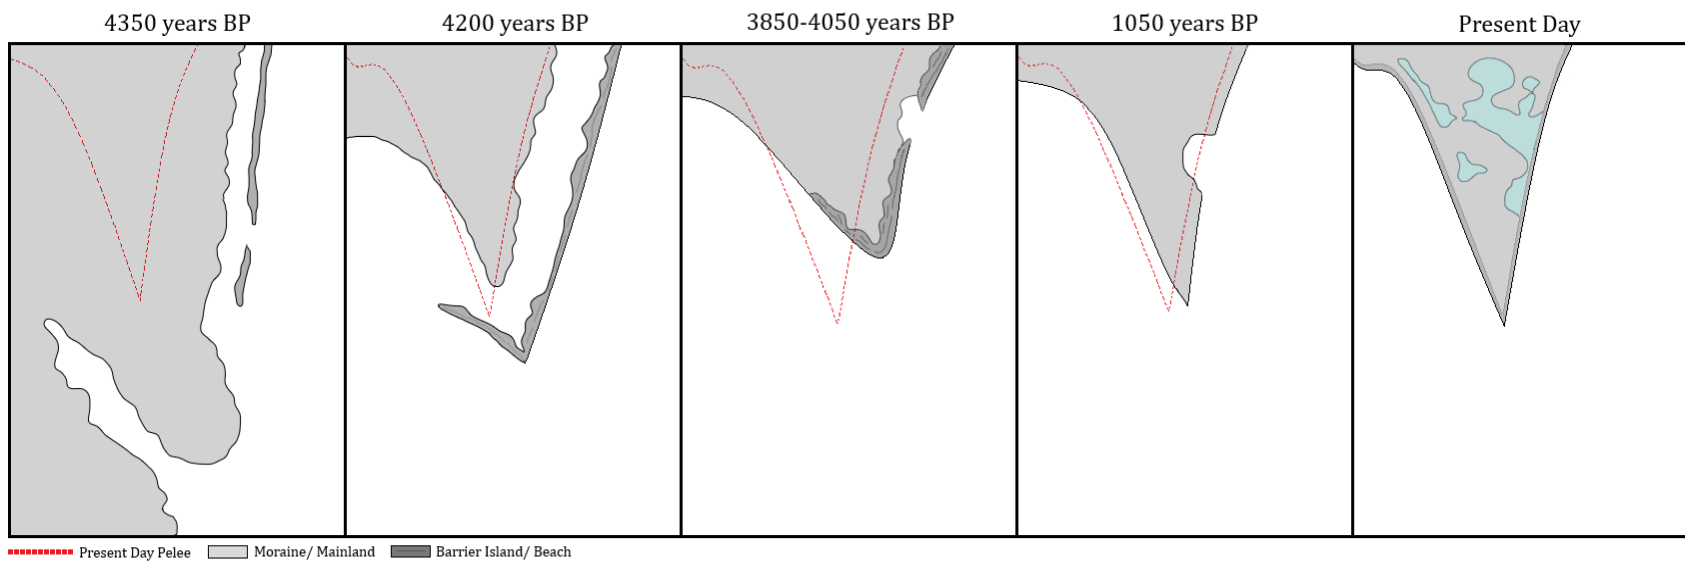
Figure 8: The evolution of the Point Pelee Foreland, from 4350 BP to present day. Adapted from Trenhaile and Dumala (1977).

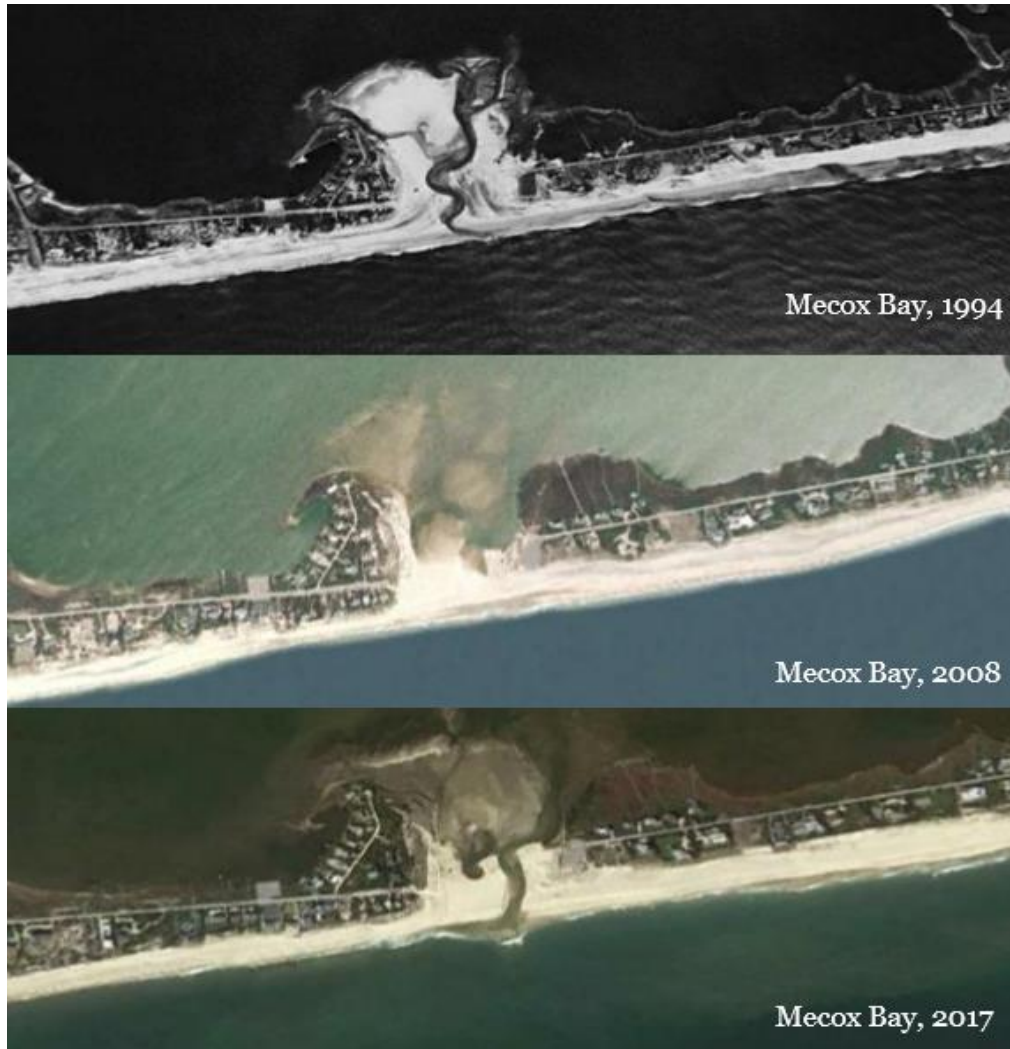
Figure 9: Annual breaching at Mecox Bay, Long Island, New York, to prevent property flooding.

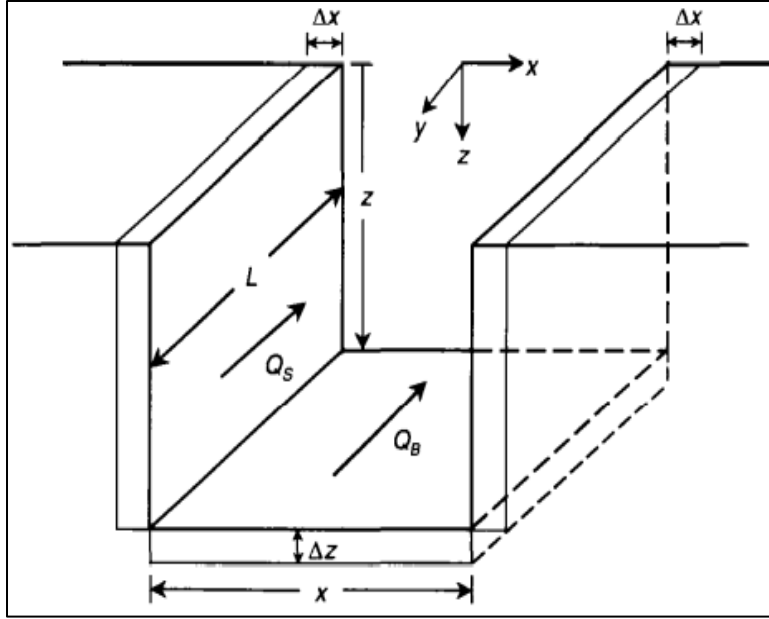
Figure 10: Definition sketch for barrier breaching model proposed by Kraus (2003).

where Q_S and Q_B are constant maximum transport rates that are not necessarily equal, and x_e and z_e are values of the breach width and depth, respectively, if the breach achieved equilibrium. The parameters of the transport rates in Eq. (4) are time dependent, with the net transport rates going to zero as equilibrium is approached (Kraus, 2003). Net zero transport rates signify that the breach width, depth, and volume are at their near-maximum and become stable.

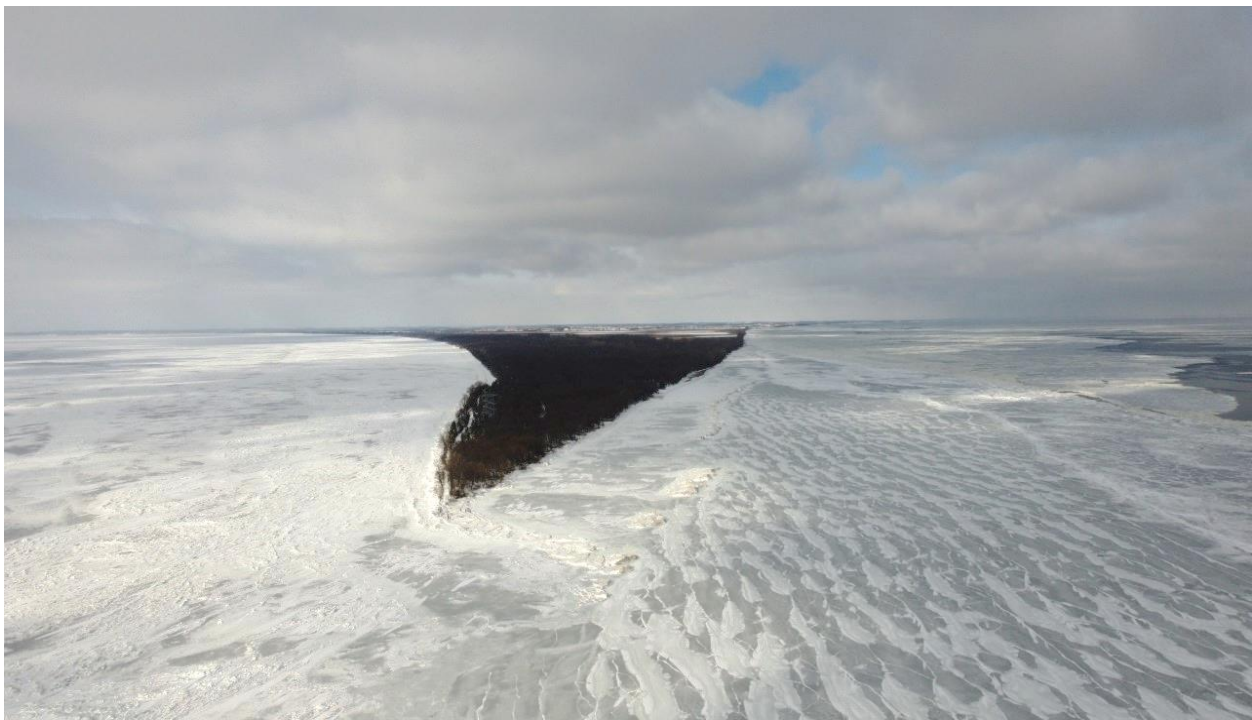
Figure 11: Ice cover on Lake Erie, around Point Pelee National Park, taken January 25th, 2022. Ice cover protects shorelines over the winter from erosion by limiting fetch distance across the lake.

consistently below freezing temperatures, an ice foot forms along the beach, blocking waves, freezing the beach and preventing sediment loss through wave action (Figure 11). Sediment entrained in the ice ends up being transported offshore as the ice melts, causing a local net sediment loss (BaMasoud & Byrne, 2012). In a case study along the Point Pelee shore, BaMasoud and Byrne (2011) conclude that ice coverage protected the shoreline from erosion, resulting in sediment accumulation, and substantial erosion took place where ice was absent. The Point Pelee Foreland is in the western basin of Lake Erie, and due to its shallower bathymetry (relative to the central basin) and shorter fetch length (subsequently created smaller waves that cause less erosion), it is protected by ice for a longer period, however, this is currently threatened by climate change.

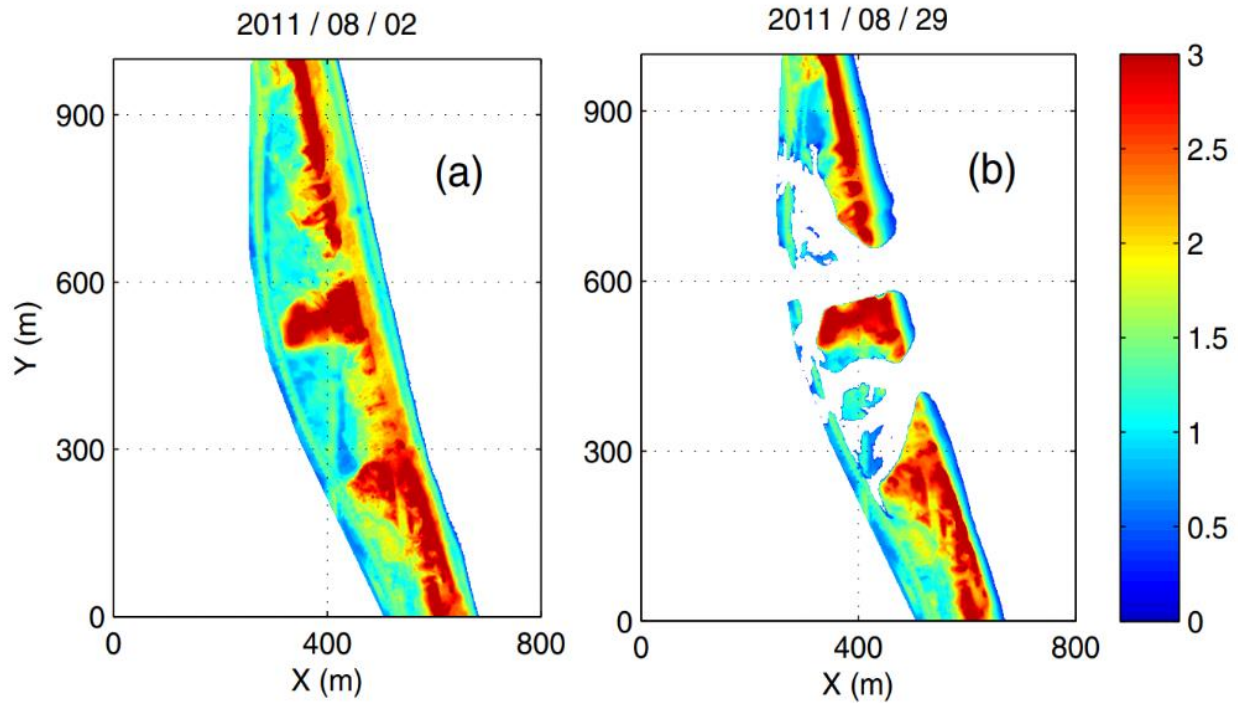
Figure 12: Topography near Pea Island, North Carolina, (A) before and (B) after Hurricane Irene.

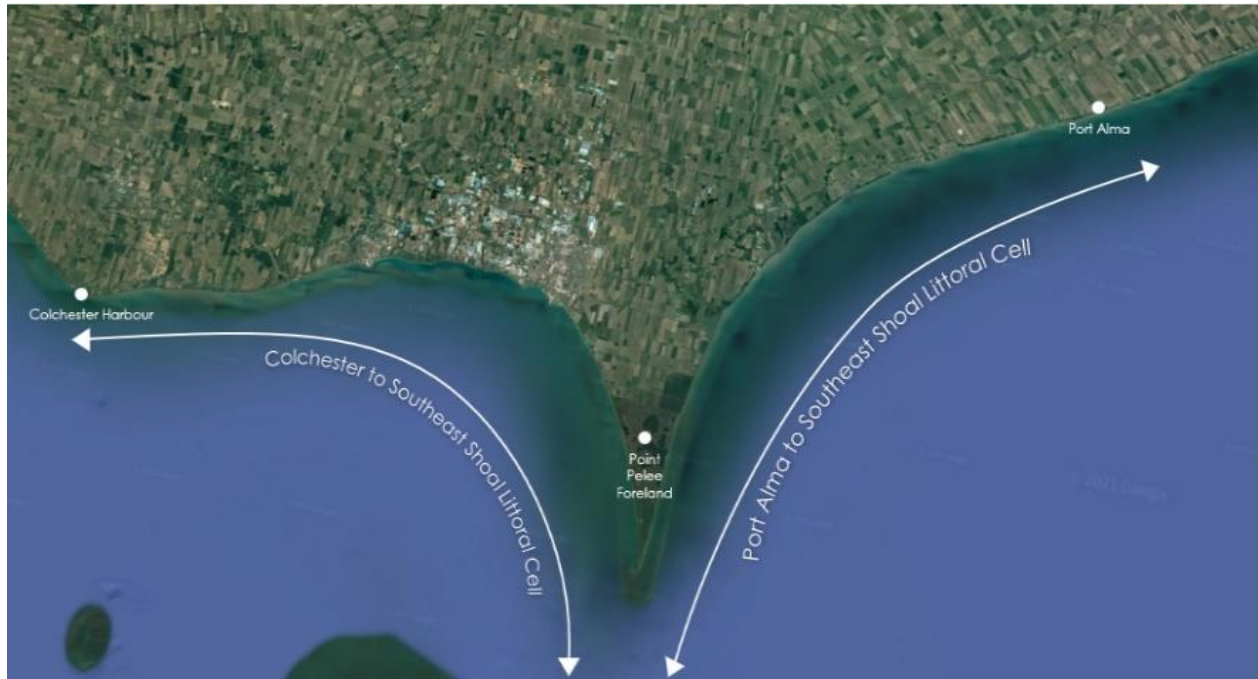
Figure 13: Sediment is supplied through alongshore drift, from the Colchester to southeast Shoal littoral cell in the west, and the Port Alma to Southeast Shoal littoral cell in the east.

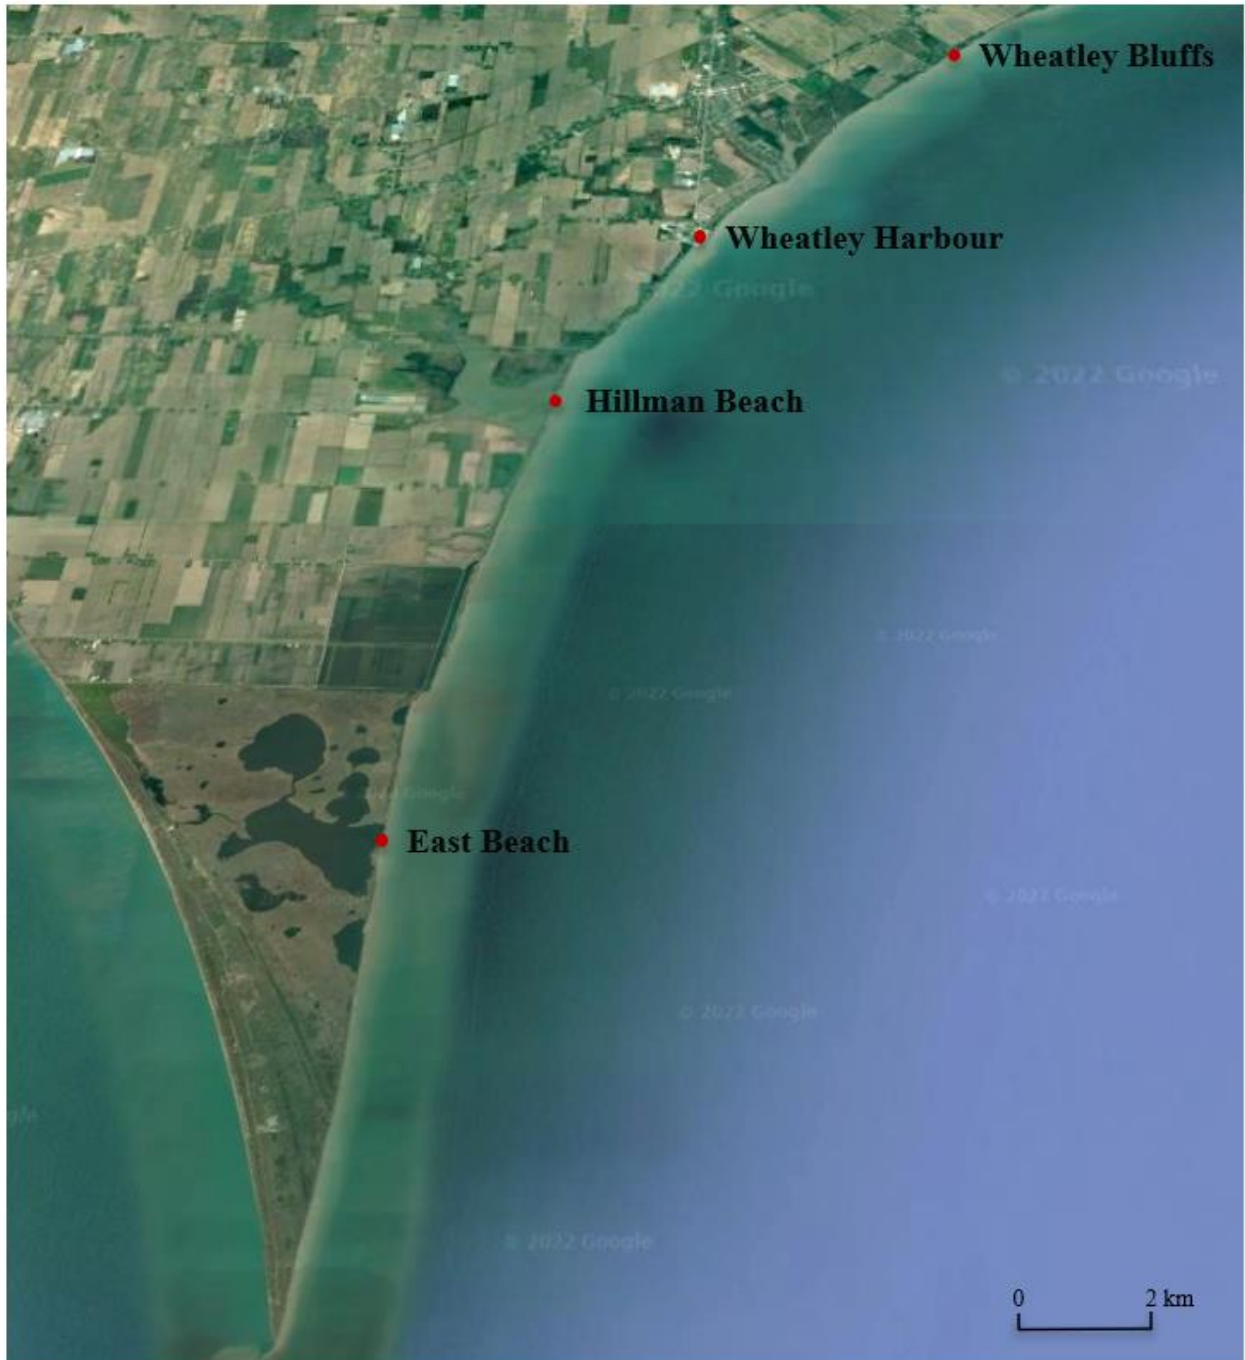
Figure 14: This study is conducted on (A) the Point Pelee Foreland, specifically at (B) Hillman Beach (HB) and (C) East Beach (EB).

This study focuses on two of Point Pelee's eastern barriers located at Hillman Beach (HB), part of the Hillman Marsh Conservation Area (Figure 14B), and the central section of East Beach (EB), located within Point Pelee National Park (Figure 14C). Point Pelee is a ~50 km² foreland that separates the Western and Central Basins of Lake Erie, projecting approximately 15 km southward from the shoreline of Essex County, Ontario (Figure 14A). Point Pelee National Park is located on the foreland extending up to 9.0 km from north to south and up to 4.2 km from east to west (BaMasoud & Byrne, 2011). Point Pelee has a unique Carolinian Forest, beach, dune, and marsh ecosystem that provides critical habitat for rare and endangered species (Drezner, 2021). The marsh is enclosed by a series of ridges to the west and a single ridge to the east. Point Pelee was formed over the Pelee-Lorraine moraine by the enclosure of the marsh by the eastern and western barriers ~3500 years BP, following a period of rapid lake level rise (Trenhaile and Dumala, 1977).

the south (BaMasoud and Byrne, 2011). Given the relative stability of the western shoreline, this study will focus on the eastern barrier system and specifically the breaches at HB (Figure 14B) and EB (Figure 14C).

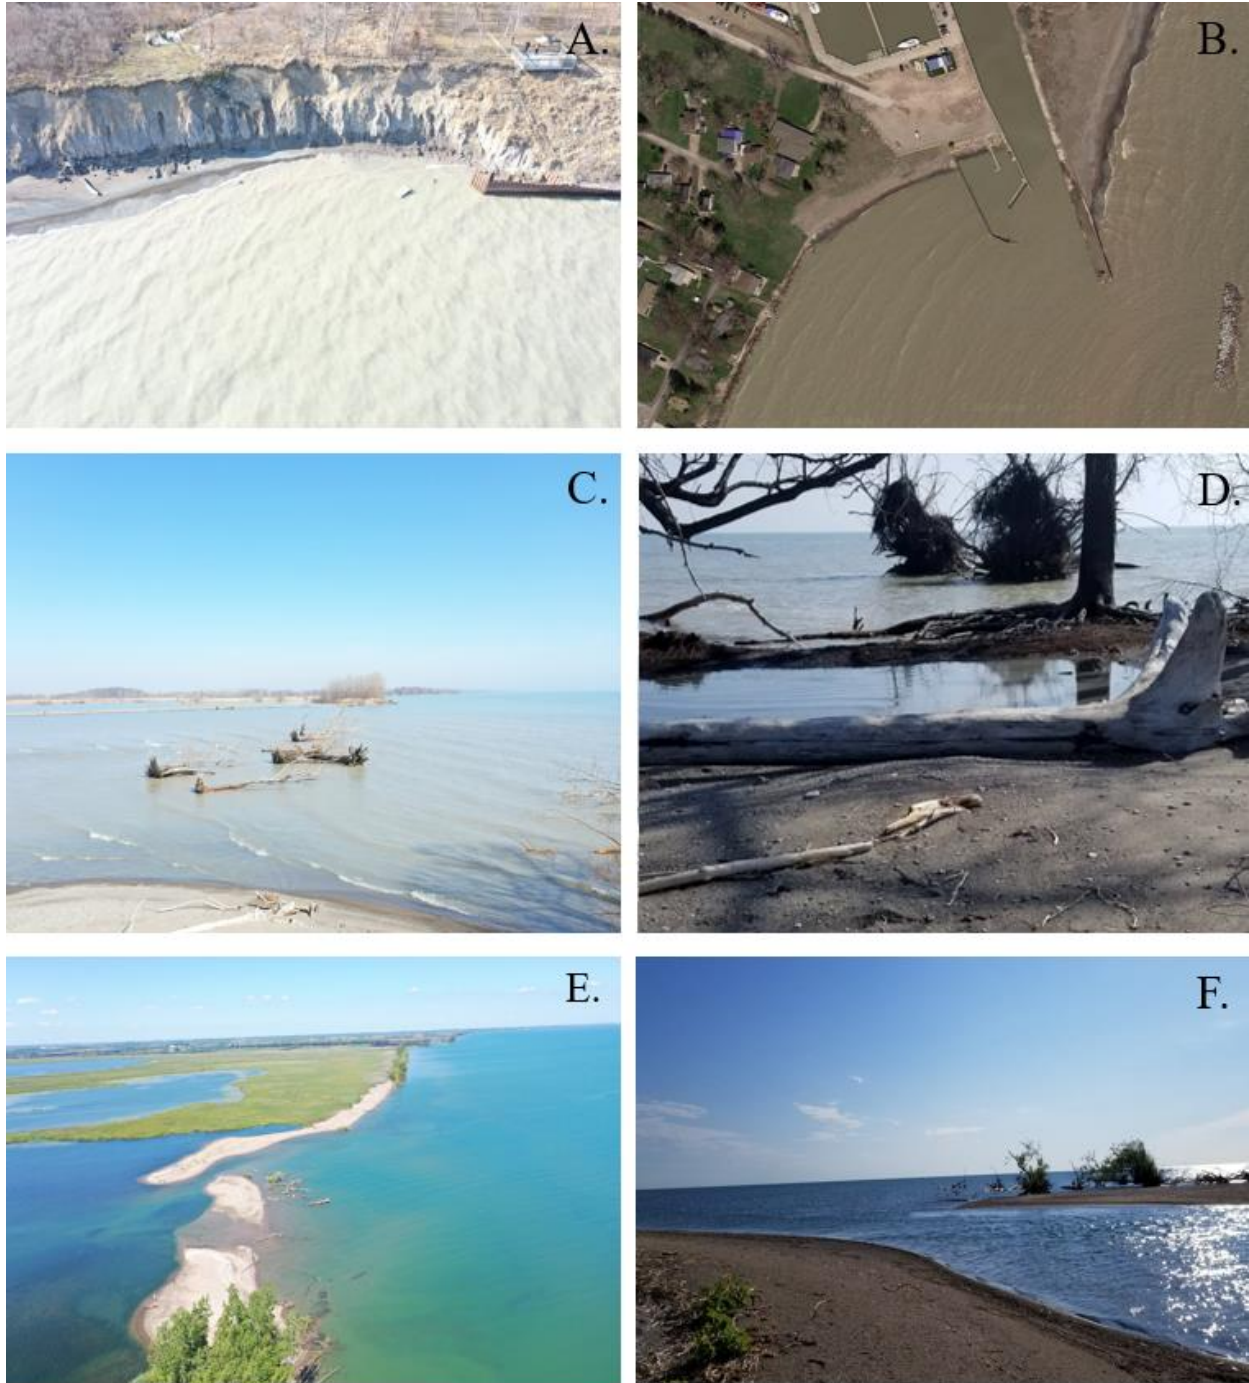
Figure 15: (A) Glacial bluffs located between Port Alma and Wheatley Harbor are the primary source of sediment in the Port Alma to Southeast Shoal littoral cell that supplies the eastern barrier of Point Pelee. (B) Wheatley Harbor and Jetty has trapped or removed $\sim 500,000 \text{ m}^3$ of sediment from the littoral cell causing an increased sediment deficit of the downdrift shorelines (Baird, 2007). (C) Hillman Beach was breached during the current high lake level period and has expanded rapidly and eroded most of the central and southern barrier. (D) Shoreline retreat at Hillman Beach has resulted in vegetation and tree loss. (E) and (F) show the aerial and ground view of the breach at East Beach.

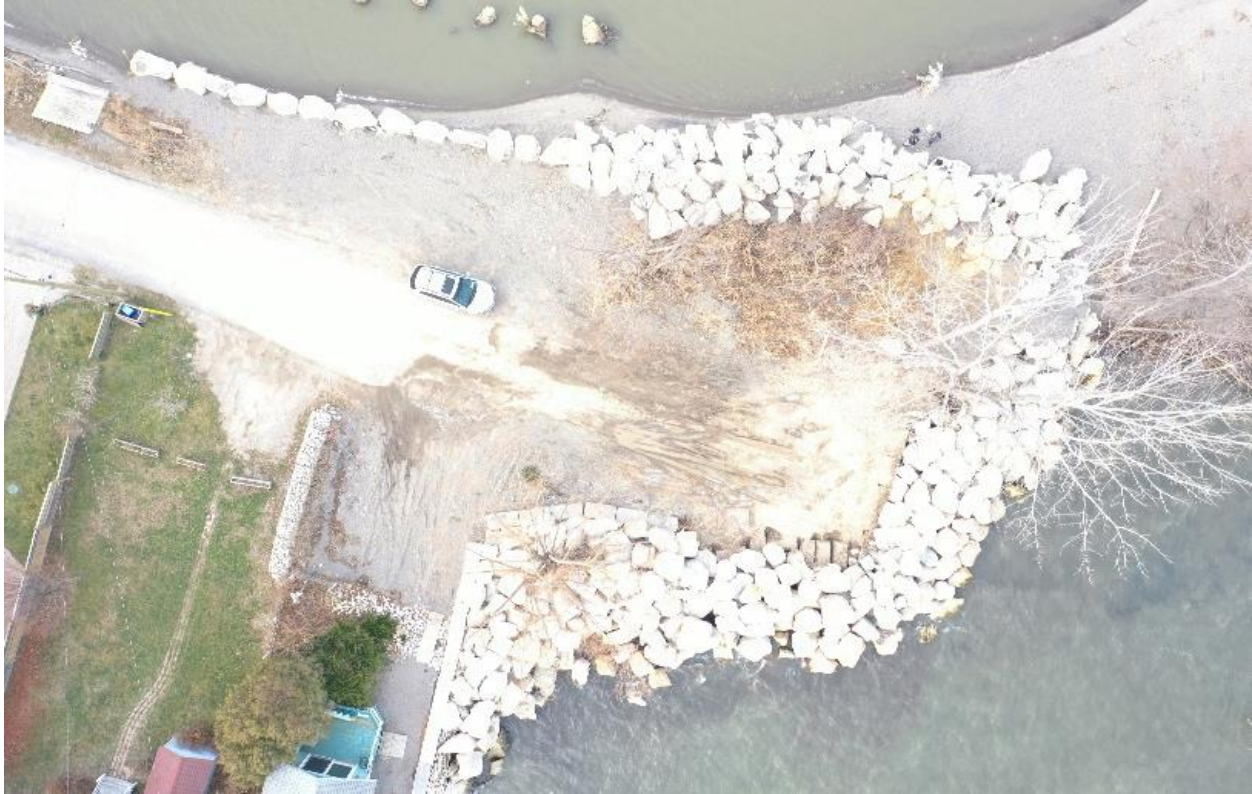
Figure 16: Rock revetment put in place by the City of Leamington in early November 2020.

Over the last century, the yearly average water level (AWL) for Lake Erie was 174.16 m; however, ~0.4–1 m fluctuations regularly occurred between decadal water level highs and lows throughout this period (Figure 17, Great Lakes Environmental Research Laboratory). Additionally, wave data was taken from NOAA's National Data Buoy Center for Station 45005, located ~25 km SSE of Point Pelee. Oblique to onshore significant wave heights (generated from the NNE – SSE) indicate an increase in erosive potential between the late autumn and early spring seasons, although lake ice coverage during winter may mitigate coastal erosion at Point Pelee (BaMasoud and Byrne, 2011, 2012). While the eastern barrier is sheltered from wind waves from the west, the highest magnitude average significant wave heights of ~0.65 m were recorded from the NE. Sedimentation rates and barrier transgression within the region have been further affected by human development including the construction of Wheatly Harbor and Jetty (Figure 15B) that has trapped or removed ~500,000 m³ of sediment from the Port Alma to Southeast Shoal littoral cell (Figure 13), and stabilized rock armored coastlines on the southern extent of Hillman Beach (Figure 16) (Baird, 2007; Trenhaile et al., 1998).

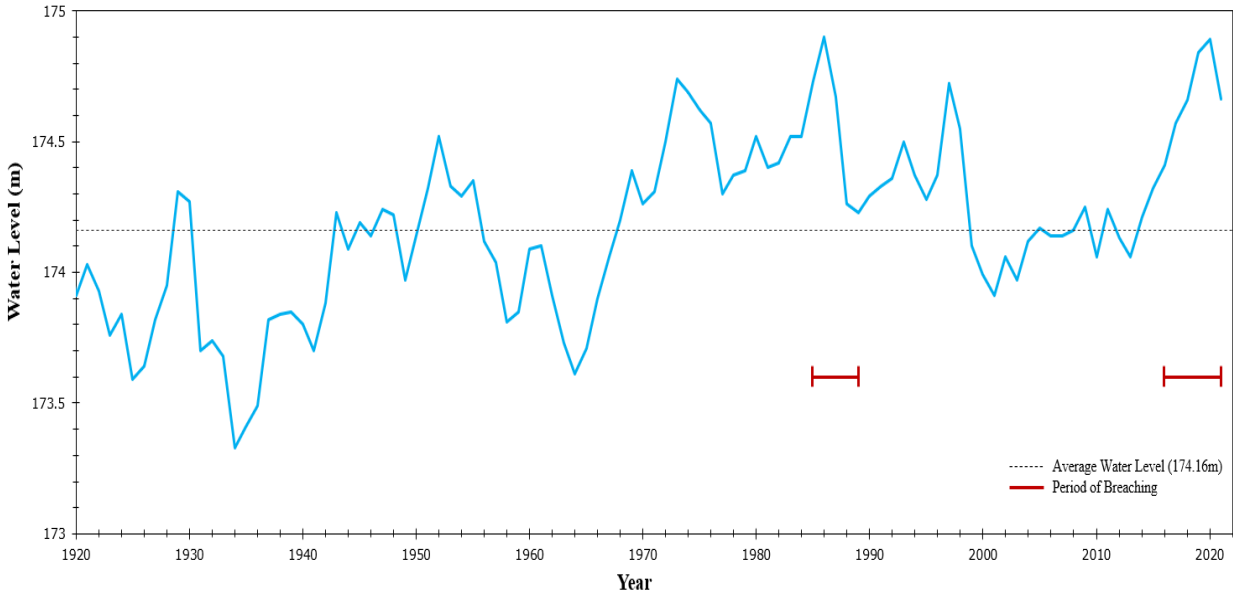
Figure 17: Lake Erie annual average water levels from 1920 to 2021. Data gathered from Great Lakes Environmental Research Laboratory.

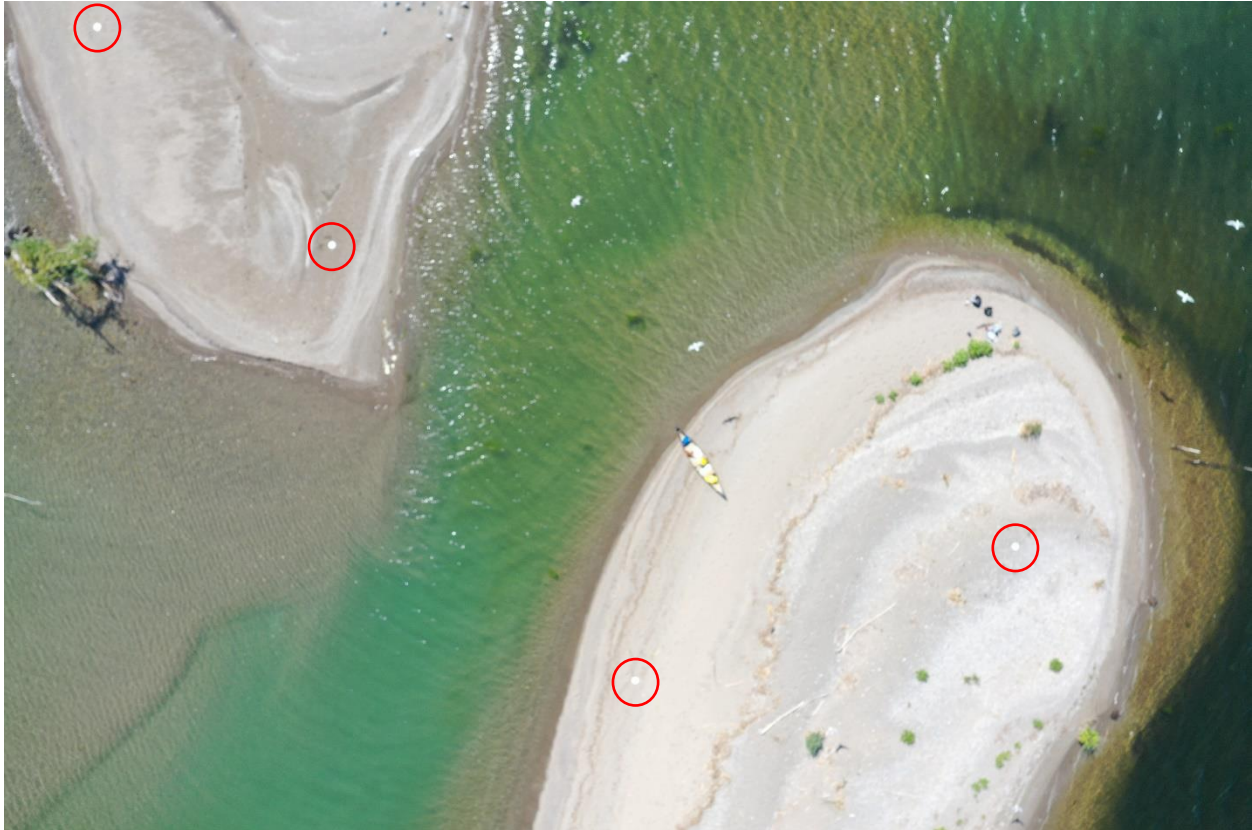
Figure 18: Ground Control Points (GCPs) in use during a survey at East Beach in August 2020. GCPs are assigned specific UTM coordinates using a Real Time Kinematic (RTK) capable GPS receiver, are georeferenced to increase the accuracy of the survey.

To supplement this data, Unmanned Aerial Vehicle (UAV) surveys are taken every two months with a DJI Mavic 2 Pro, using the Pix4DCapture application. These flights were conducted in a series of overlapping grids at a height of 55 metres and maintained a ground sampling distance of approximately 1 cm per pixel. White bucket lids (30 cm diameter, Figure 18) were used as Ground Control Points (GCPs), distributed randomly, and were assigned specific UTM coordinates using a Real Time Kinematic (RTK) capable GPS receiver. These were georeferenced to increase the accuracy of the orthomosaics produced in post-processing, and GCPs with high error were removed. Flights were processed using the Structure from Motion (SfM) Pix4DMapper software to generate a point cloud, orthomosaic, and digital surface model (DSM). Noise filtering was used to correct the altitude of the points to avoid inaccurate points while generating the DSM, as well as sharp surface smoothing to correct areas with small erroneous bumps, while still preserving the orientation of the surface and keep sharp features such as rock walls and wave breaks. The DSM and orthomosaic were generated with a resolution of 1 cm/pixel, using the triangulation algorithm based on Delaunay triangulation, as this is more suitable for flat areas and works up to ten times faster.

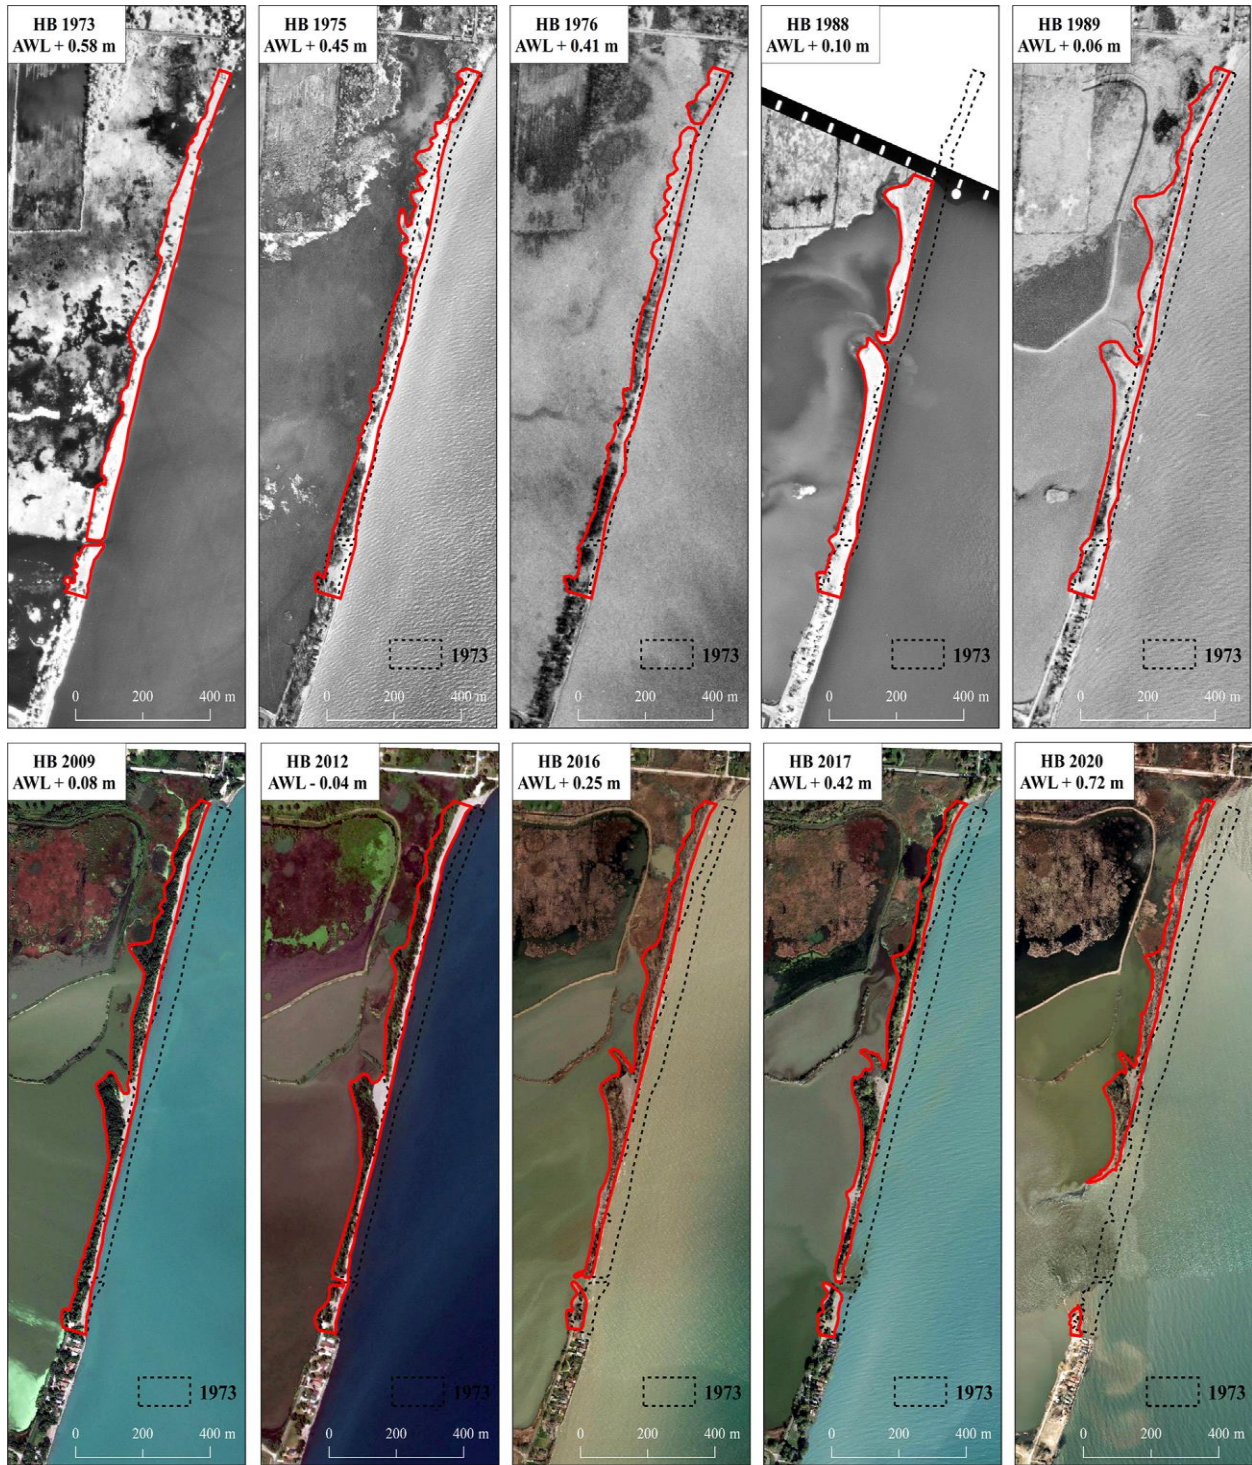
Figure 19: Historical changes at Hillman Beach (HB) between 1973 and 2020. Patterns of barrier transgression, overwash, and breach initiation and closure can be observed in response to lake level fluctuations relative to the longer-period Lake Erie average water level (AWL).

In 1973, water levels peaked at +0.58 m (relative to AWL) before slowly falling to +0.45 m in 1975 and to +0.41 m in 1976. During this period of high lake levels, shoreline retreat was well above longer-term averages at -4.92 m/y, small ~20 m breaches can be observed on the southern (1973) and northern (1976) ends of the barrier, and overwash deposits were visible along the back barrier (1975). A record water level peak occurred in 1986 at +0.72 m, however, imagery was not available until 1988 when water levels had already fallen to +0.1 m. A relatively small ~20 m breach is evident in 1988 with the landward transfer of sediment visible in the lagoonal water column and by the considerable accumulation of sediment in the lobate downdrift end of the breach. By 1989, water levels fell to +0.06 m, the breach closed, and shoreline progradation of 9.35 m/y significantly increased the width of the barrier. This is particularly evident in areas adjacent to the former breach which also expanded landward and became the widest section of the

barrier. The landward migration of the breach formed a localized concavity in the shoreline that appears to act as a sediment sink as lake levels dropped. Following another water level peak in 1997 at +0.55 m, a prolonged period of near-AWL and stable water levels occurred between 2001 and 2013. By 2009, shoreline transgression was slightly less than the longer-period average at -0.95 m/y, although a noticeable increase in vegetation cover occurred on the back barrier and in areas of former disturbances (i.e., breaches and overwash) suggesting this was a period of relative inactivity. Water levels rose in 2016 to +0.25 m and in 2017 to +0.42 m. During this period, a small ~30 m breach opened near the same location as the breach in 1973 and shoreline transgression increased to -2.95 m/y. In 2020, lake levels matched the previous 1986 record at +0.72 m, shoreline transgression accelerated to -5.46 m/y, and the breach significantly expanded to the largest on record at ~320 m. Much of the southern end of HB has been entirely eroded, herbaceous and woody vegetation removed, and the marsh exposed to fully developed lake waves.
