**Patterns and Behaviours of Barrier Breaching
in Lacustrine Environments: A Case Study
from the Point Pelee Foreland**

A Thesis

Submitted to the Faculty of Graduate Studies
through the School of the Environment
in Partial Fulfillment of the Requirements for
the Degree of Master of Science
at the University of Windsor

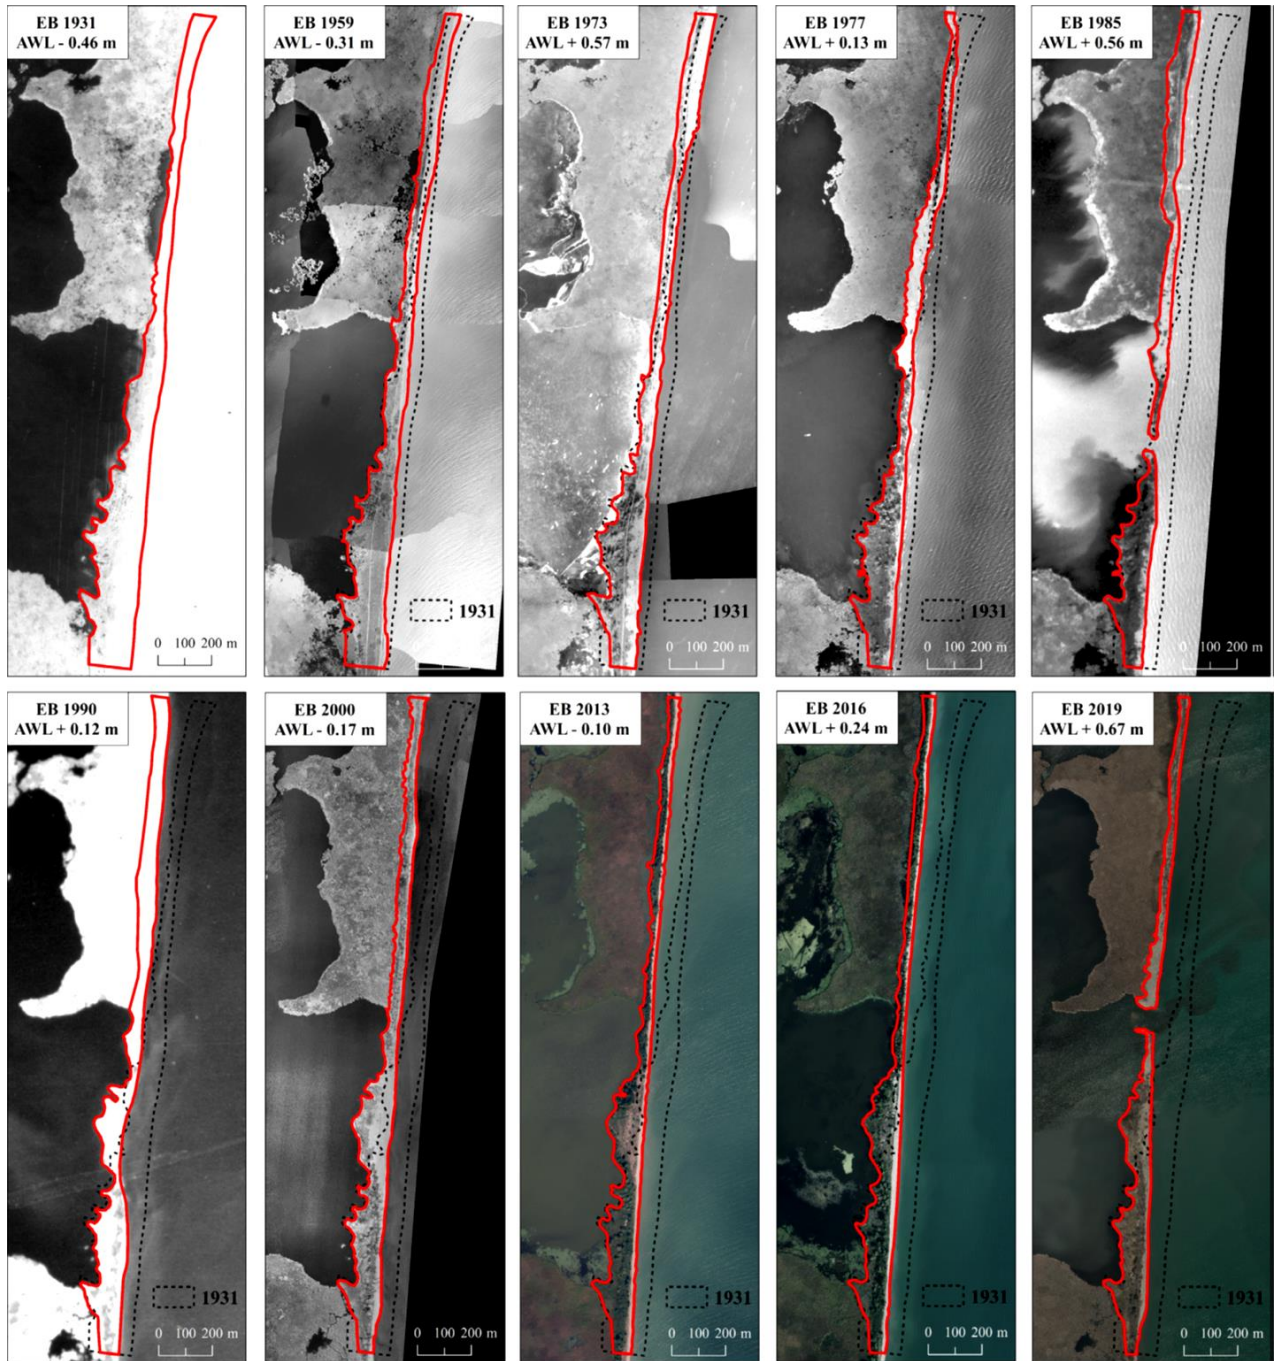
Figure 20: Historical changes at East Beach between 1931 and 2019. Patterns of barrier transgression, overflow, and breach initiation and closure can be observed in response to lake level fluctuations relative to the longer-period Lake Erie average water level (AWL).

overwash deposits, increasing the width of this section of EB following closure. Between 2000 and 2013, a prolonged period of stable and below AWL lake levels occurred, the shoreline convexity lakeward of the former breach filled-in and became the widest section of the barrier, vegetation colonized areas that were previously breached or overwashed, and transgression rates were below longer period averages at -0.75 m/y. In 2016, lake levels rose to +0.24 m and shoreline transgression increased to -2.95 m/y. Lake levels peaked by 2019 at +0.67 m and increased transgression rates of -5.36 m/y were observed. Additionally, a ~77 m breach formed at the northern end of Lake Pond and overwash fans were deposited in the adjacent marsh.

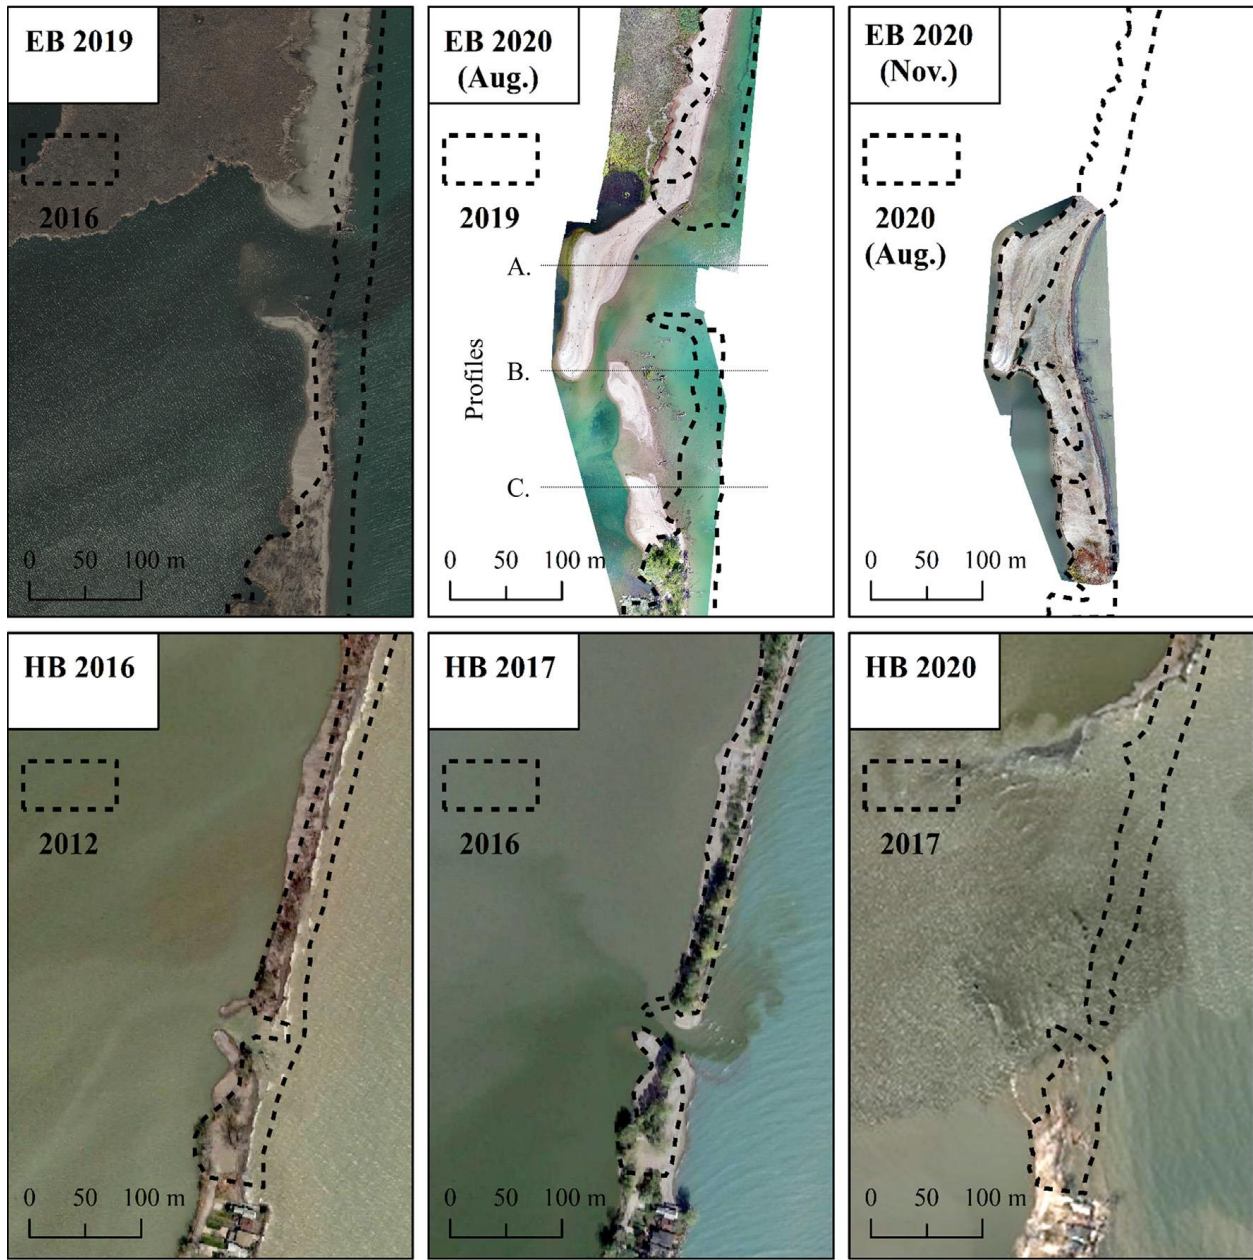
Figure 21: Examples of barrier breach initiation, expansion, and closure occurring at East Beach (top row) and Hillman Beach (bottom row) during a 2013 – 2020 period of lake level rise.

m in width was observed welded onto the lakeside of the former breach as of November 2020 (Figure 21).

At Hillman Beach (HB), a ~15 m breach was first observed in 2016 as lake levels rose (Figure 21). By 2017, the breach expanded to 31 m wide, three years later, the breach expanded significantly to a record ~320 m in the fall of 2020. During this period, average significant wave heights were below the long-term average at 0.48 m and no extreme storm events were identified from the buoy data. However, these records do not include wave conditions from January through March as the buoy is retrieved during the winter months. The winter of 2019/2020 had a near record low maximum ice extent of 15% (Figure 3), compared to the longer-term average of 81%. Low winter ice coverage during the higher energy wave season has been observed to accelerate shoreline retreat around Point Pelee (BaMasoud and Byrne, 2012) and may have contributed to the rapid expansion of the breach. The rock armored shoreline protecting homes further south on HB, now extended to protect the remnant spit at the southern end of the breach, has been stable following the 1970s and is ~35 m lakeward of the adjacent shoreline as of 2020. Given the bistability of the system, it is unclear if it can maintain the historical breach and recovery processes or if the barrier will return to its current position at the southern extent once lake levels fall.

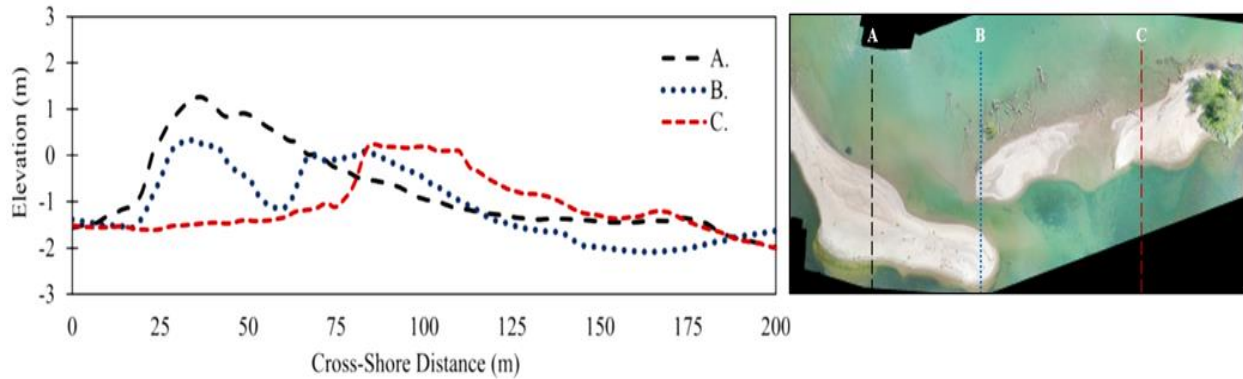
Figure 22: Profiles extending from Lake Pond, across the breached barrier at East Beach, and into the nearshore of Lake Erie. All three cross-sections are from a UAV survey in August 2020. Profile A from the northern end of the barrier, profile B from the centre, and profile C from the southern end of the barrier.

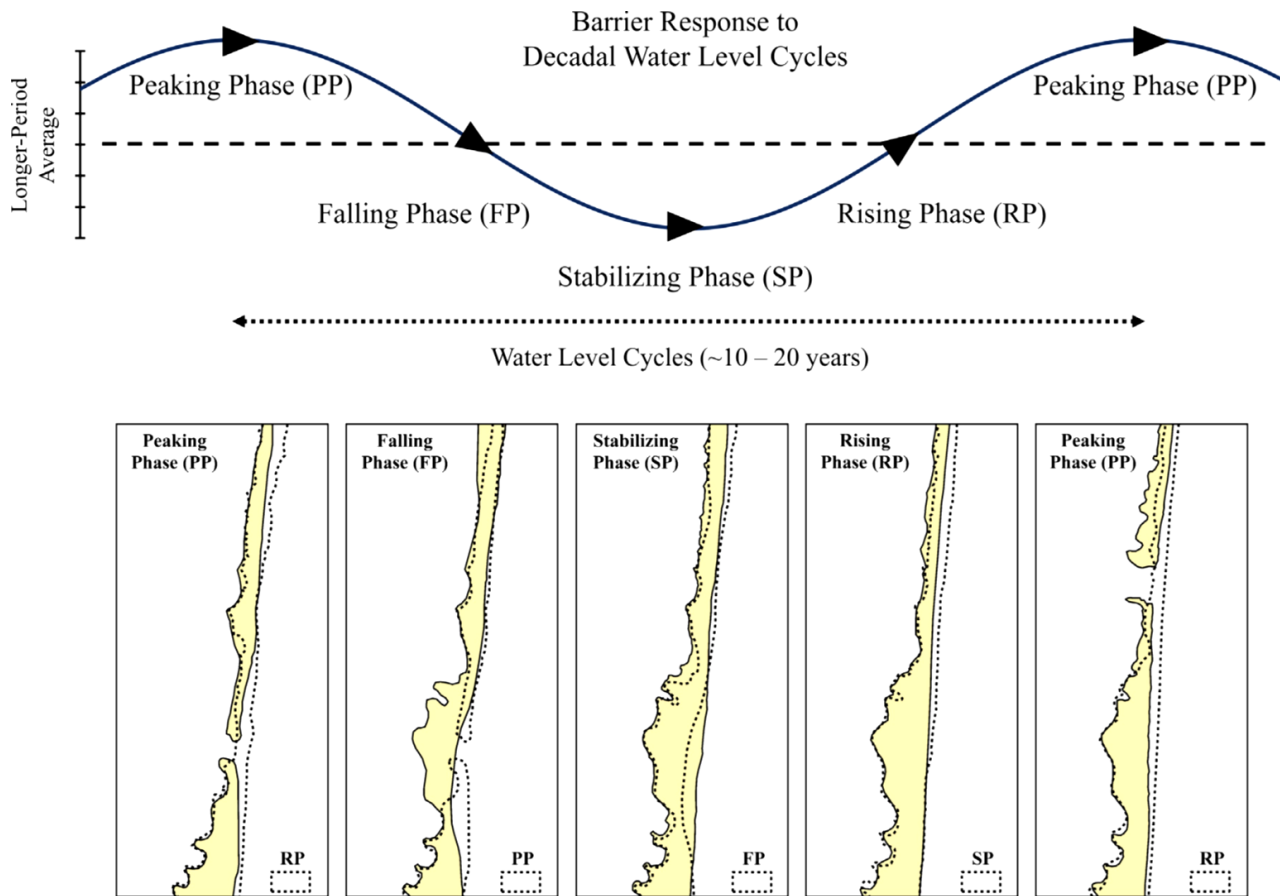
Figure 23: Conceptual model to describe transgressive beach-ridge and breach initiation and recovery processes occurring along Point Pelee’s eastern barriers in response to decadal water level cycles.

Davidson-Arnott and Fisher (1992) also noted how decadal lake level highs and lows influenced overwash dynamics occurring at Long Point spit, located on the northeastern shoreline of Lake Erie. The authors proposed a conceptual model to indicate the spit's vulnerability to overwash processes and potential for recovery that coincided with rising, peaking, falling, and passive or low lake level phases. In general, the potential for landward transport of sediment through overwash fans or terraces increased as lake levels neared peaks in the cycle. As lake levels neared lows in the cycle, the potential for foredune, beach, and vegetation recovery increased. It is also noted that breaches and landward deposits formed during high lake levels, however, these features often closed quickly and were only a minor source of landward sediment transport relative to overwash and aeolian processes. Modifying the Davidson-Arnott and Fisher (1992) model, a model is proposed that synthesizes the observations of transgressive beach-ridge barrier and breach initiation and recovery processes on the eastern shore of Point Pelee in response to decadal water level cycles (Figure 23):

2. Falling Phase (FP) – Lake levels are falling from a Peaking Phase (PP) and are near decadal averages. The barrier width begins to increase, the potential for overwash decreases, and small-scale breaching may occur but will often close quickly. Larger breaches formed during the PP are closed with the barrier increasing in width on the lagoonal or pond margin through storm-induced flood delta deposits. On the lake side, the breach can cause the adjacent shoreline to migrate further landward than the rest of the barrier forming an alongshore concavity or sediment sink. Shoreline transgression rates are usually above longer-term averages but progradation can occur, particularly lakeward of the former breach. Areas of previous disturbances remain largely unvegetated.

4. Rising Phase (RP) – Lake levels are rising from a Stabilizing Phase (SP), or in some cases a shorter period Falling Phase (FP), and are near decadal averages. The barrier is narrowing and the potential for overwash and small-scale breaching increases. Barrier transgression rates typically begin to accelerate and are above longer-term averages. However, following a prolonged SP a lag in acceleration of shoreline retreat can occur and may result from increased sediment accumulation in the nearshore. If occurring after a SP, vegetation is nearing its maximum coverage although new disturbances can cause localized vegetation burial or removal.

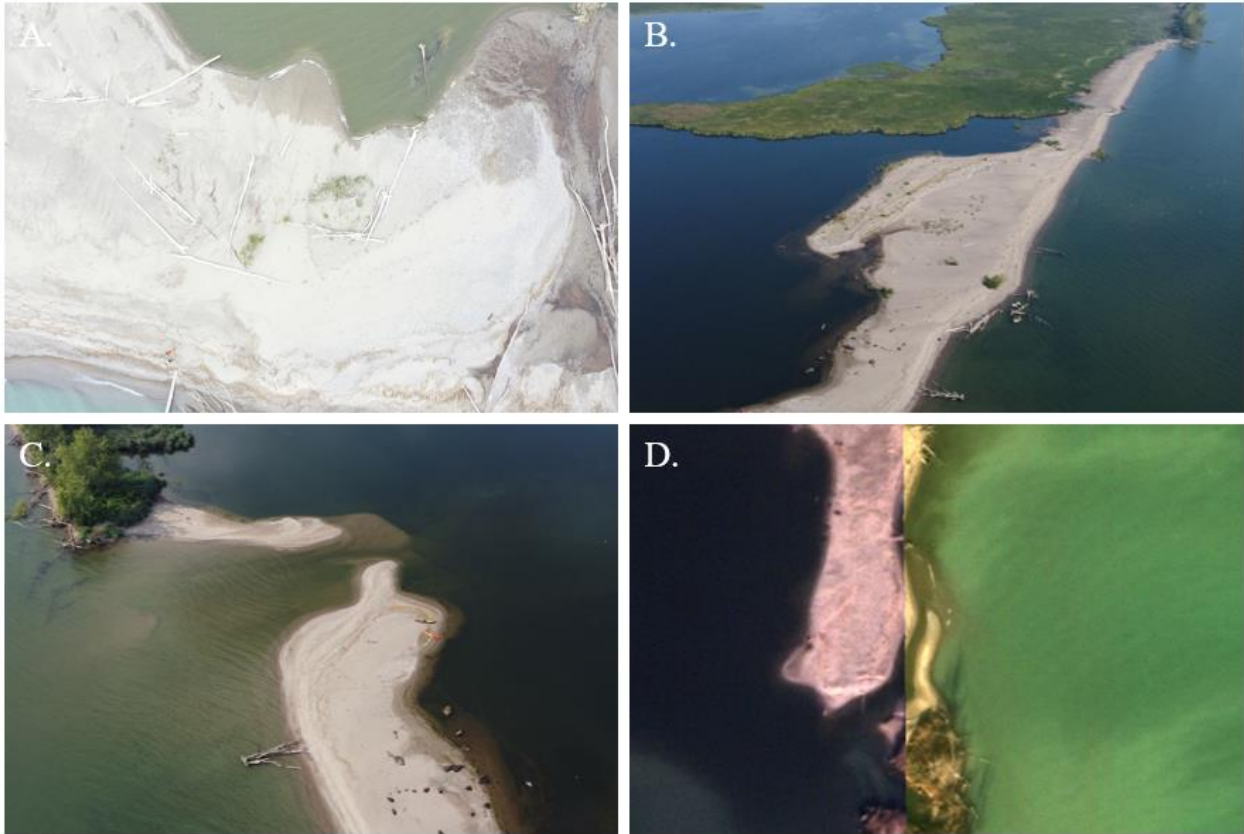
Figure 24: (A) In June 2021, EB had sparse vegetation cover, and (B) 43% of the barrier had doubled in width due to lower water levels exposing sand that was deposited during previous overwash events. (C) In August 2021, breach width decreased to 15 m, both spits were rotating inwards, and the northern spit had a temporary extension from a period of weak currents that allowed for more sedimentation to occur. (D) In November 2021, breach width decreased to 9 m, and multiple overwash fans are visible along the barrier.

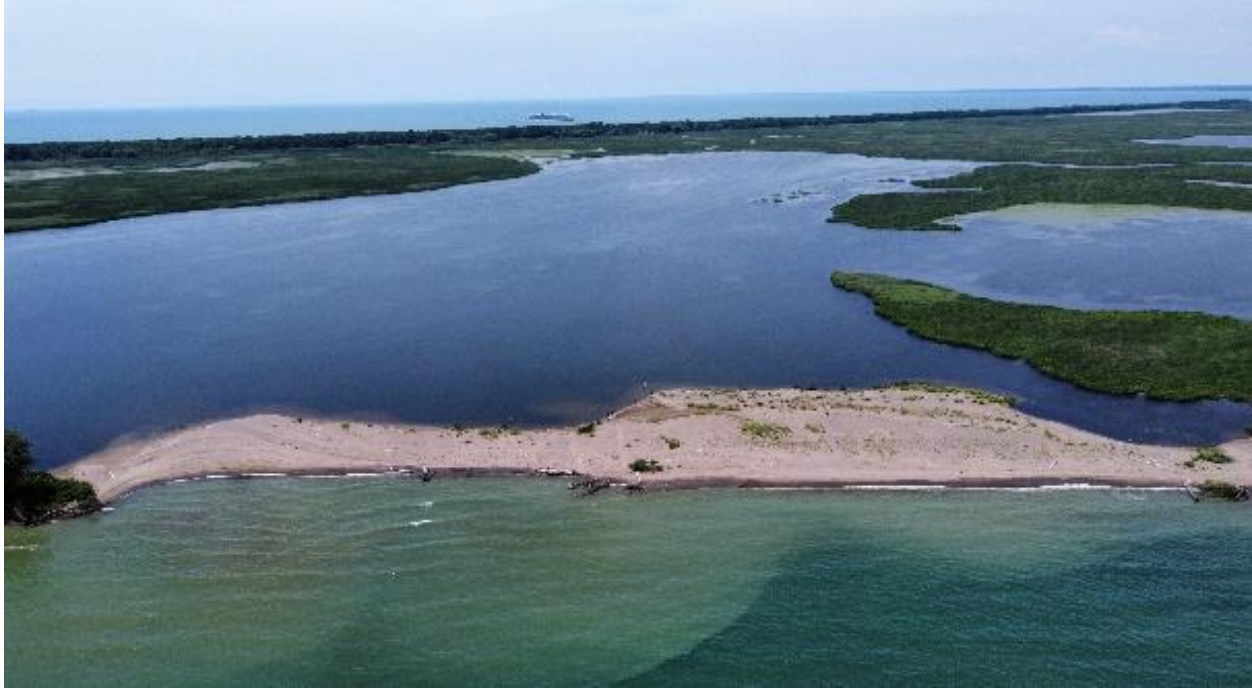
Figure 25: The East Beach breach was reported closed by Point Pelee National Park on June 3rd, 2022.

The breach remained open as winter ice formed, and its closure was confirmed by researchers at Point Pelee National Park on June 3rd, 2022 (Figure 25). Lake Erie's monthly average for June was 174.68 m, and 174.66 m specifically on June 3rd. Results from Chapter One and Chapter Two show a consistent loop pattern, on both a large scale and small scale (Figure 26).

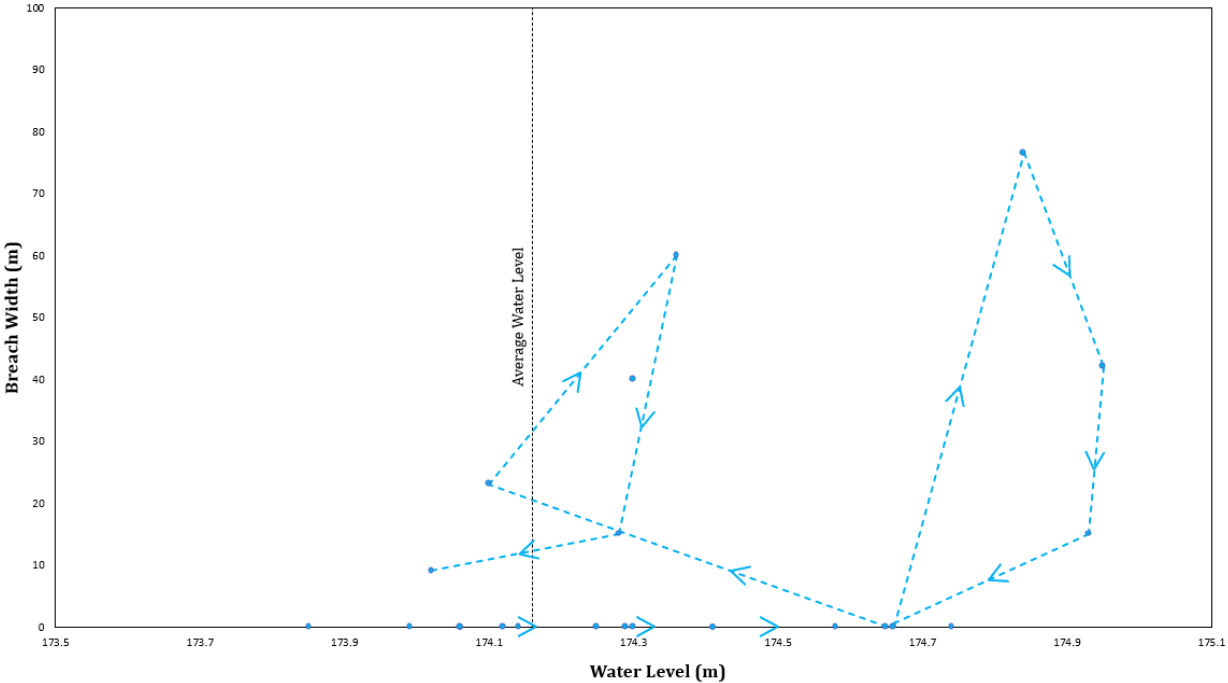
Figure 26: Breach widths at EB plotted against water levels. Loop on the right represents breaching event from Chapter One, and loop on the left represents breaching event from Chapter Two. Data in Table 3.

The ability of a barrier beach to fully recover after breaching relies on its ability to recover in width and elevation prior to the next storm event or period of water level rise. Historically, EB has exceeded the water levels that caused it to breach in 2019, but while in the recovery phase following the first breaching event, the barrier became vulnerable to breaching at lower water levels (Figure 26).

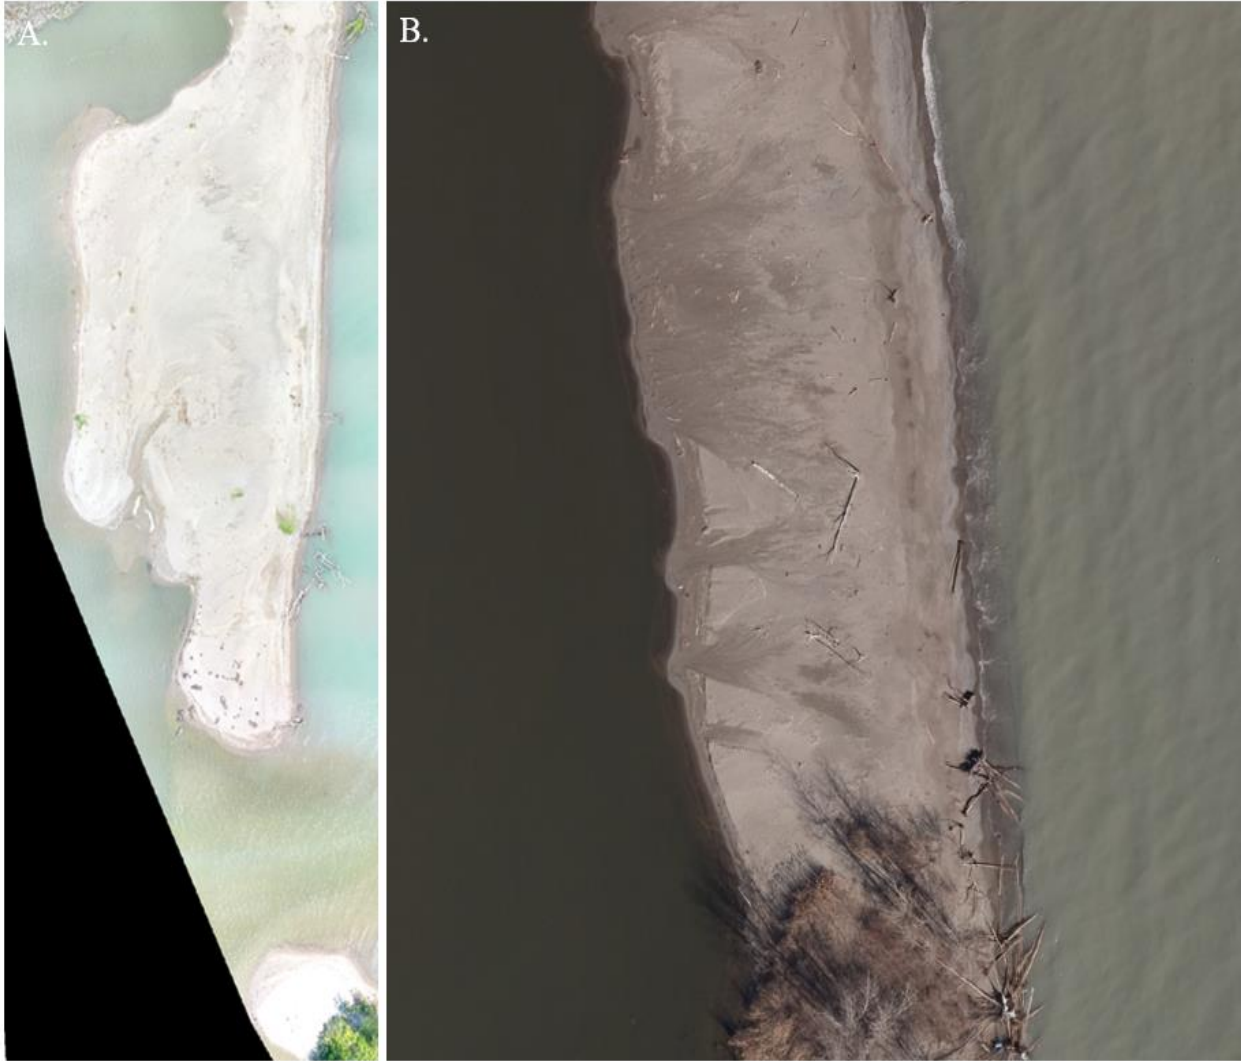
Figure 27: (A) Exposed sediment deposited during overwash events has increased the width of EB barrier by 43%. (B) Survey imagery from November 2021, multiple overwash fans are visible along the barrier.

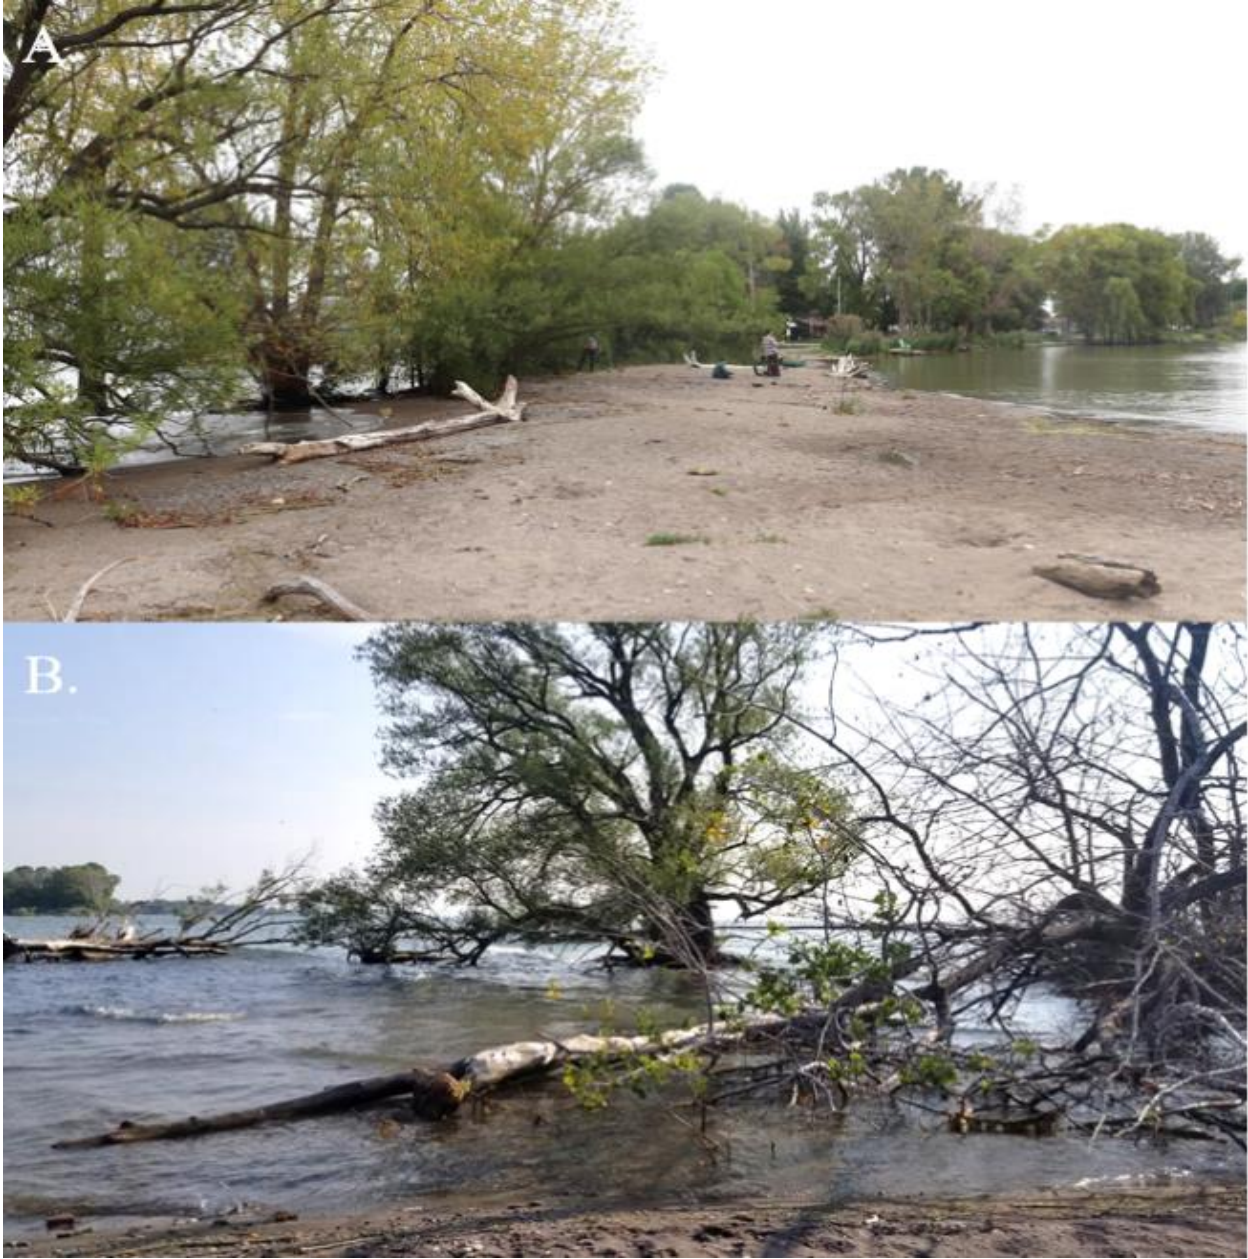
Figure 28: (A) Treeline at HB, before the rock revetment was installed, in September 2020. (B) Fallen trees and woody debris as a result of the retreating shoreline.

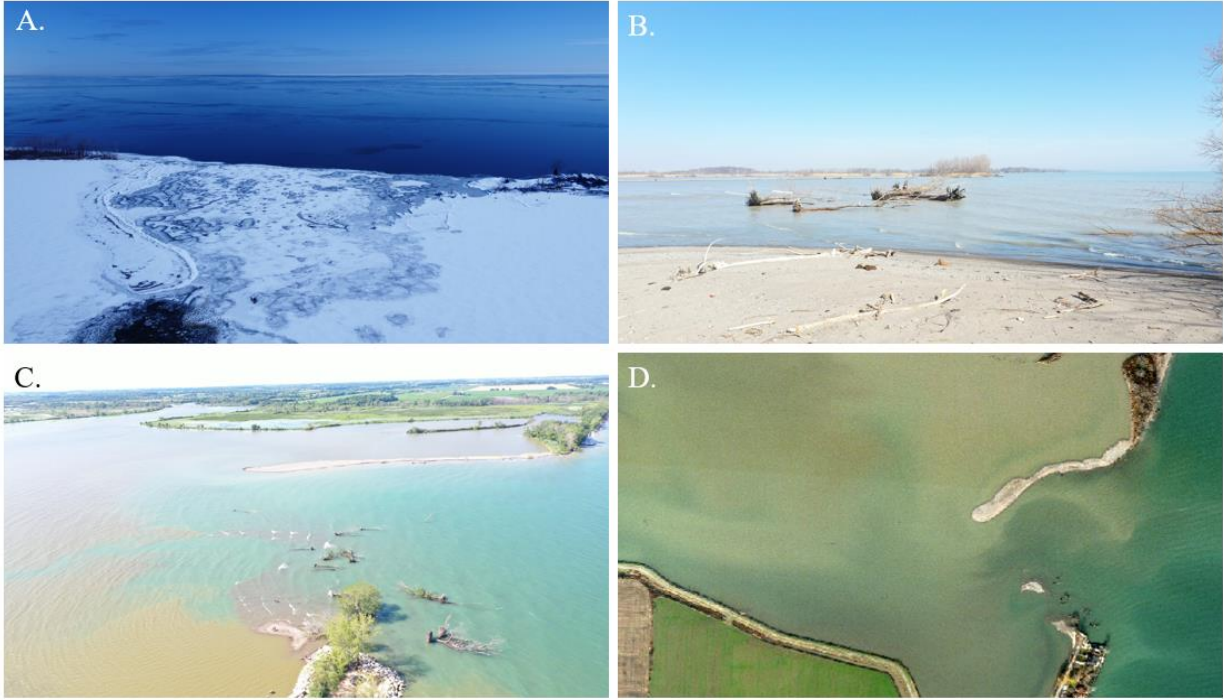
Figure 29: (A) Ice cover at HB on January 25, 2022. (B) Submerged vegetation at HB, due to the retreating shoreline. (C) July 2021, southern spit is separated from the barrier and rock revetement by a channel of water. (D) HB survey from November 2021 (Essex Geocortex Database).

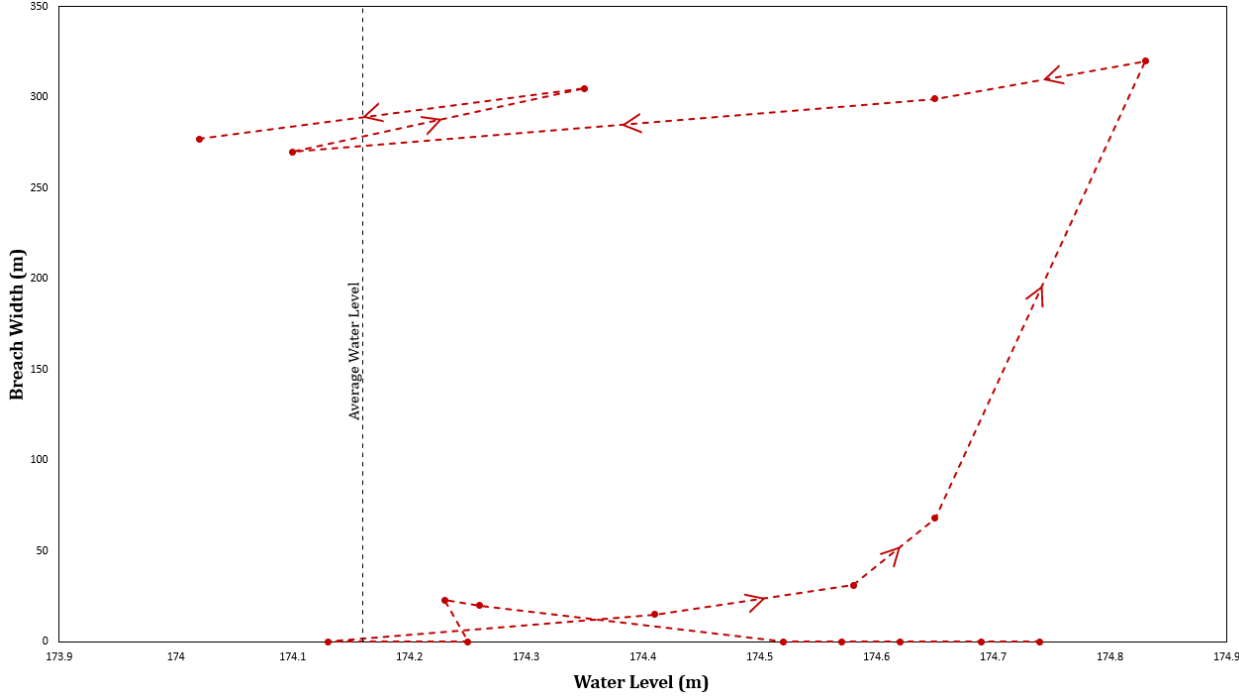
Figure 30: Breach widths at HB plotted against water levels. Breach opens quickly due to the limited sediment supply, and rock revetement is installed right after peak breach width. Data in Table 4.

more trees that extended from the opposite sides of the beach, coming in from the marsh area. In July 2021, the breach increased to 305 m wide as water levels increased by 0.25 m. The northern spit has remained the same, but the southern spit has retreated even further and is only 15 m long, it is separated from the rock revetment (previously the barrier) by a narrow channel of water (Figure 29C). After the survey in November 2021, the breach was recorded to be 277 m wide and water levels dropped down to 174.02 m (Figure 29D). HB appeared to have the potential to follow a similar pattern to EB when the breach width slightly dropped, and because both sites are exposed to the same water levels and wave action. However, once the rock revetement was installed, the breach did not decrease at nearly the same rate it opened, leading to an opposite pattern known as a hysteresis loop (Figure 30).

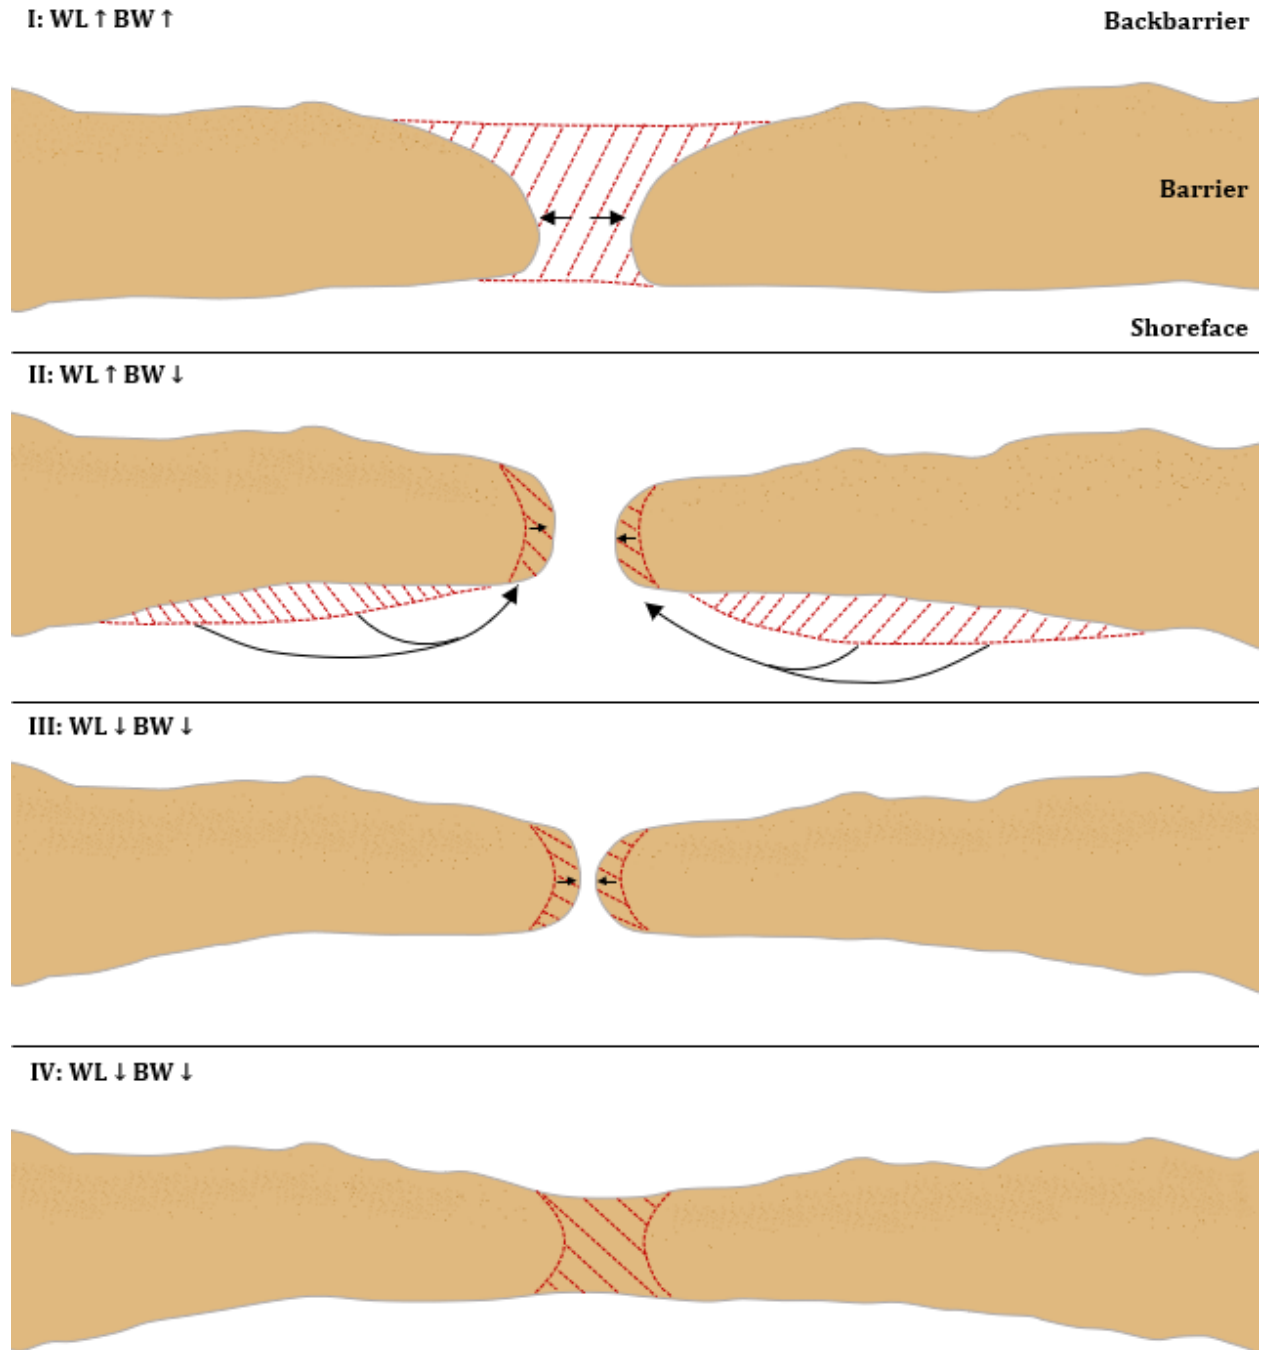
Figure 31: Four-step cycle of barrier breaching of a shoreline with no coastal structures and adequate sediment supply. (I) Large increase in lake water levels causes the barrier beach to breach in the middle of the barrier. (II) Increased wave action erodes sediment from sides of barrier and is then carried to the centre, decreasing breach width. (III) Water levels drop, exposing low elevation of the breach. (IV) Further drop in water levels fully closes the beach.

The stability of a breach is dependent on the consistency of strong waves and the strength of the longshore transport (Kraus, 2003). In this study, alongside the aforementioned drivers, water levels are considered to play a main role in barrier breaching in lacustrine environments. Water levels are the control on longshore transport and the waves impacting the barrier. At EB, barrier initiation and closure have been found to follow a four-step cycle of breaching (Figure 31, 32):

I) Large increase in lake water levels that exceeds the elevation of the barrier beach causes it to breach in the middle of the barrier, at the weakest point. At this point, barrier elevation is the lowest, width is the narrowest, and vegetation is sparse or non-existent. At EB this occurred at lake levels of 174.84 m, and a breach width of 76.5 m.

II) Further increase in lake water levels, with a small decrease in breach width. As water levels continue to increase during this step, increased wave action erodes sediment away from the stronger sides of the barrier where elevation is high. Through alongshore transport, this sediment is carried to the centre of the barrier, slightly beginning to fill in the breach. At EB, this was observed when there was a 0.11 m increase in lake water level, but the breach decreased to 42 m wide.

IV) Decrease in lake water levels (0.28 m) causes the breach to close.

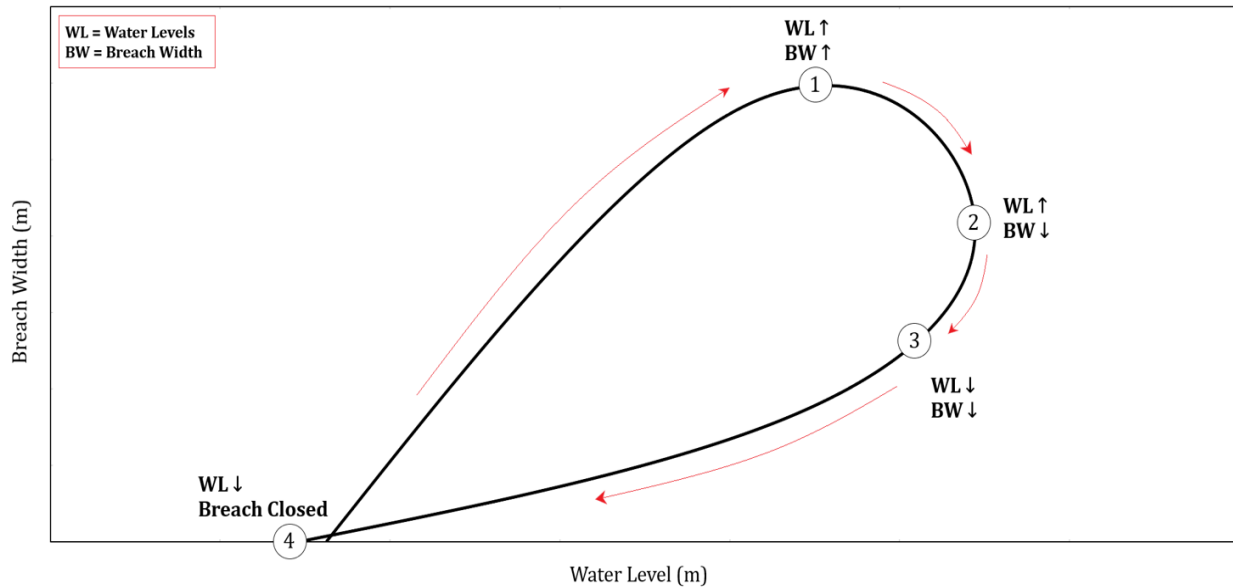
Figure 32: Conceptual model visualizing barrier breaching of a shoreline with no coastal structures and adequate sediment supply.

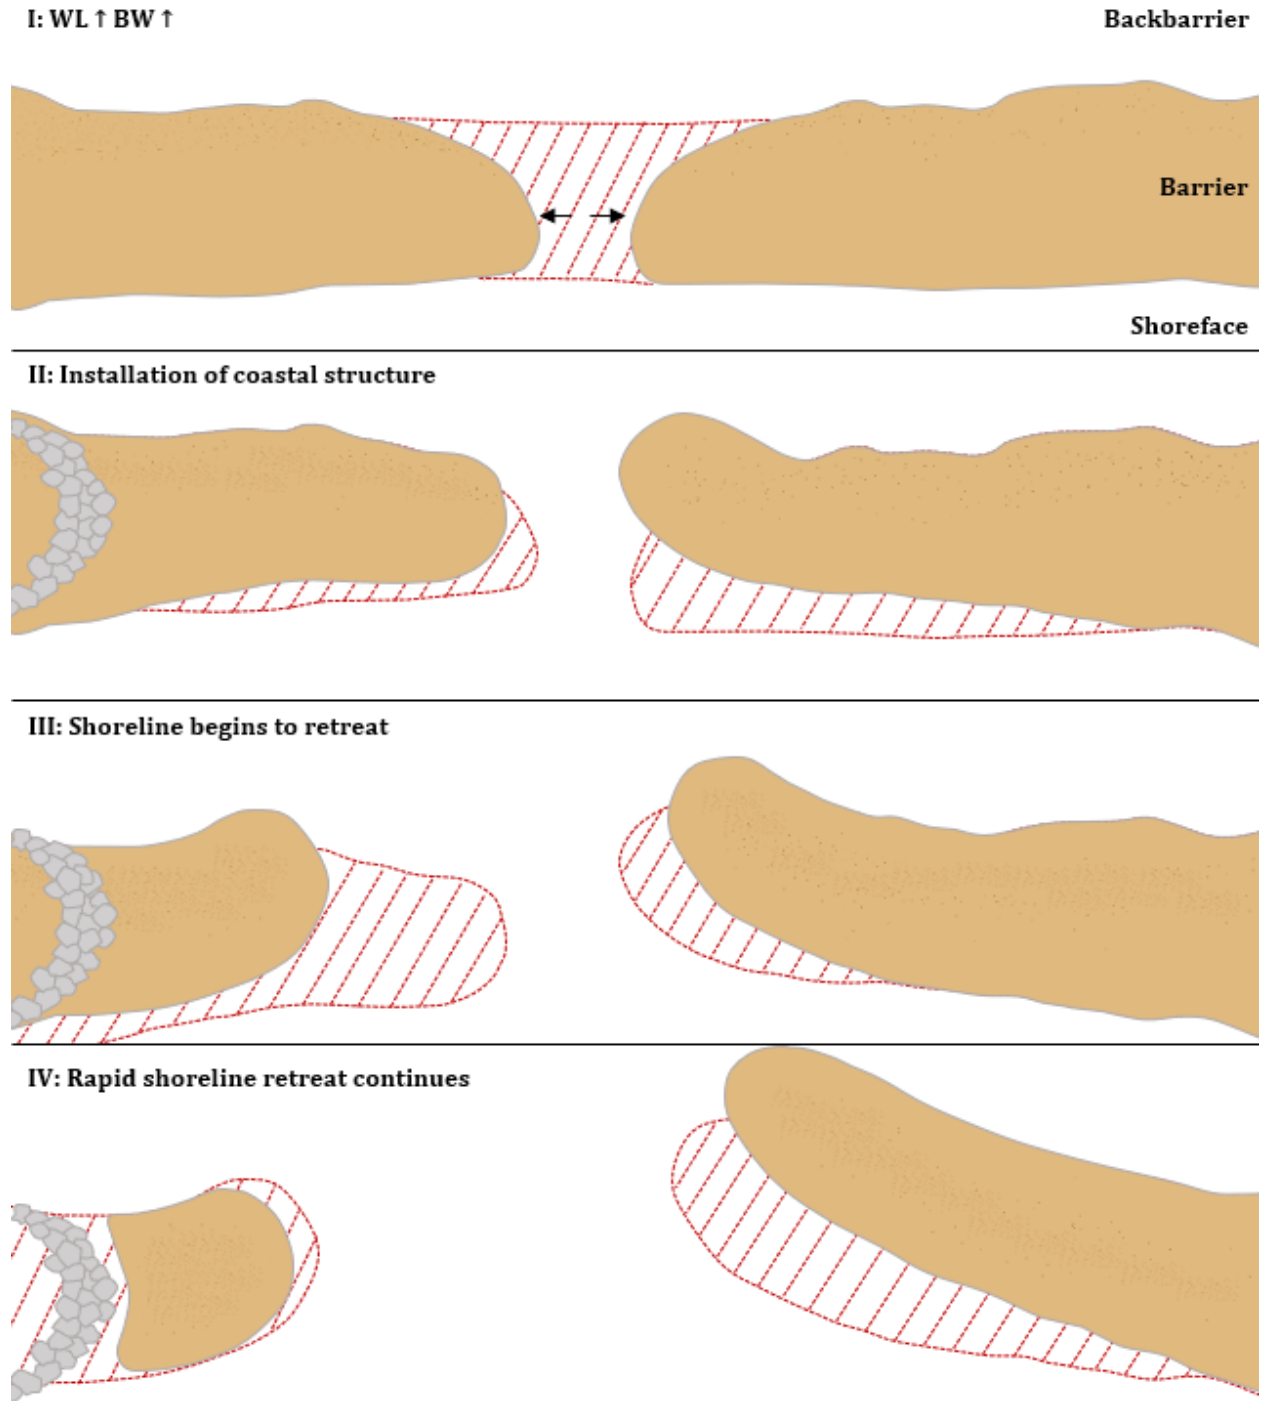
Figure 33: Barrier breaching of a modified shoreline. (I) Increase in water levels cause the barrier beach to breach. (II) Installation of hard coastal structure. (III) Shoreline begins to retreat due to cut off sediment supply. (IV) Rapid shoreline retreat continues; breach expansion occurs at a much faster rate than closure.

It is reasonable to expect that under natural circumstances (a barrier beach without adjacent coastal structures) HB would also follow this cycle. However, after a revetment was put in place, the rate of growth is much faster than the rate at which the breach closes (Figure 34). The patterns of barrier breaching at HB show a trend identified as a hysteresis loop. Defined as a time-lag response by Cho, Suzuki & Nakamura (2010), hysteresis is seen in barrier breaching as breach initiation and growth is occurring at a faster rate than breach closure and recovery. HB is a starved system due to the Wheatley Harbour Jetty trapping alongshore sediment transport and the installation of a revetment only starved it further as coastal structures can disrupt longshore drift, cut off sediment supply, and disrupt normal processes of wind, wave, and current movement (Vaidya et al., 2015; Airoidi et al., 2005; Figure 33). Cutting off sediment supply in turn controls barrier inertia (how rapidly a barrier can be reorganized in response to external forces), restricting the response time of a barrier to external forces (Cooper et al., 2018).

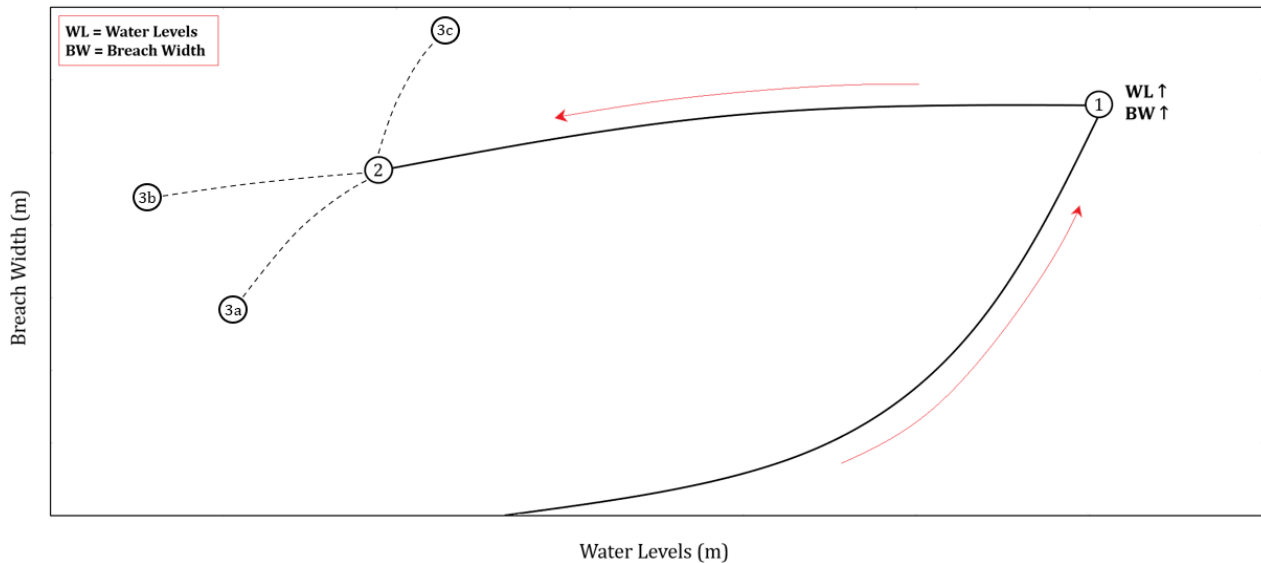
Figure 34: Conceptual model visualizing barrier breaching of a modified shoreline, and three potential future scenarios.

future of Hillman Beach being unknown, three potential scenarios can be hypothesized (Figure 34). In the first scenario (3a), water levels drop below the elevation of the breached part of the barrier, sediment is exposed, and the beach slowly starts to repair itself. In the second scenario (3b), water levels drop but due to a lack of sediment, it can not recover to its prior potential. In the third scenario (3c), water levels increase, and the size of the breach increases with it. This study helped bridge the gap in current breaching literature that focused on marine and tidal environments and introduced lacustrine environments.

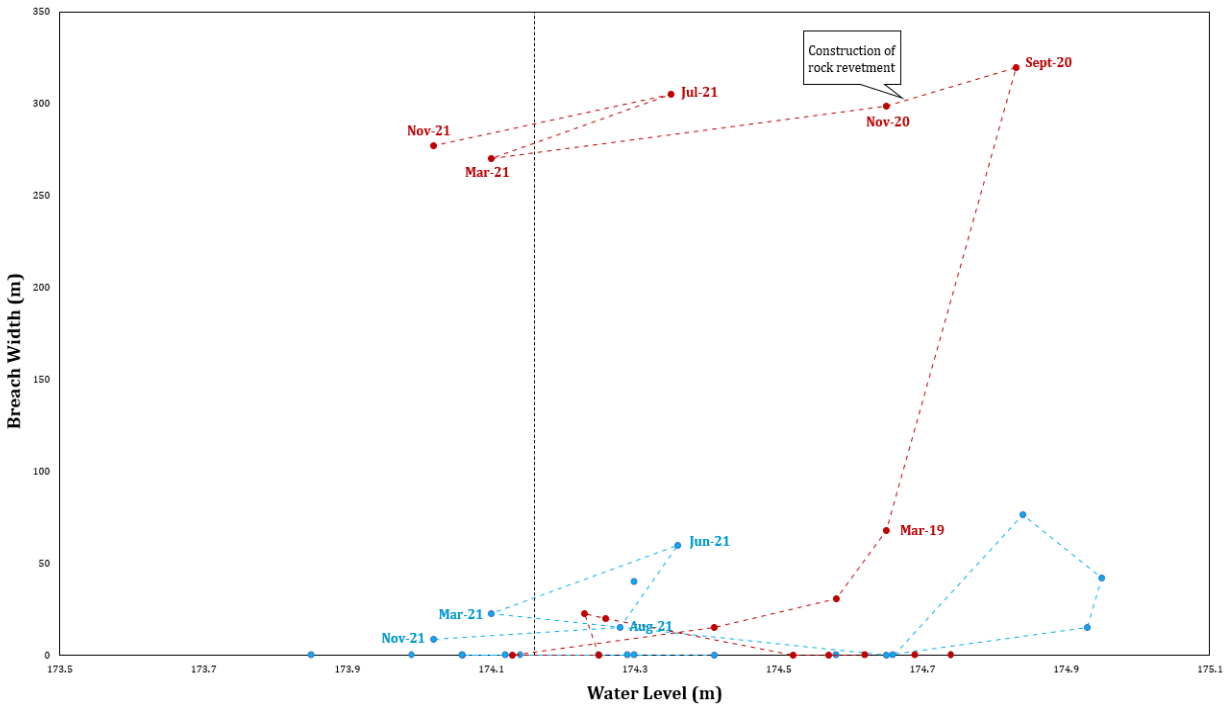
Figure 35: Breach widths plotted against water levels at both EB (blue) and HB (red), displaying much larger scale breaching at HB. Data from Table 3 and 4.

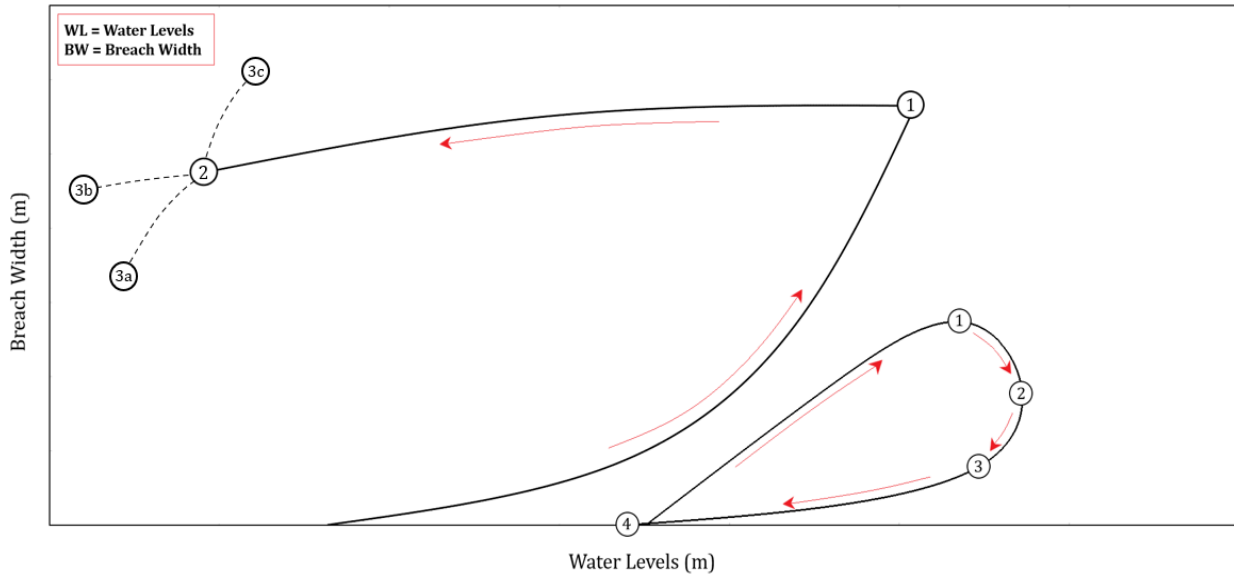
Figure 36: Conceptual model of barrier breaching at an unmodified shoreline with adequate sediment supply, and a modified shoreline with limited sediment supply. Stylized model of Figure 35.
