**Patterns and Behaviours of Barrier Breaching
in Lacustrine Environments: A Case Study
from the Point Pelee Foreland**

A Thesis

Submitted to the Faculty of Graduate Studies
through the School of the Environment
in Partial Fulfillment of the Requirements for
the Degree of Master of Science
at the University of Windsor

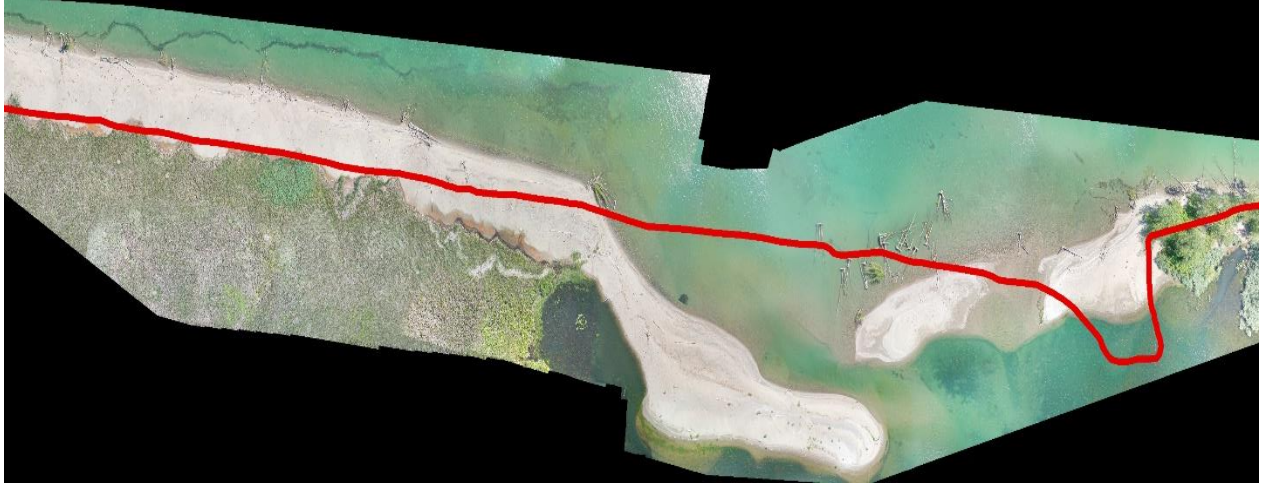
Figure 37: First UAV survey of this project (conducted in August 2020), compared to latest shoreline digitization (survey from July 2022).

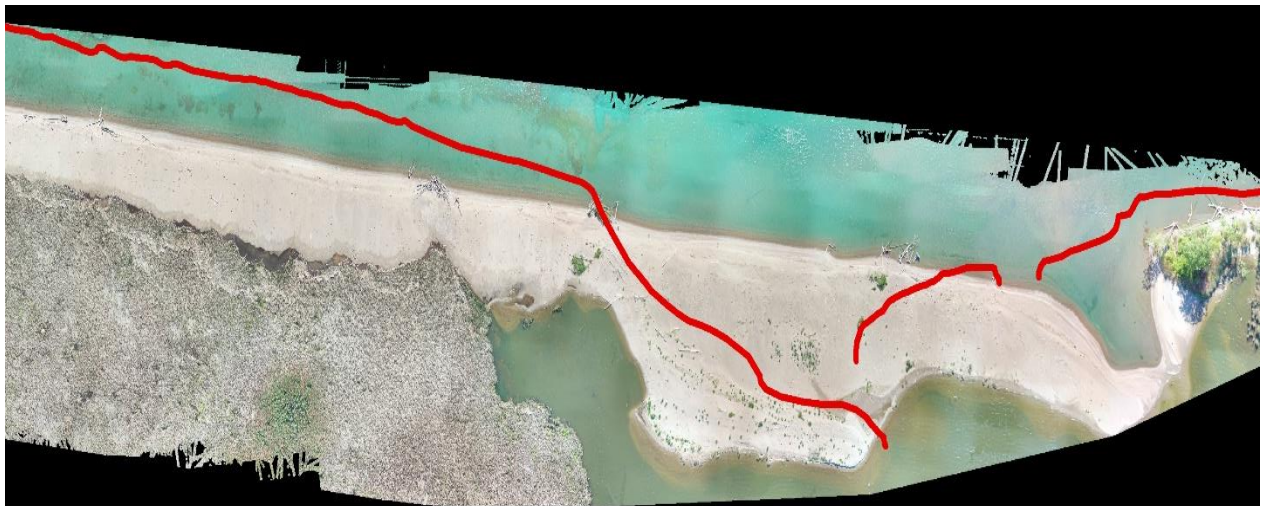
Figure 38: Last UAV survey of this project (conducted in July 2022), compared to first shoreline digitization (survey from August 2020).
