Tension and compression behavior of corroded steel beams rehabilitated with BFRP

A Thesis

Submitted to the Faculty of Graduate Studies
through the Department of Civil and Environmental Engineering
in Partial Fulfillment of the Requirements for
the Degree of Master of Applied Science
at the University of Windsor

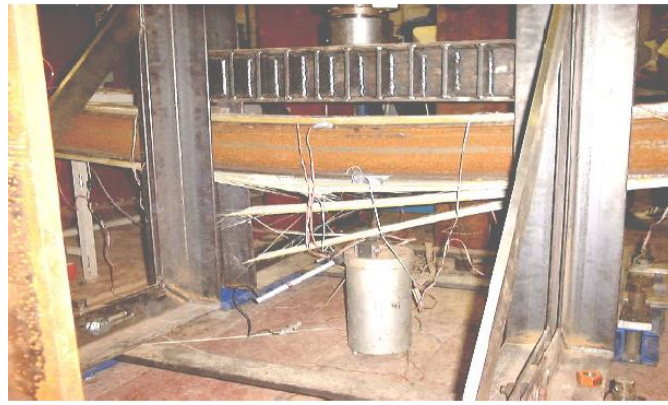
Figure 1.3: Failure mode observed in the rehabilitated beams (El Damatty et al.)

El Damatty et al. [23] strengthened steel I-beams of section W150x37 [22] using 19 mm thick GFRP plates. The GFRP plates were formed by pultrusion process using unidirectional layers of GFRP sheets to provide strength and stiffness in the longitudinal direction. The plates were attached to the steel beams using a methacrylate adhesive system which is a heavy-duty adhesive system. The beams were sandblasted initially to prepare the surface for rehabilitation and ensure good bonding between the plates and the steel. The strengthened beam was cured for 15 days before it was tested in four-point bending as shown in Figure 1.3. It was observed that there was an increase in stiffness of about

15%, the yield load of the strengthened beams showed an increase of about 23% and the ultimate load of the strengthened beam increased to about 78% as compared to the reference (undamaged) steel beam. There was no failure observed at the interface of steel and GFRP indicating very good performance of the adhesive used. The mode of failure observed was a sudden drop in load value due to the tensile failure of the GFRP fabrics. Hence, it can be concluded from the studies that both CFRP and GFRP fabrics as well as plates can be effectively used for rehabilitation or strengthening of steel beams. The advantages of FRP fabrics over plates is fabrics can be applied to a structure of any shape making it possible for rehabilitation. However, FRP plates can only be applied to flat surfaces.

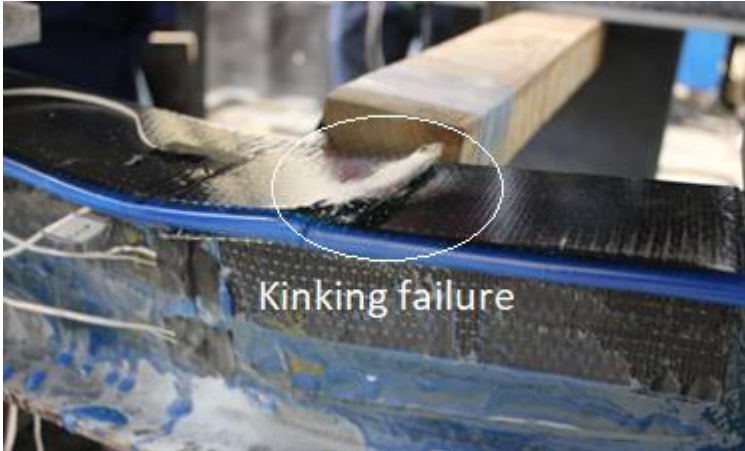
The final failure mode observed in the rehabilitated beams was local buckling of the top flange and followed by a lateral torsional buckling of the beam. The first failure was observed in the attached BFRP fabrics due to kinking along the stress concentration line formed due to the corrosion defect (see Figure 3.11). It caused the first load drop in the experiment as indicated by K (see Figures 3.9 and 3.10).

Figure 3.11: Kinking along the stress concentration line

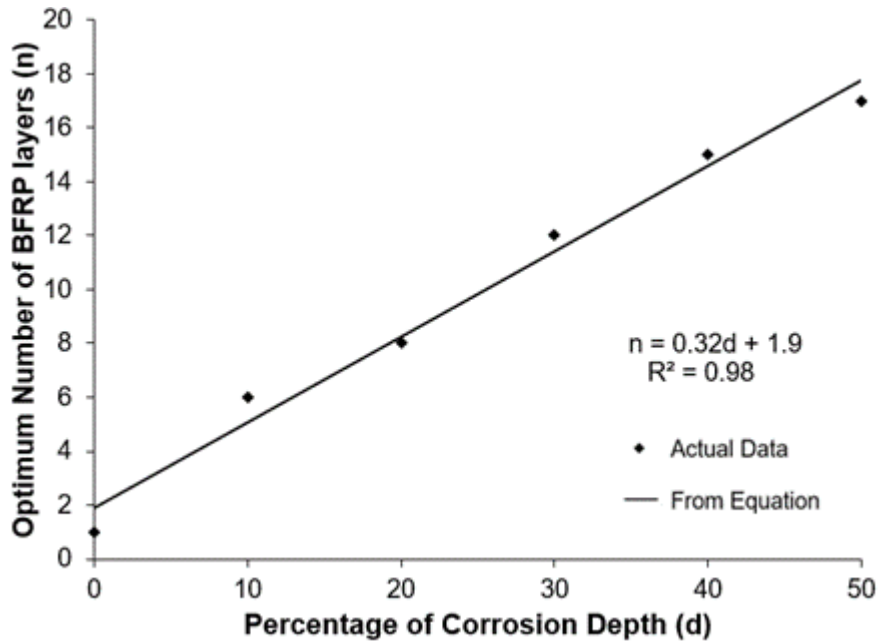
varied to determine the optimum number of BFRP fabric for each corrosion depth. Figure 3,26 shows the optimum number of BFRP fabric layers required to restore the ultimate strength of the corroded specimens to the level of uncorroded corrosion (virgin) specimen, UB for various corrosion depths. The optimum number of layers refers to the minimum number of BFRP fabrics layers required for restoring the ultimate load capacity of the rehabilitated specimens to level of the uncorroded control (virgin) specimen, UB.

Figure 3.26: Relationship between percentage of corrosion and number of BFRP layers

Based on this data, Equation 3.8 is developed which can be used for determining the optimum numbers of BFRP fabrics layers required to rehabilitate a beam with corrosion defect in the compression flange.
