Failure Mechanisms of the Protective Coatings for the Hot Stamping Applications

A Thesis

Through the Department of Mechanical, Automotive and Materials Engineering

The Degree of Master of Applied Science

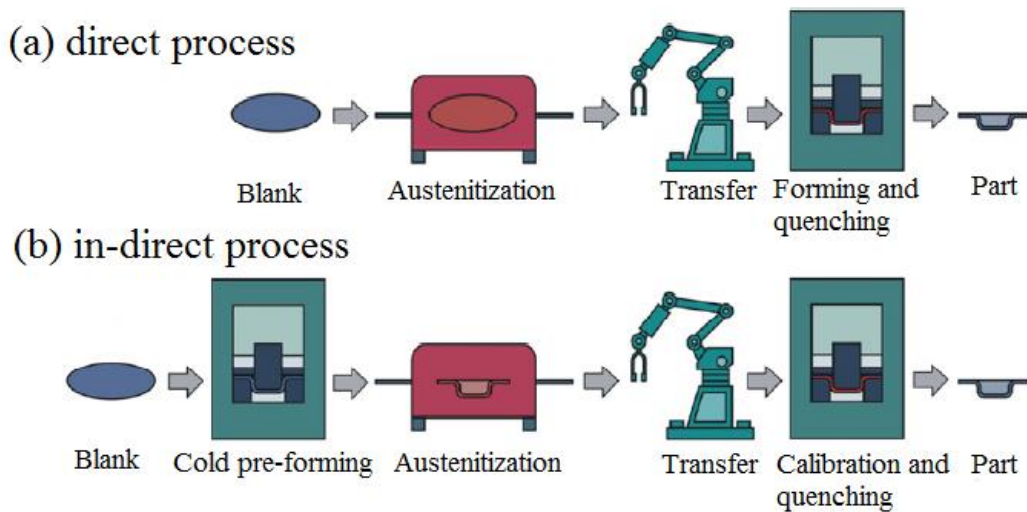
Figure 2.1 Setup illustration of the (a) direct; and (b) indirect hot stamping processes [22].

- 1) Indirect process: the blank is formed, trimmed, and pierced in cold condition. It is later heated and quenched in a die to get high strength properties;
- 2) Direct process: the unformed blank is heated in a furnace, formed in hot condition, and quenched in the die to achieve the required properties.

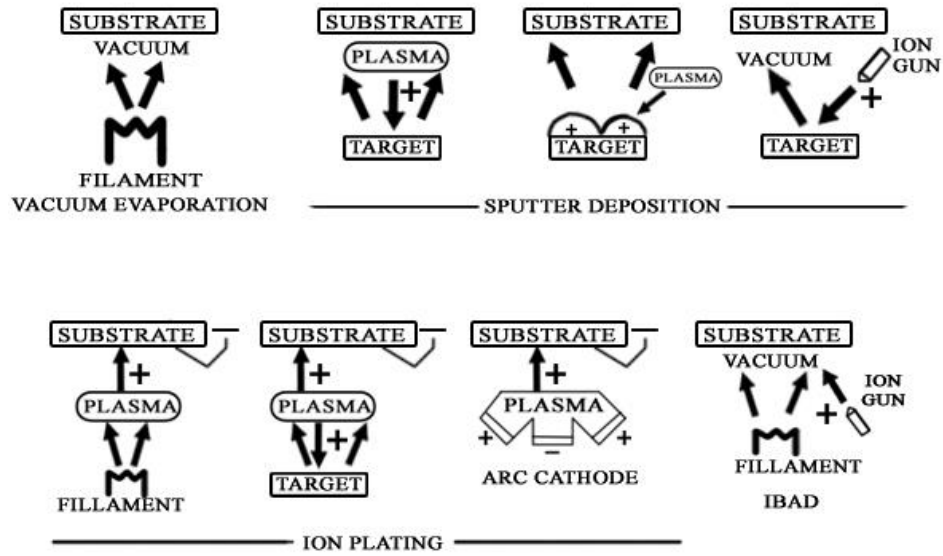
Figure 2.8 PVD processing techniques include vacuum evaporation, sputter deposition, ion plating and ion beam assisted deposition (IBAD) [46].

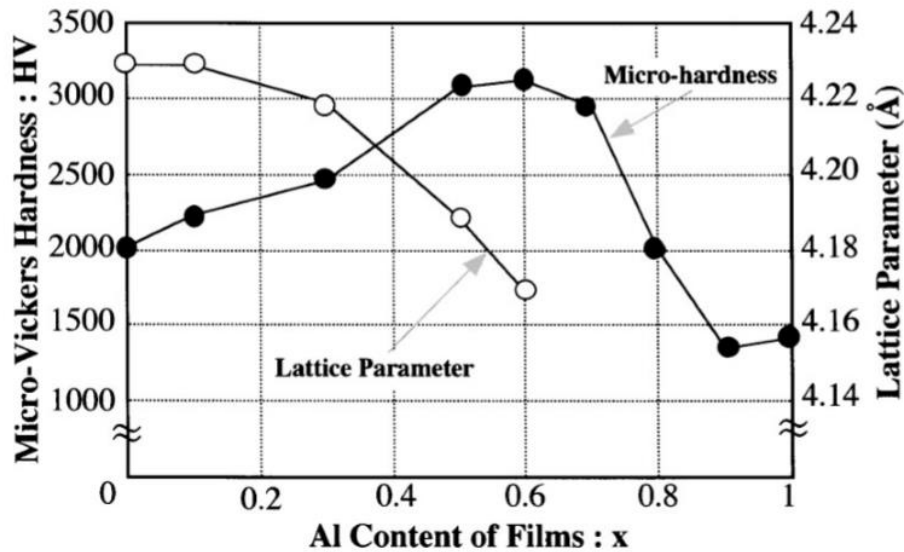
Figure 2.15 Changes in lattice parameter and micro-hardness of $Ti_{1-x}Al_xN$ films with $x=0, 0.1, 0.3, 0.5, 0.6, 0.7, 0.8, 0.9, 1.0$, respectively. The hardness and lattice parameter of TiN film were ~ 2000 HV and 4.23 \AA , respectively. With the addition of Al into Ti-based targets, the micro-hardness gradually increased up to ~ 3200 HV at $x=0.6$ and rapidly decreased to ~ 1400 HV at $x=0.9$ [65].

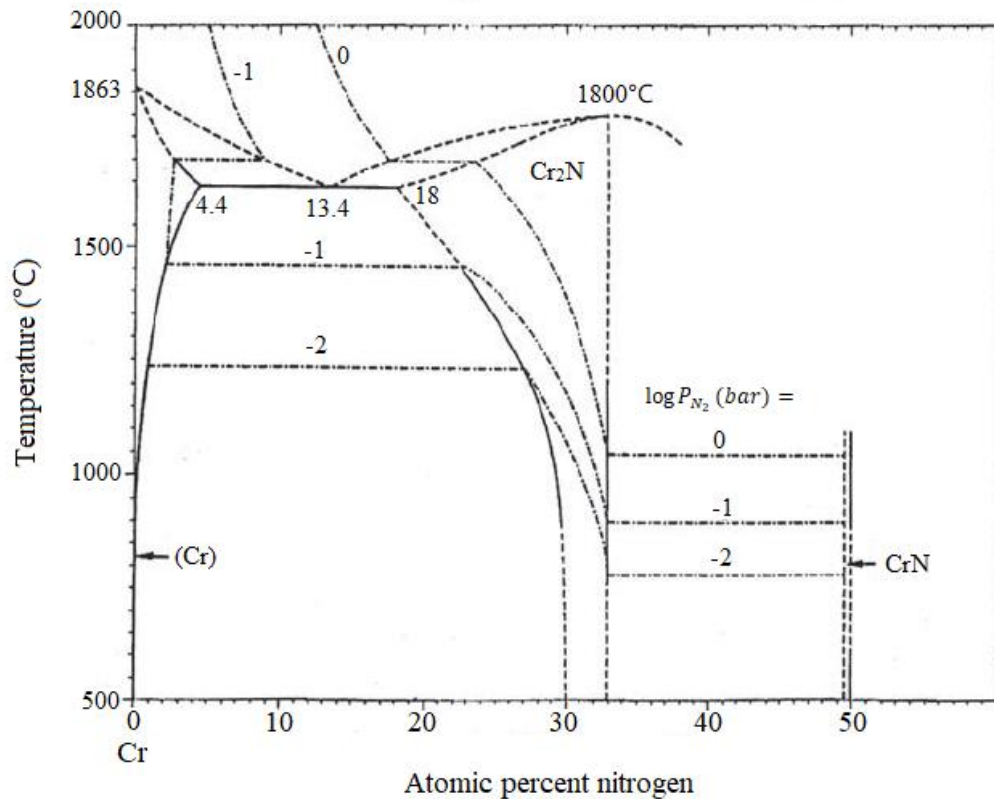
Figure 2.17 Equilibrium phase diagram of Cr-N binary system [74].

Chromium (III) nitride can be prepared by direct combination of chromium and nitrogen at 800°C: $2\text{Cr} + \text{N}_2 \rightarrow 2\text{CrN}$. It can also synthesize by Physical Vapour Deposition technique such as cathodic arc deposition. Chromium nitride crystallizes in the B1 NaCl structure and exists over a narrow range of composition according to the equilibrium phase diagram as shown in Figure 2.17 [74].

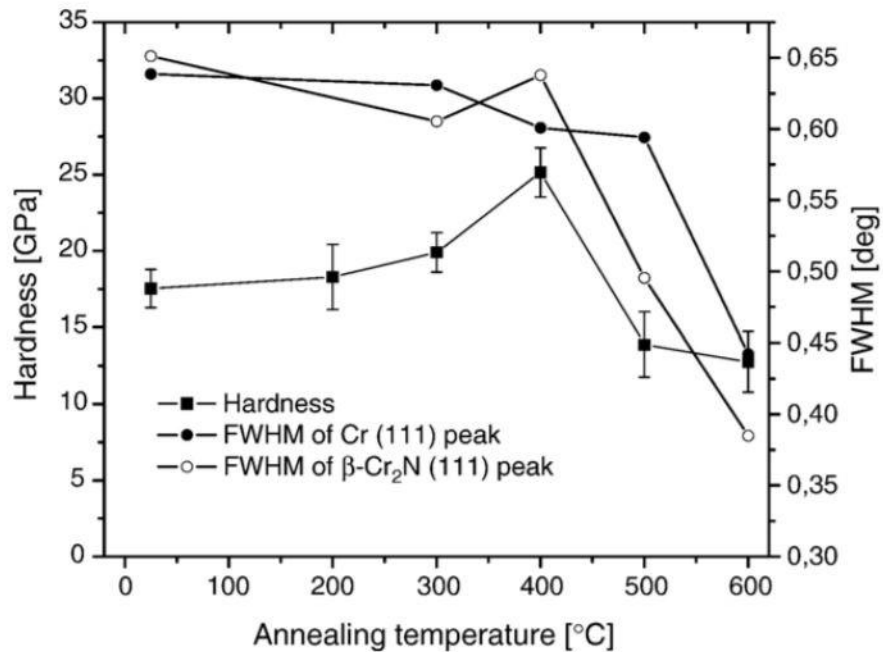
Figure 2.18 Hardness and FWHM of the Cr (111) and β -Cr₂N (111) diffraction peak as a function of annealing temperature [76].

A. Ehiasarian et al. [75] utilized high power pulsed magnetron sputtering (HIPIMS) technique to deposit CrN coating on high-speed steel and stainless steel. A residual compressive stress of 3GPa and a hardness value of $HK_{0.025}=2600$ were achieved. T. Polcar et al. [76] studied the properties of CrN coating at temperatures up to 500°C, and claimed that CrN coating could retain its hardness at 500°C, as shown in Figure 2.18.

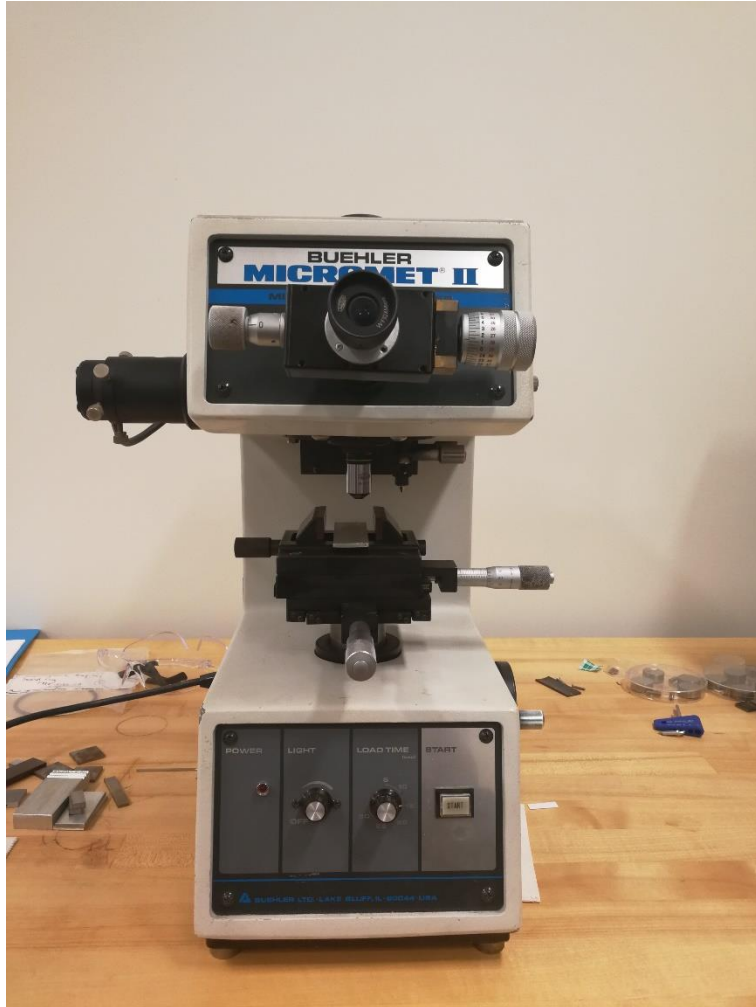
Figure 3.3 Buehler MicroMet II micro-hardness tester.

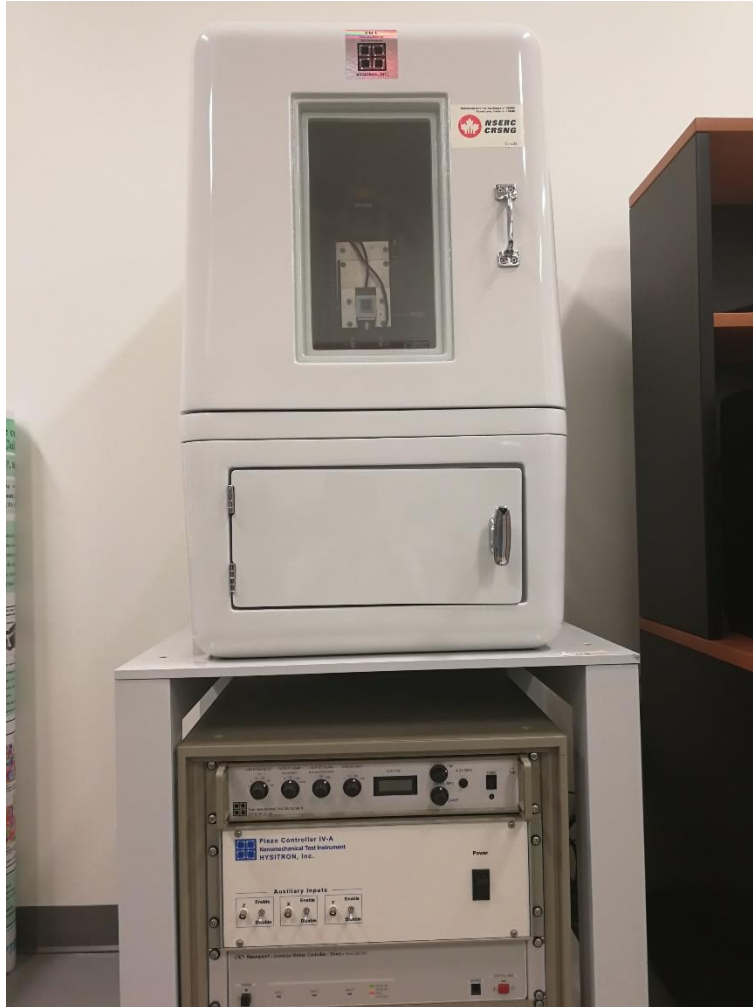
Figure 3.4 Hysitron nanoindentation machine.

The elastic modulus was measured by Hysitron nanoindentation machine (Figure 3.4) with a load of 2500 μN .

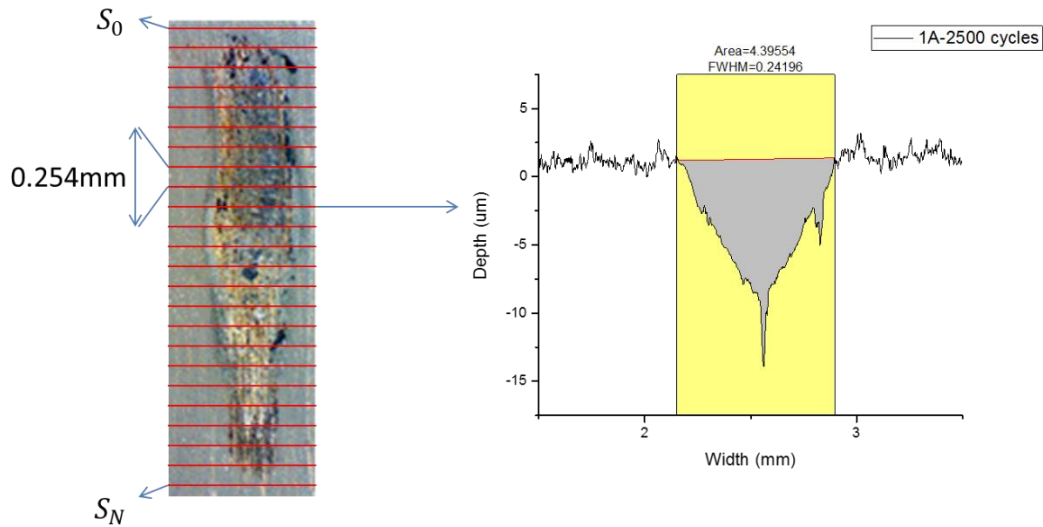
Figure 4.1 Setup illustration of measuring wear volume loss.

where V_w is the wear volume loss, S_i is the section area of the i -th measurements along the wear track, as demonstrated in Figure 4.1.

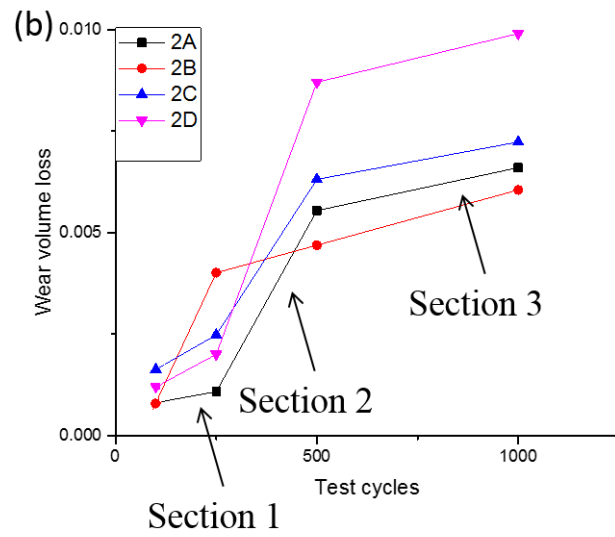
Figure 4.2 Wear volume loss vs. test cycles curves for nitrided die materials (a) D6510, and (b) S0050A.

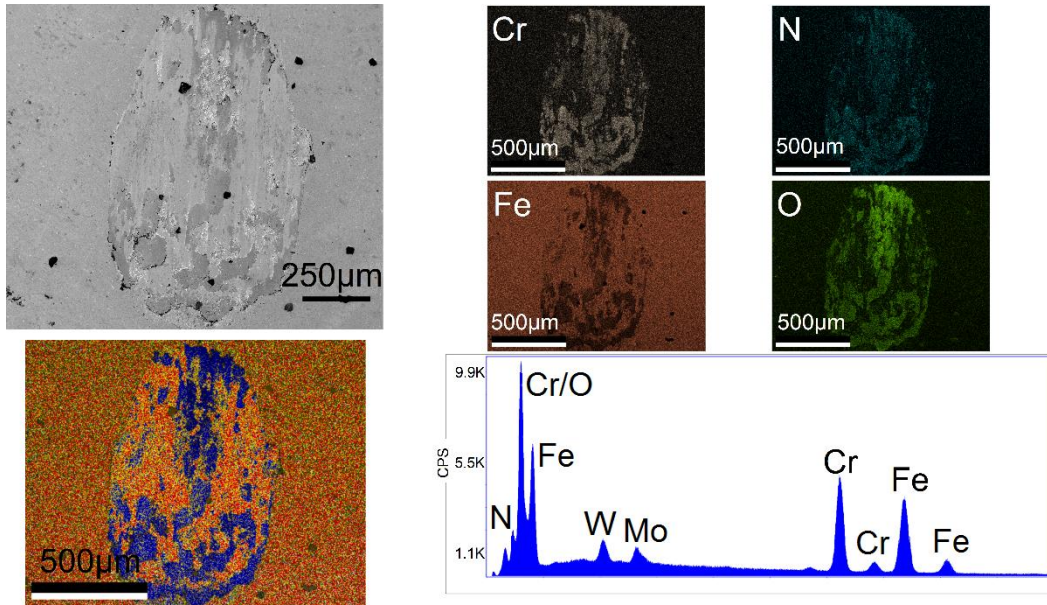
Figure 5.5 SEM images of the wear scar on the M50 steel ball after 100 cycles test at room temperature. Inserts are the live map (with EDS spectra) and elements map.
