Mechanics and mechanisms of surface damage in Al-Si alloys under ultra-mild wear conditions

**MECHANICS AND MECHANISMS OF SURFACE
DAMAGE IN Al-Si ALLOYS UNDER ULTRA-MILD WEAR
CONDITIONS**

**A Dissertation
Submitted to the Faculty of Graduate Studies
through the Engineering Materials Program
in Partial Fulfillment of the Requirements for
the Degree of Doctor of Philosophy
at the University of Windsor**

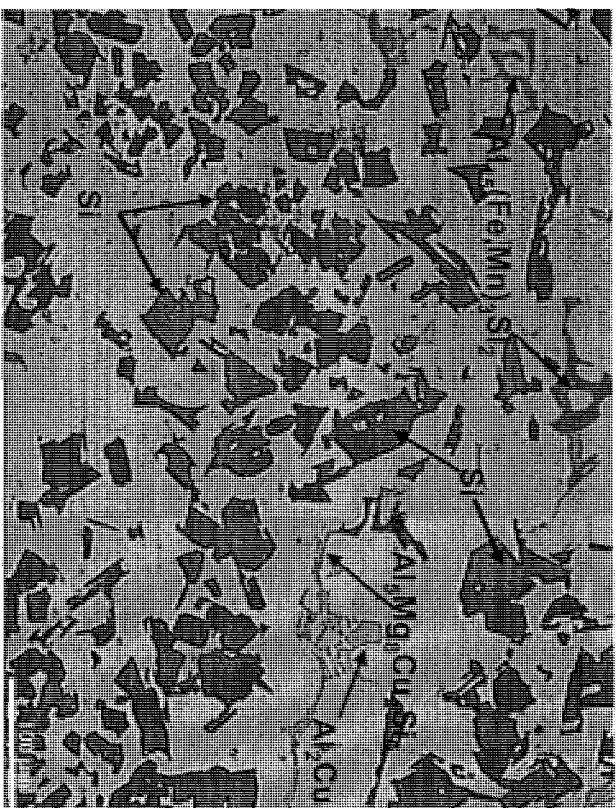
Fig. 3.8. Optical micrograph showing the microstructure in Al-18.5% Si.
